ALAMEDA DAM

CASE STUDY

BUREAU OF LAND MANAGEMENT
DAM SAFETY INSPECTION REPORT
ALAMEDA DAM

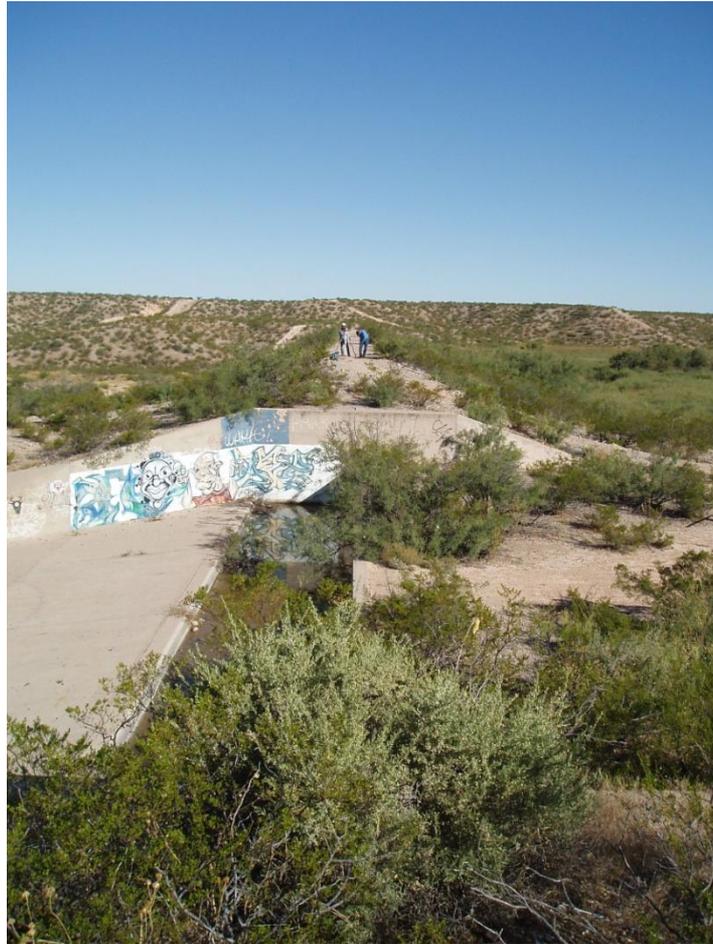
Item No.	Item	N/A	Y	N	CAR RIM	Flag No.	Remarks
a	Any Visual Settlements		x				Minor – surface erosion
b	Cracking			x			
c	Lateral Movement			x			
d	Visible Sinkhole			x			
e	Erosion		x				Minor – surface erosion
f	Trees & Brush		x				Along edges, 3' high
g	FAMs Road on Crest			x			
h	Rodent holes			x

PHOTO: LOOKING ACROSS CREST OF DAM FROM LEFT TO RIGHT

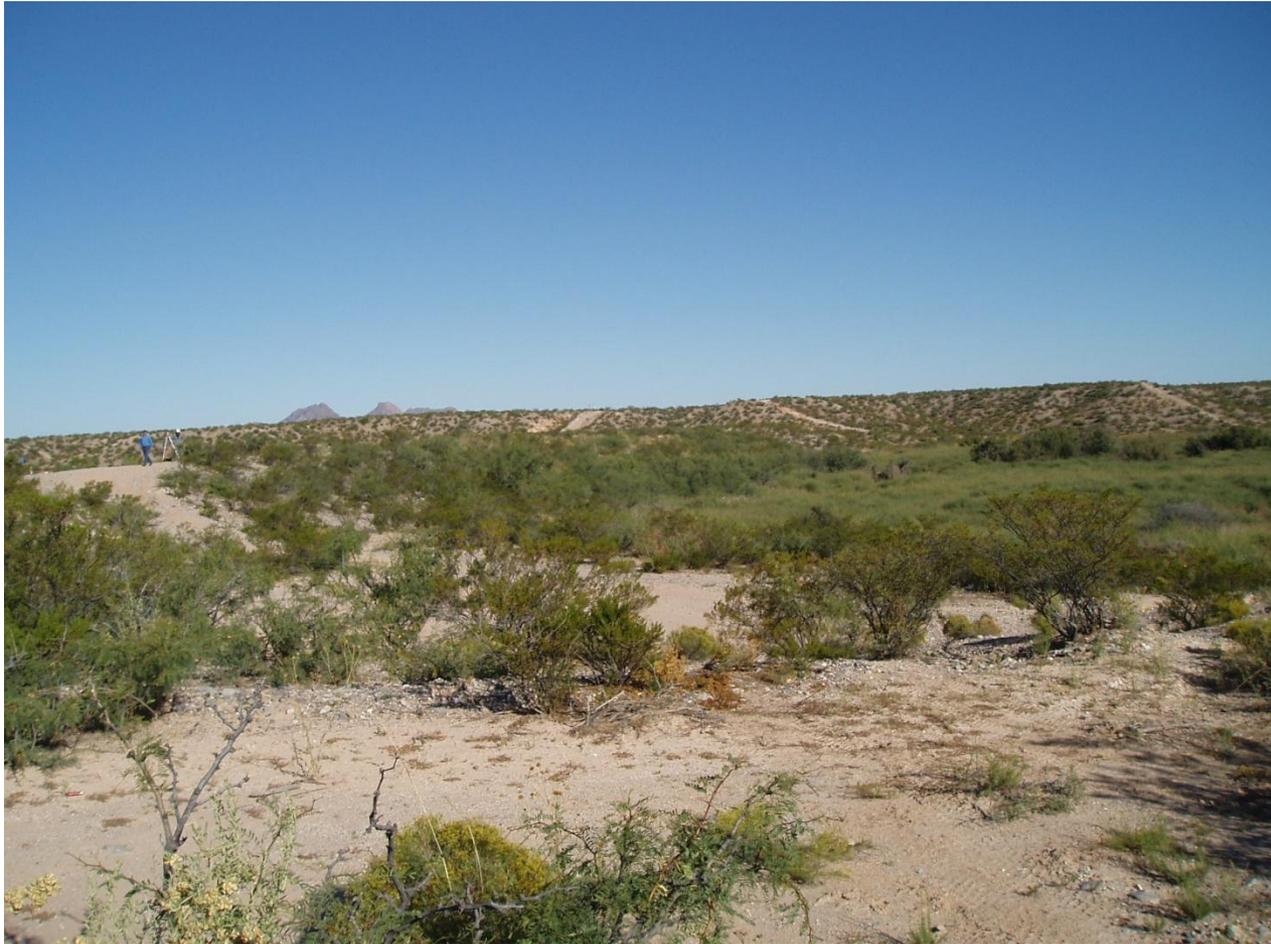
Item No.	Item	N/A	Y	N	CAR RIM	Flag No.	Remarks
a	Erosion		x		R	4	
b	Trees & Brush		x		R	5	
c	Longitudinal Cracks	x				5	
d	Transverse Cracks	x				5	
e	Visual depressions or bulges	x				5	
f	Visual settlements	x				5	
g	Visible sinkhole	x				5	
h	Debris		x		R		By intake structure
i	Rodent holes			x

- CALCULATIONS NOTE: Recommended work items listed below were discovered during the field inspection. List Flag No.'s from checklist and comment as needed. Group similar items, calculate estimated quantities, and enter totals on Summary .
4. **1 foot of debris on top of trash rack and around bottom 5 feet of intake structure. Scour around right half of intake and up to 8 feet vertical height of upstream slope of embankment. Sediment deposit in impoundment area and along left side of intake structure.**
 5. **Vegetation covers 90% of upstream slope impeding ability to inspect upstream face of embankment. Mesquite is 8'+ and other brush is up to 5' high. Vegetation should be removed.**

PHOTO: LOOKING ACROSS UPSTREAM FACE OF DAM FROM LEFT TO RIGHT

This dam is in poor condition due to the amount of vegetation growth on the upstream face of the embankment. The vegetation is up to 8 feet tall and covers 90% of the upstream face impeding the ability to inspect the upstream face for cracks, depressions, sink holes and settlement. Recommend removing all vegetation from dam embankment (upstream face, downstream face, and crest) and both spillways.

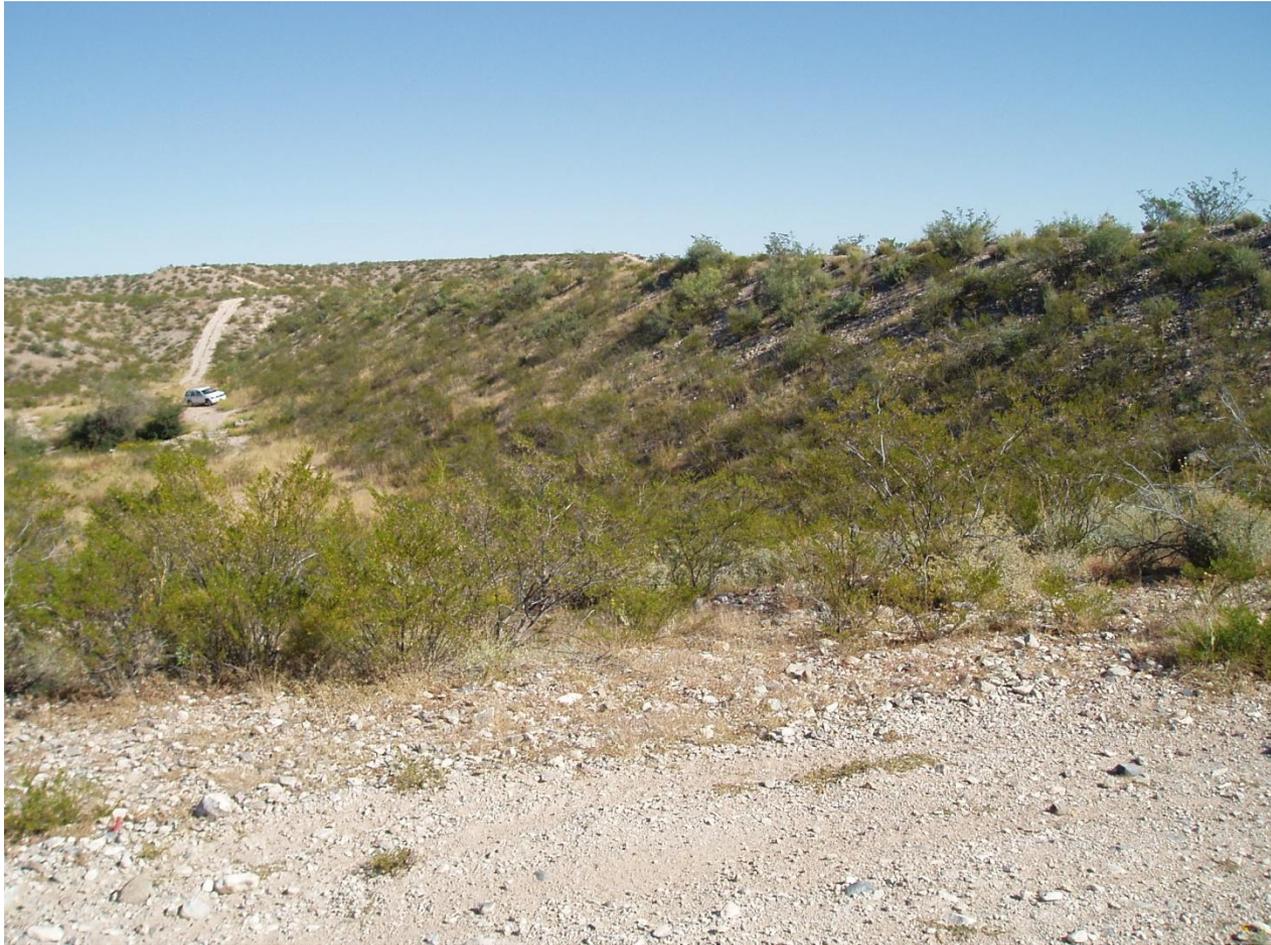
Item No.	Item	N/A	Y	N	CAR RIM	Flag No.	Remarks
a	Erosion		x		R	3	
b	Trees & Brush		x				Up to 6' high, 75% coverage
c	Longitudinal Cracks			x			
d	Transverse Cracks			x			
e	Visual depressions or bulges			x			
f	Visual settlements			x			
g	Visible sinkhole			x			
h	Boils present at toe			x

PHOTO: LOOKING ACROSS DOWNSTREAM FACE OF DAM FROM LEFT TO RIGHT

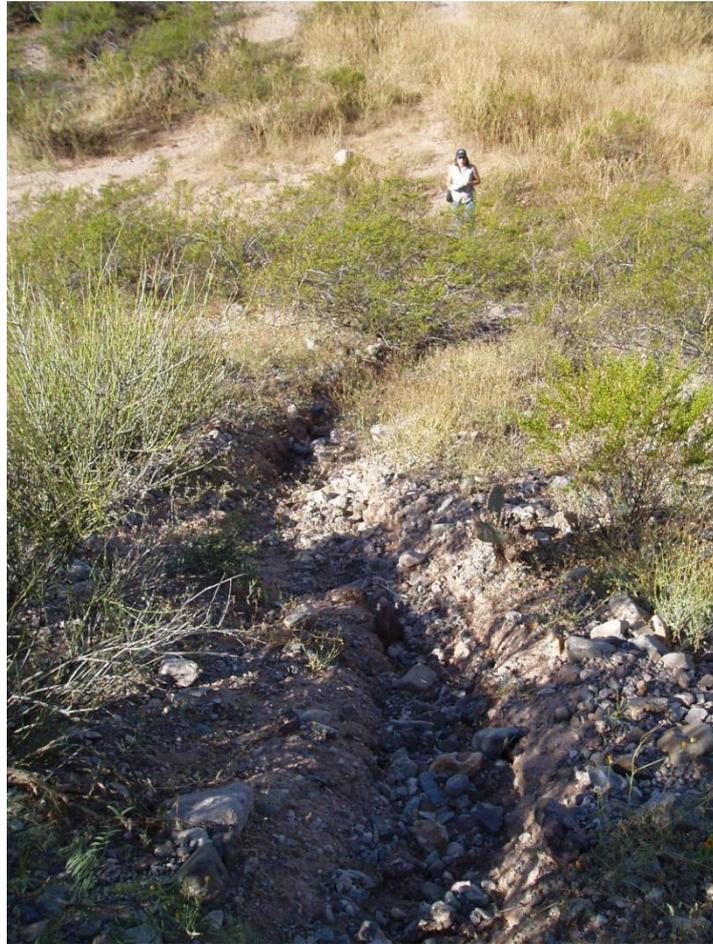
3. **Several locations of surface runoff erosion on downstream face of embankment (Sta. 3+18, 4+82, 6+62, 7+60 and above conduit). Max. depth of erosion is 2' deep at Sta. 6+62. There appears to be vehicle tracks near the erosion at Sta. 6+62. Both downstream groins also have surface erosion. This erosion should be repaired.**

PHOTO: Erosion downstream face at Sta. 3+18

The downstream face of the embankment has several areas showing signs of erosion including the groins. This erosion is up to 2 feet deep in some locations. In addition, the upstream face also is eroding near the intake structure. These areas should be repaired so that rainfall runoff does not concentrate in these locations creating further damage.

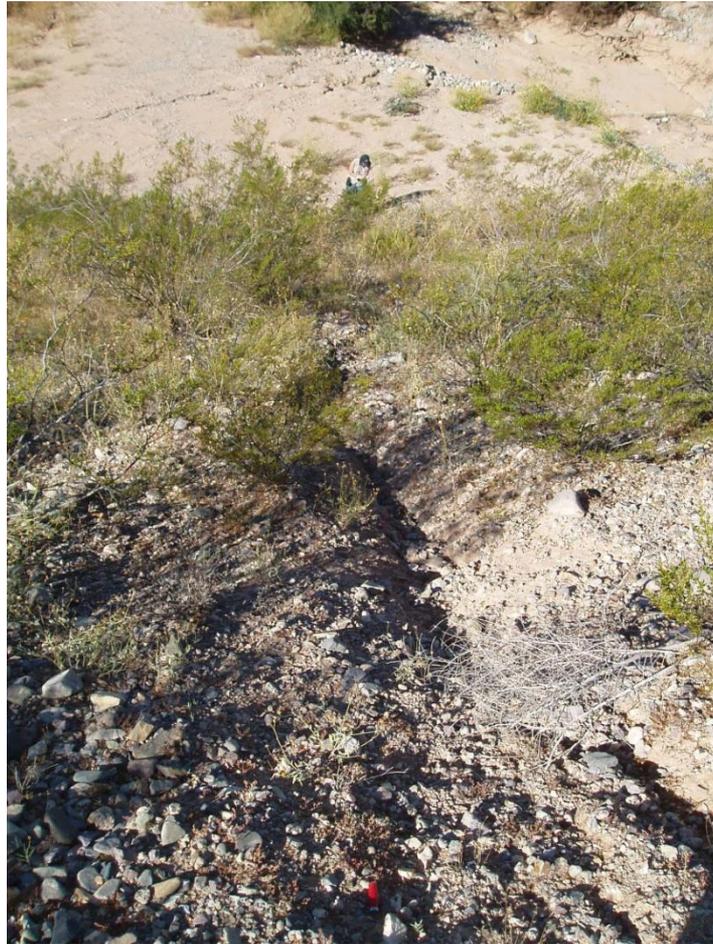
PHOTO: Erosion upper half of downstream face at Sta. 4+82

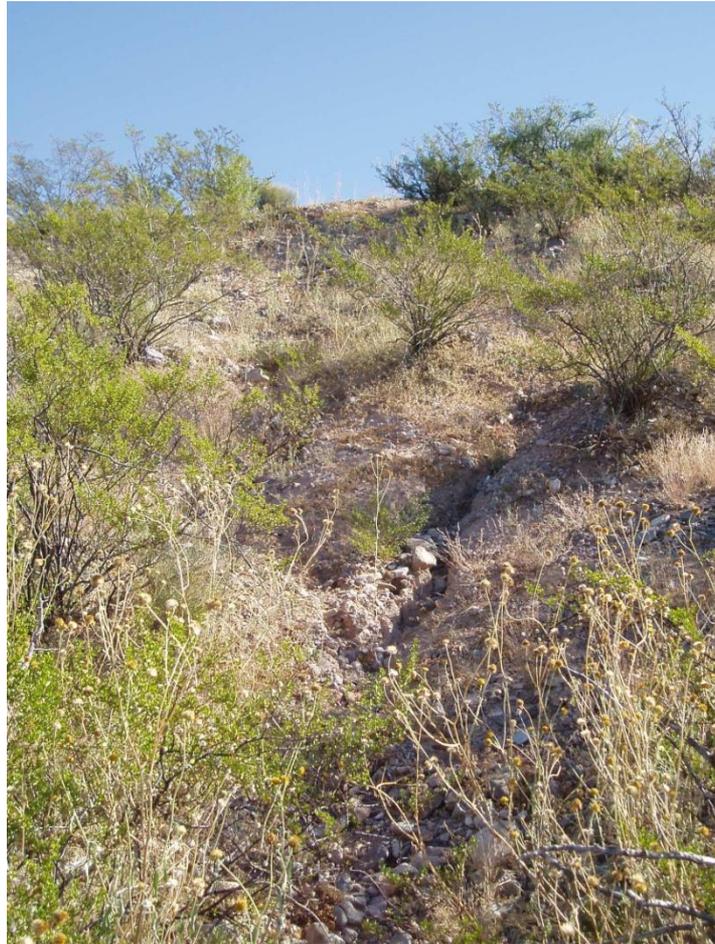
PHOTO: Erosion on downstream face above outlet works

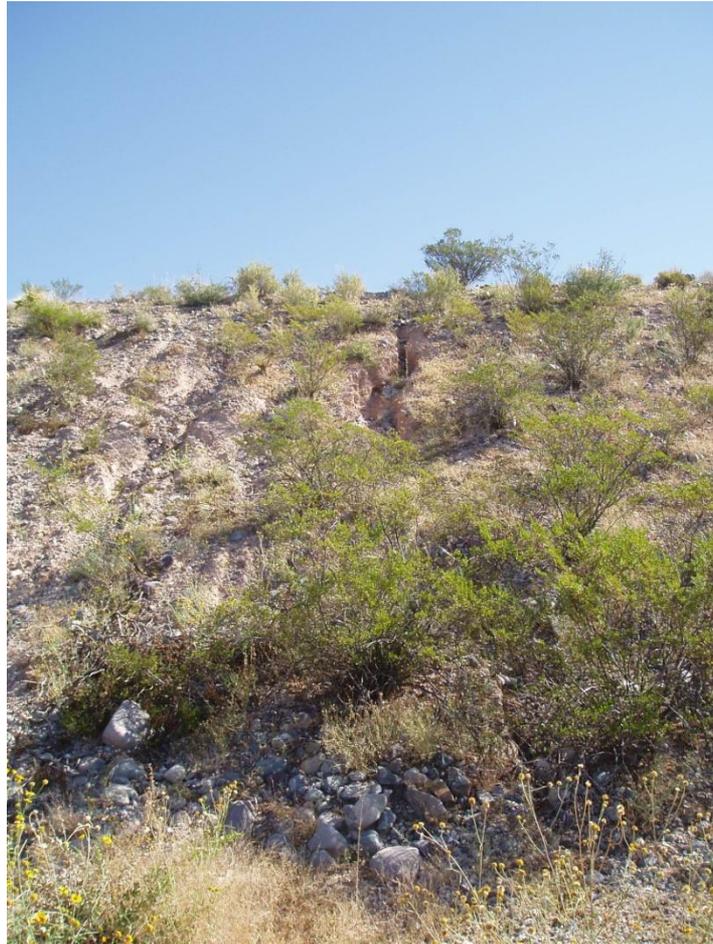
PHOTO: Downstream face, surface erosion at Sta. 6+62

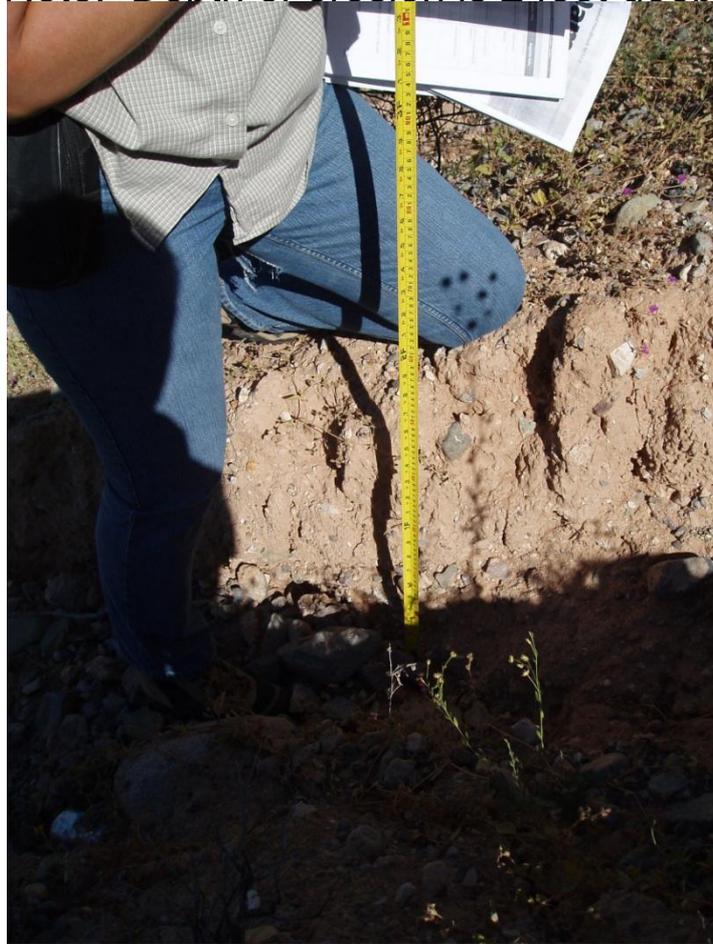
PHOTO: Close up of surface erosion at Sta. 6+62, downstream face.

Note: Depth of erosion is 2 feet deep.

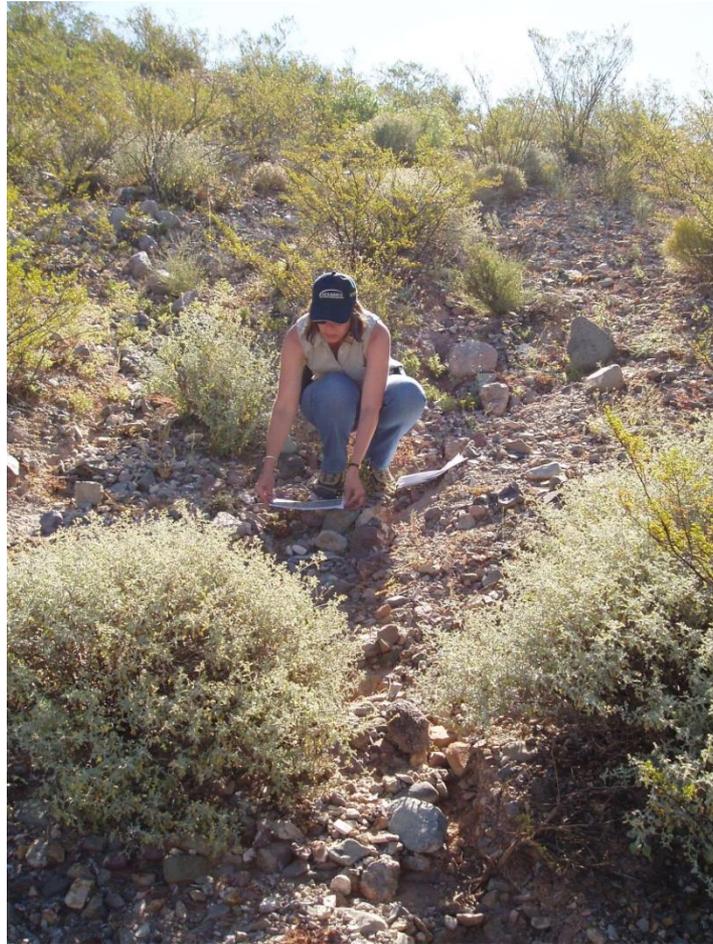
Item No.	Item	N/A	Y	N	CAR RIM	Flag No.	Remarks
a	Erosion		x		RM	3	
b	Visual differential movement			x			
c	Cracks			x			
d	Seepage Present			x			
e	Trees & Brush		x

PHOTO: Left downstream face groin, surface erosion.

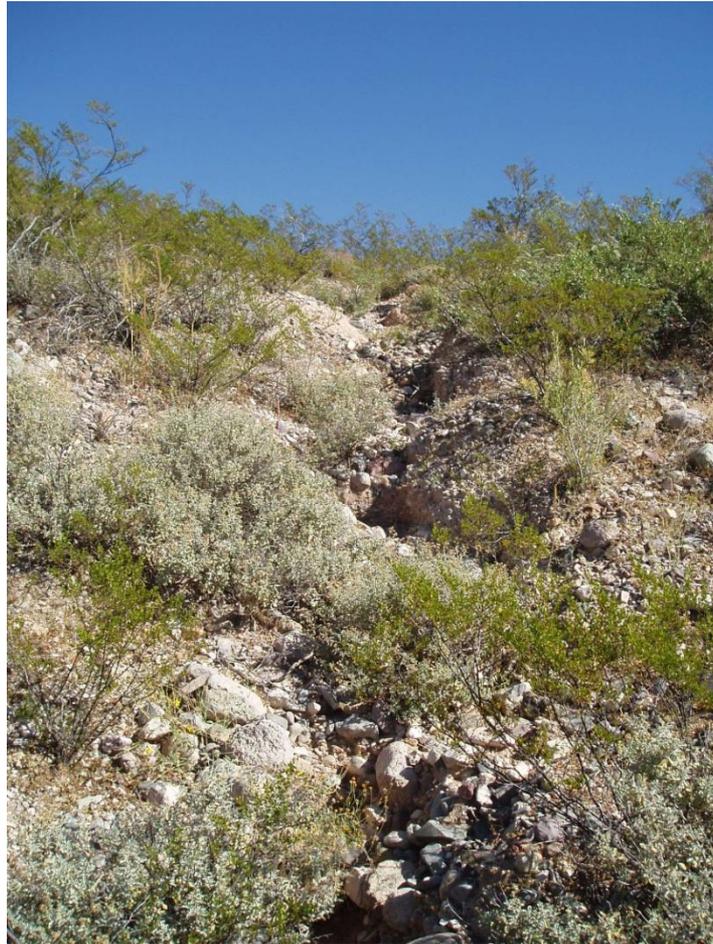
PHOTO: Surface erosion, right downstream face groin

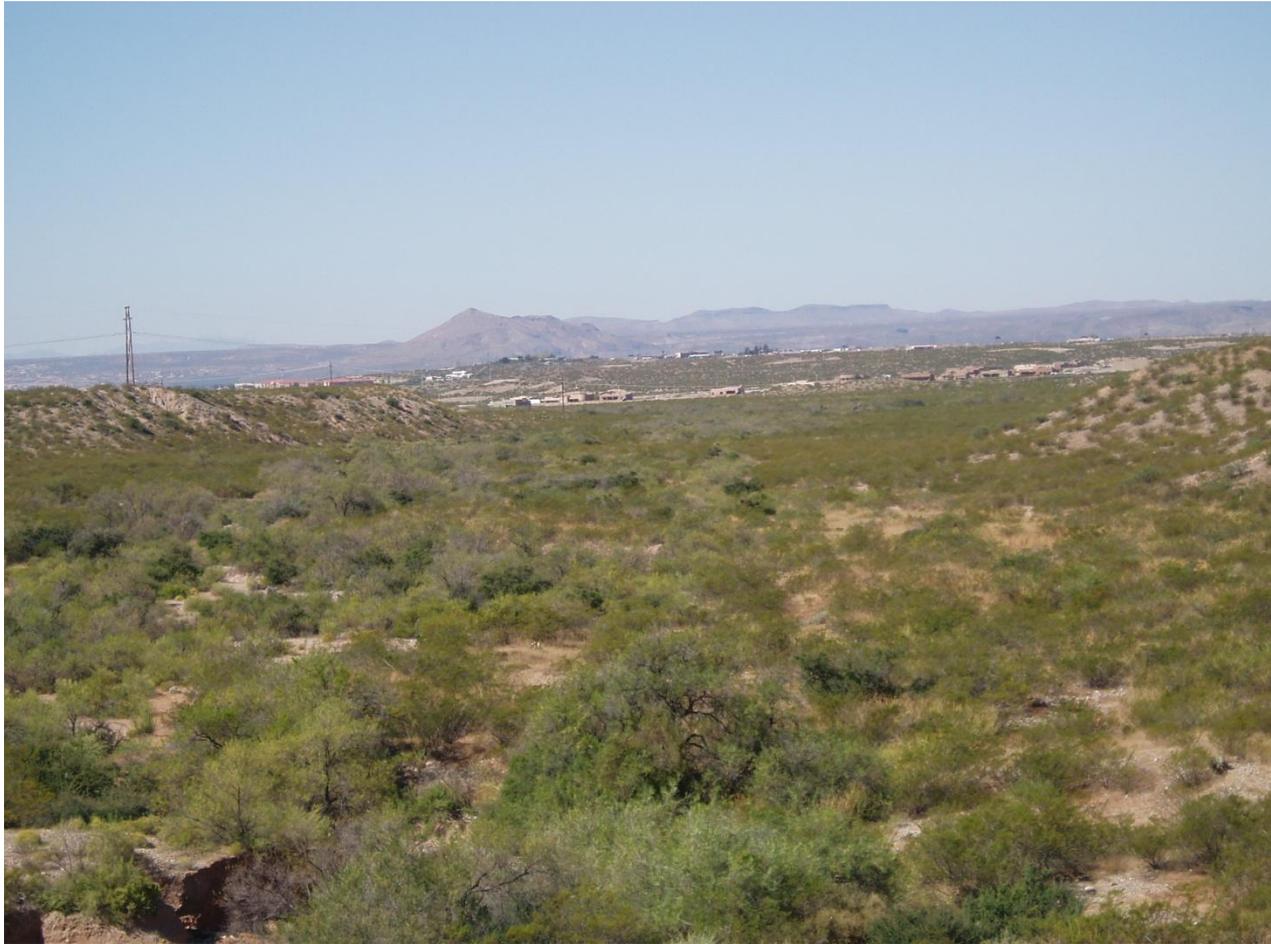
Describe any development within 3 miles downstream since the last inspection. If none, write "None":
There are numerous new housing and commercial developments downstream of the structure.

PHOTO: Looking downstream at recent development

- YES, as we understand this dam does not have a classification assessment. With the number of houses downstream, we recommend that the District have BOR or an A-E perform a hazard classification.

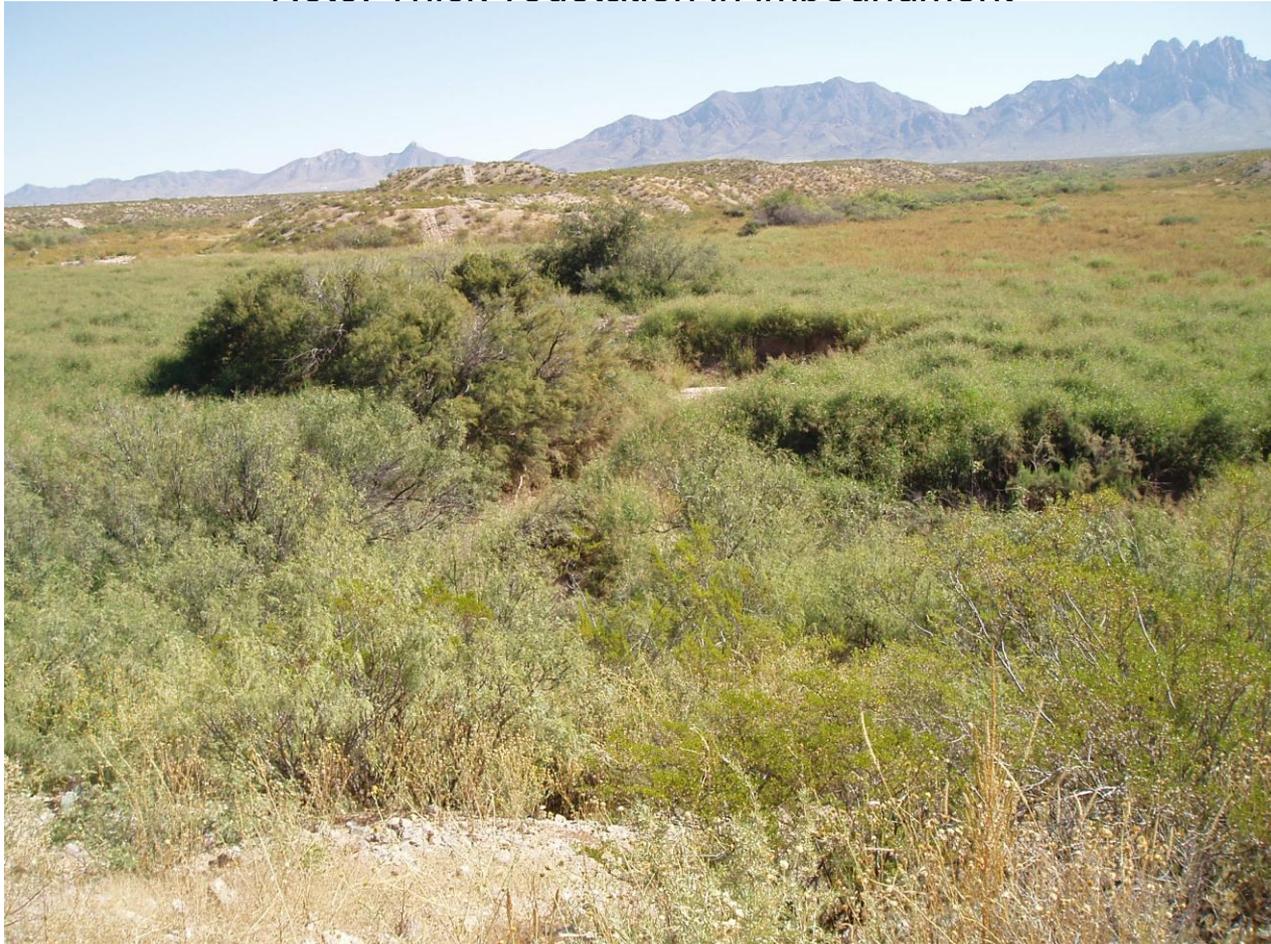
PHOTO: Looking upstream at impoundment from Sta. 5+21

Note: Thick vegetation in impoundment

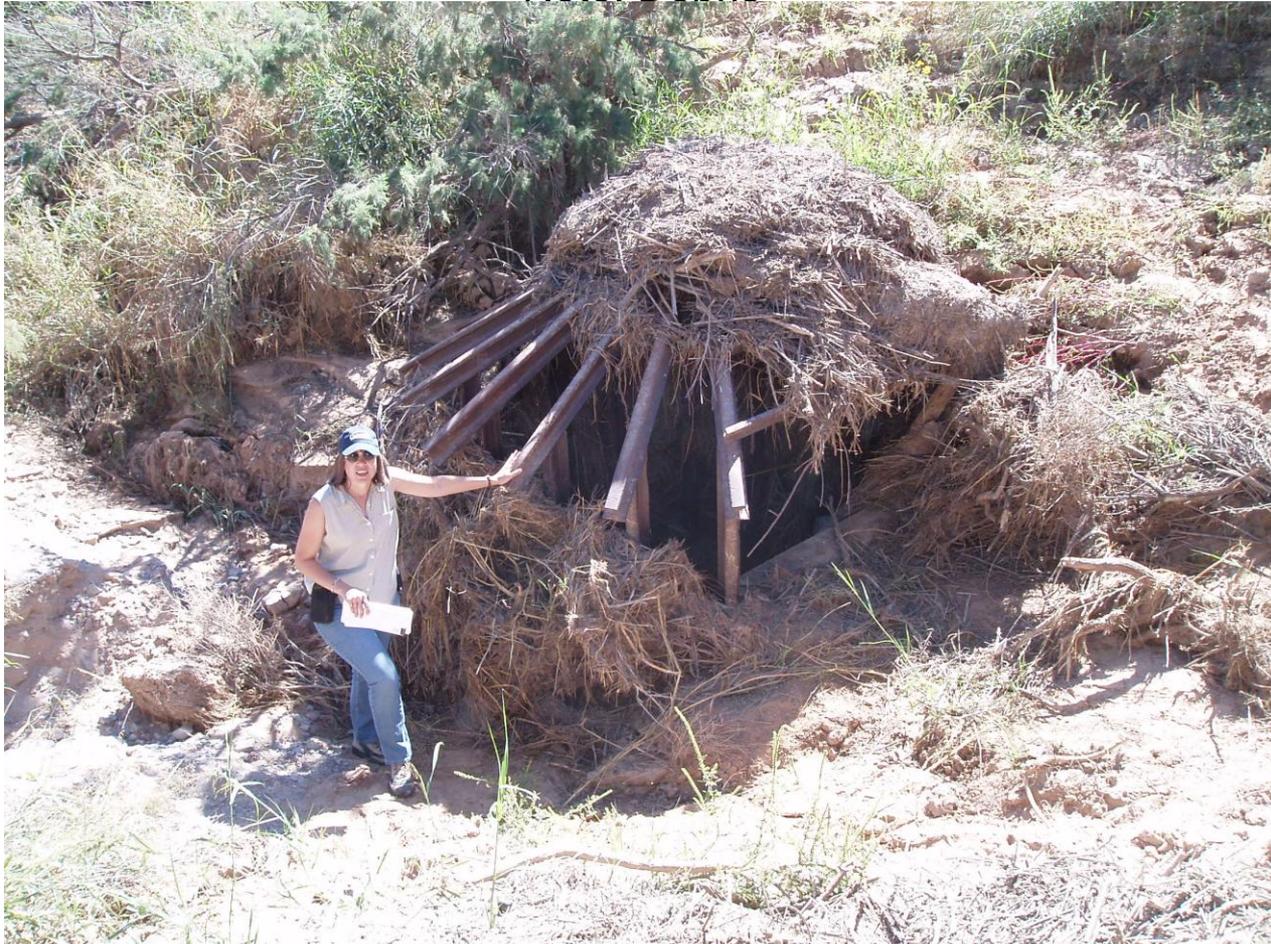
Item No.	Item	N/A	Y	N	CAR RIM	Flag No.	Remarks
c.	Joint condition	x					
(1)	Displacement or offset	x					
(2)	Loss of joint material	x					
(3)	Leakage	x					
d.	Metal appurtenances		x				8' dia. X 8' high trash rack
(1)	Corrosion present		x				On RR iron trash rack
(2)	Breakage present			x			
(3)	Anchor system secure		x

PHOTO: Looking RR tie trash rack at intake structure

Note: Debris

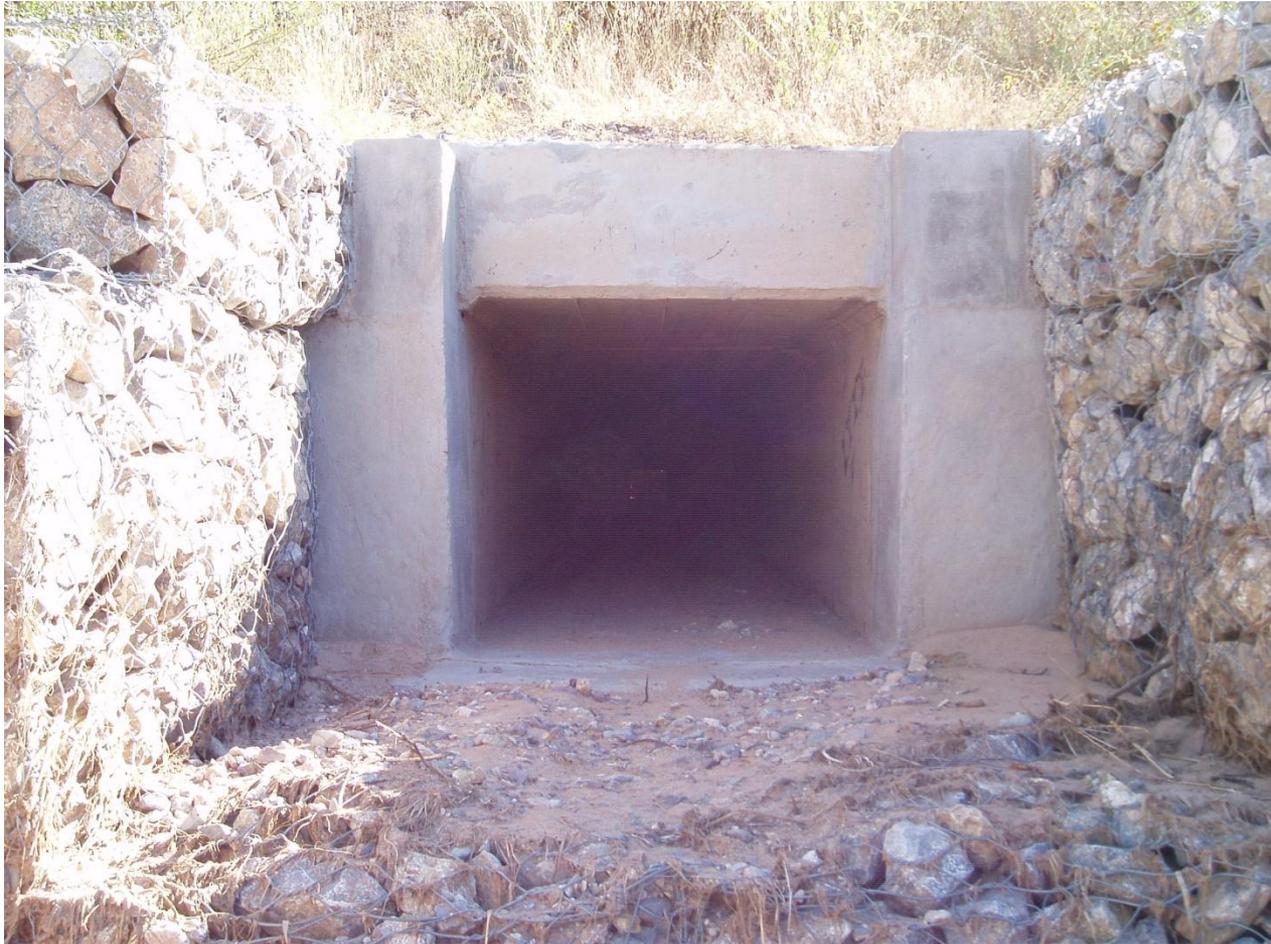
Item No.	Item	N/A	Y	N	CAR RIM	Flag No.	Remarks
a	Is Conduit Concrete		x				42" wide x 36" high
b	Concrete Surface condition						
(1)	Spalling		x				Minor at inlet
(2)	Cracking			x			
(3)	Erosion			x			
(4)	Scaling		x				Minor on outlet
(5)	Exposed reinforcement			x			
(6)	Displacement or offset			x

PHOTO: Looking upstream at conduit outlet

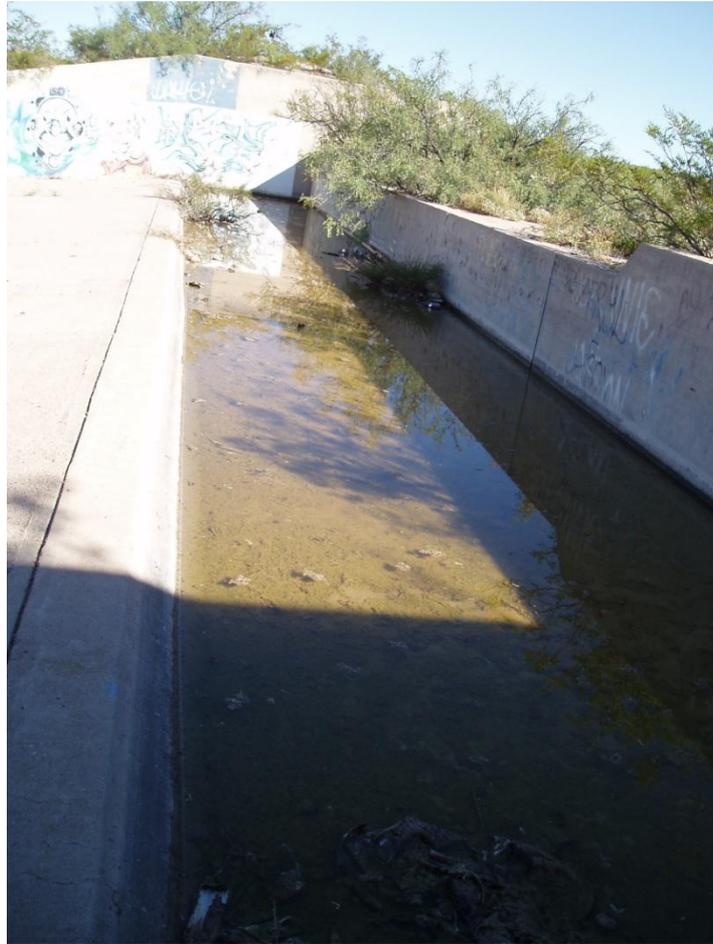
PHOTO: Water and silt in concrete stilling basin, left emergency spillway

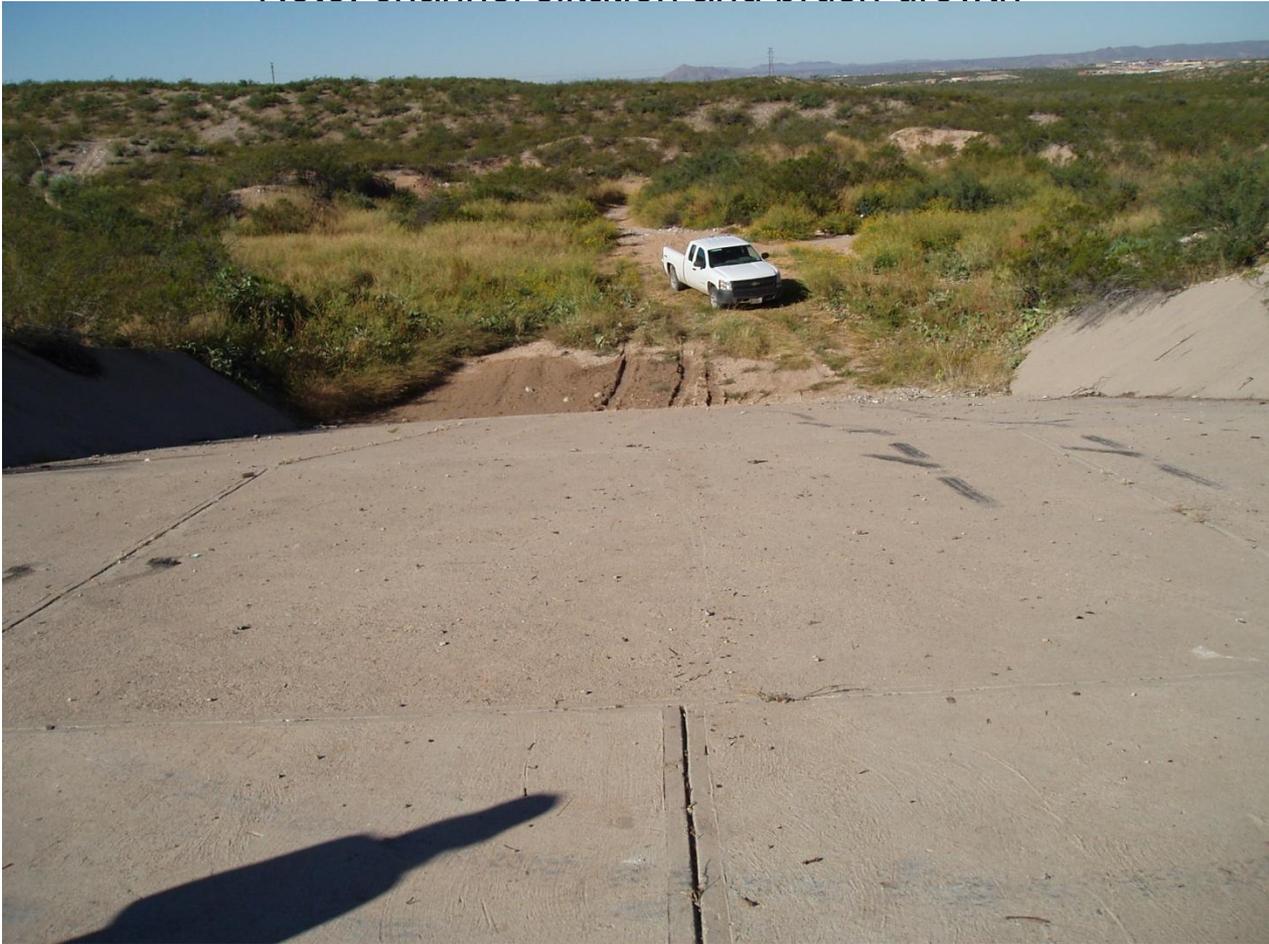
Item No.	Item	N/A	Y	N	CAR RIM	Flag No.	Remarks
d	Channel Condition						Full of Sediment
(1)	Eroding or backcutting			x			
(2)	Sloughing			x			
(3)	Obstructed		x				Sediment and brush
(4)	Undercut by released water			x			
(5)	Embankment erosion by released water			x

PHOTO: Looking downstream through left emergency spillway

Note: channel siltation and brush growth

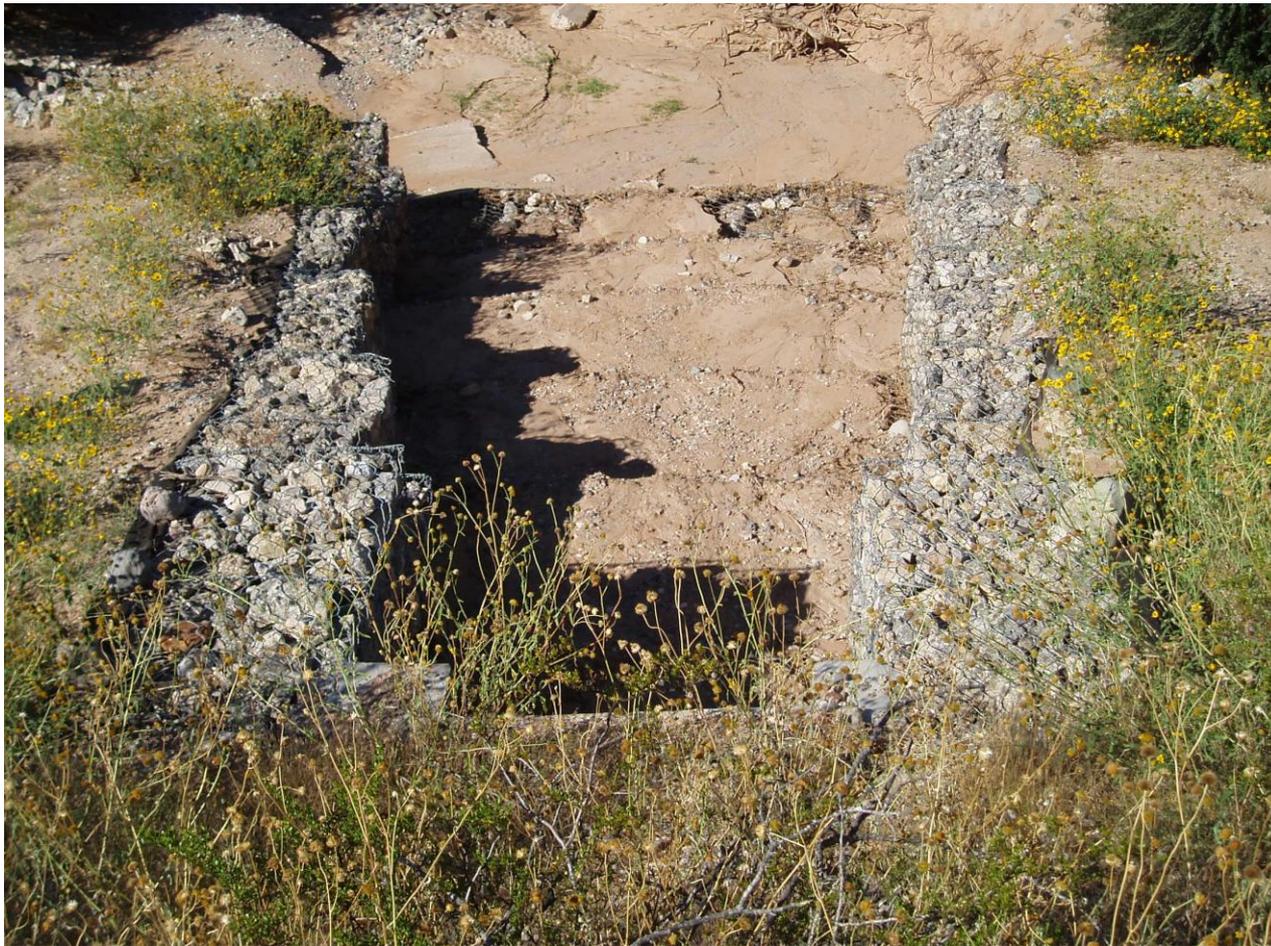
PHOTO: Looking downstream thru gabion stilling basin at conduit outlet

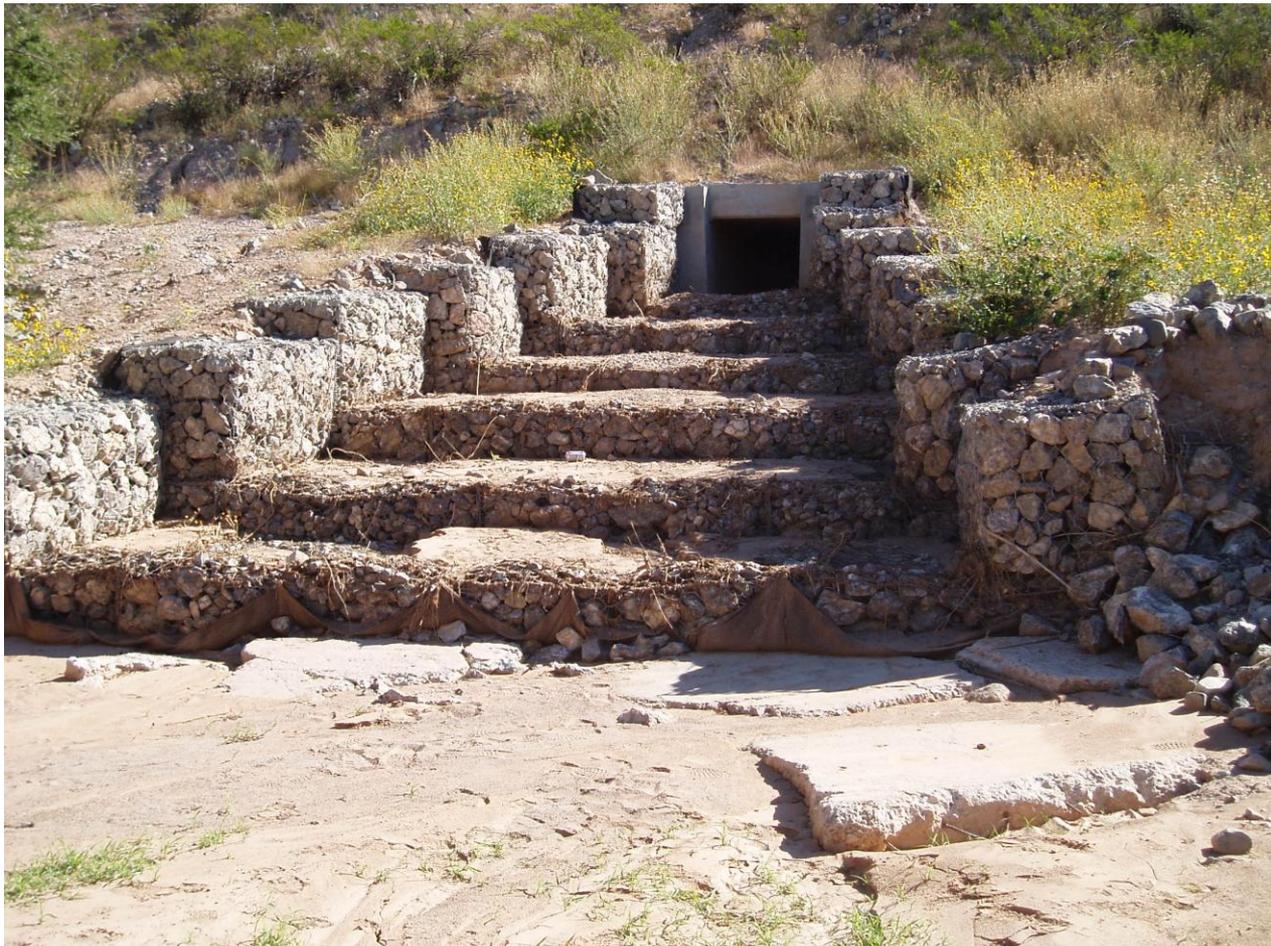
PHOTO: Looking upstream thru gabion stilling basin at conduit outlet

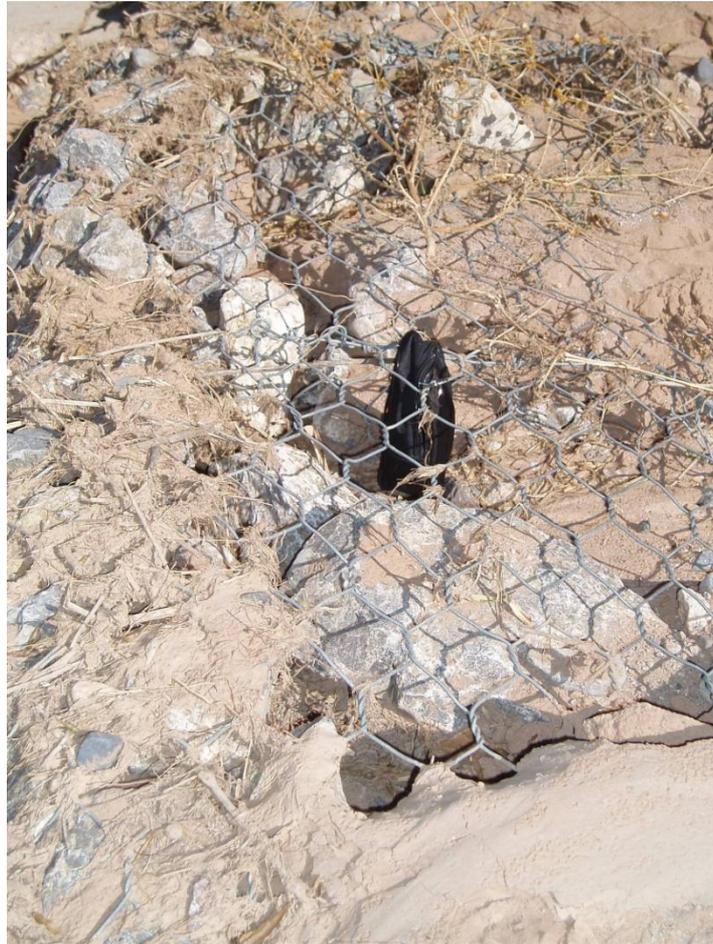
Item No.	Item	N/A	Y	N	CAR RIM	Flag No.	Remarks
e	Gabion condition						@ Conduit Outlet works
(1)	Corroded			x			
(2)	Baskets misalign			x			
(3)	Basket settlement		x		R	2	Scour of gabion rock
(4)	Brush growing in gabions			x			
f	Riprap Condition						Left side by gabion structure
(1)	Erosion, undercut or settlement		x				
(2)	Vegetation			x			
(3)	Extent of riprap adequacy			x	R		Could use more on top
(4)	Migration of riprap		x		R	2

PHOTO: Scour in gabion baskets due to undersize rock

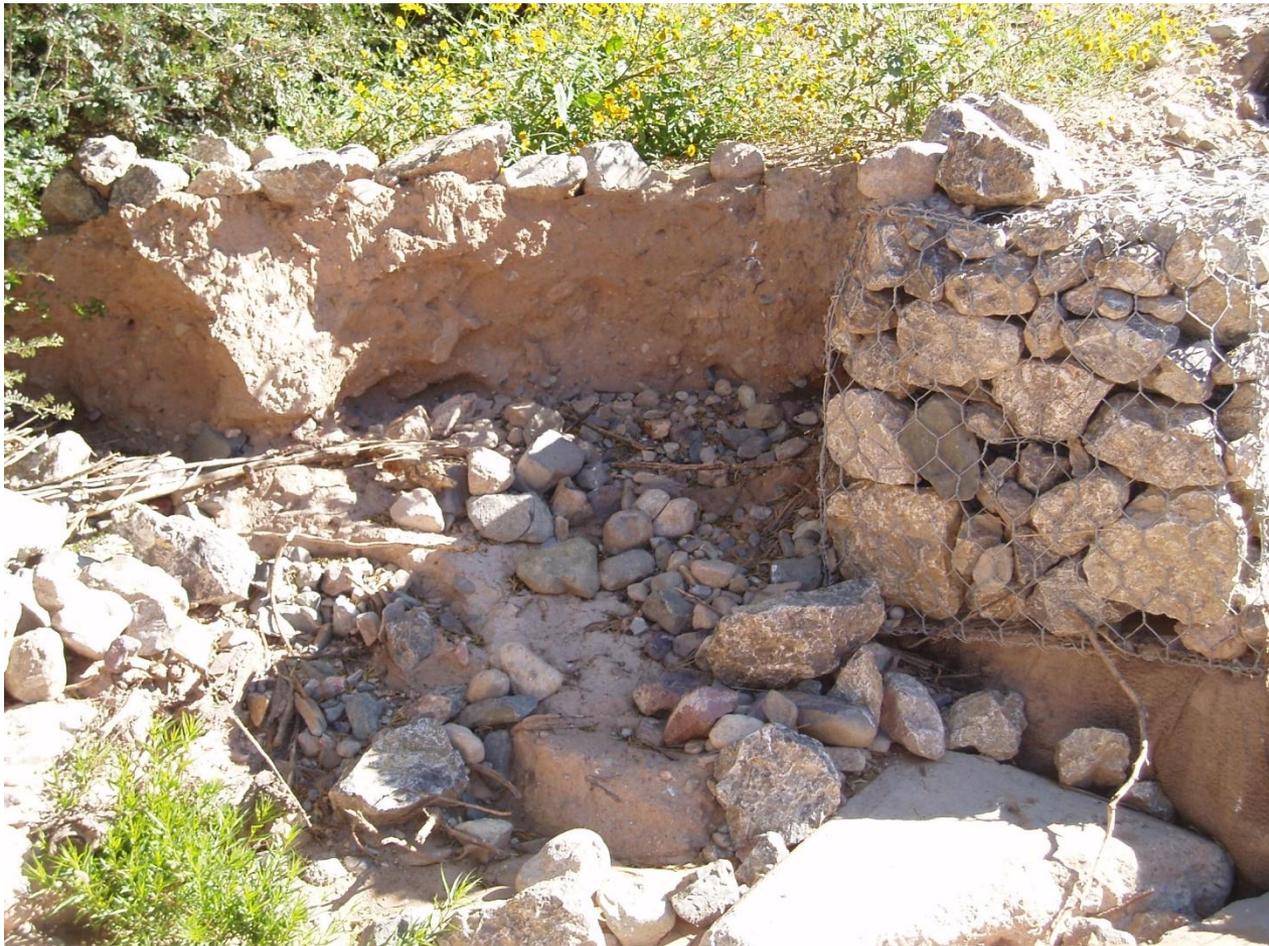
PHOTO: Scour at end of gabion stilling basin, right side

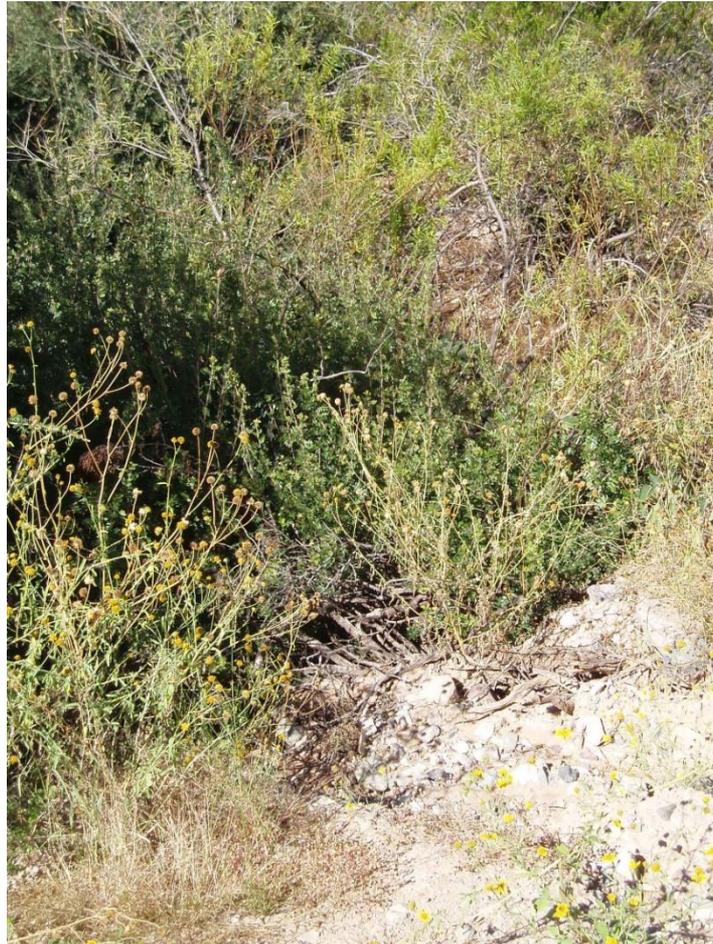
PHOTO: Brush growing in old scour pocket to the right of the gabion stilling basin

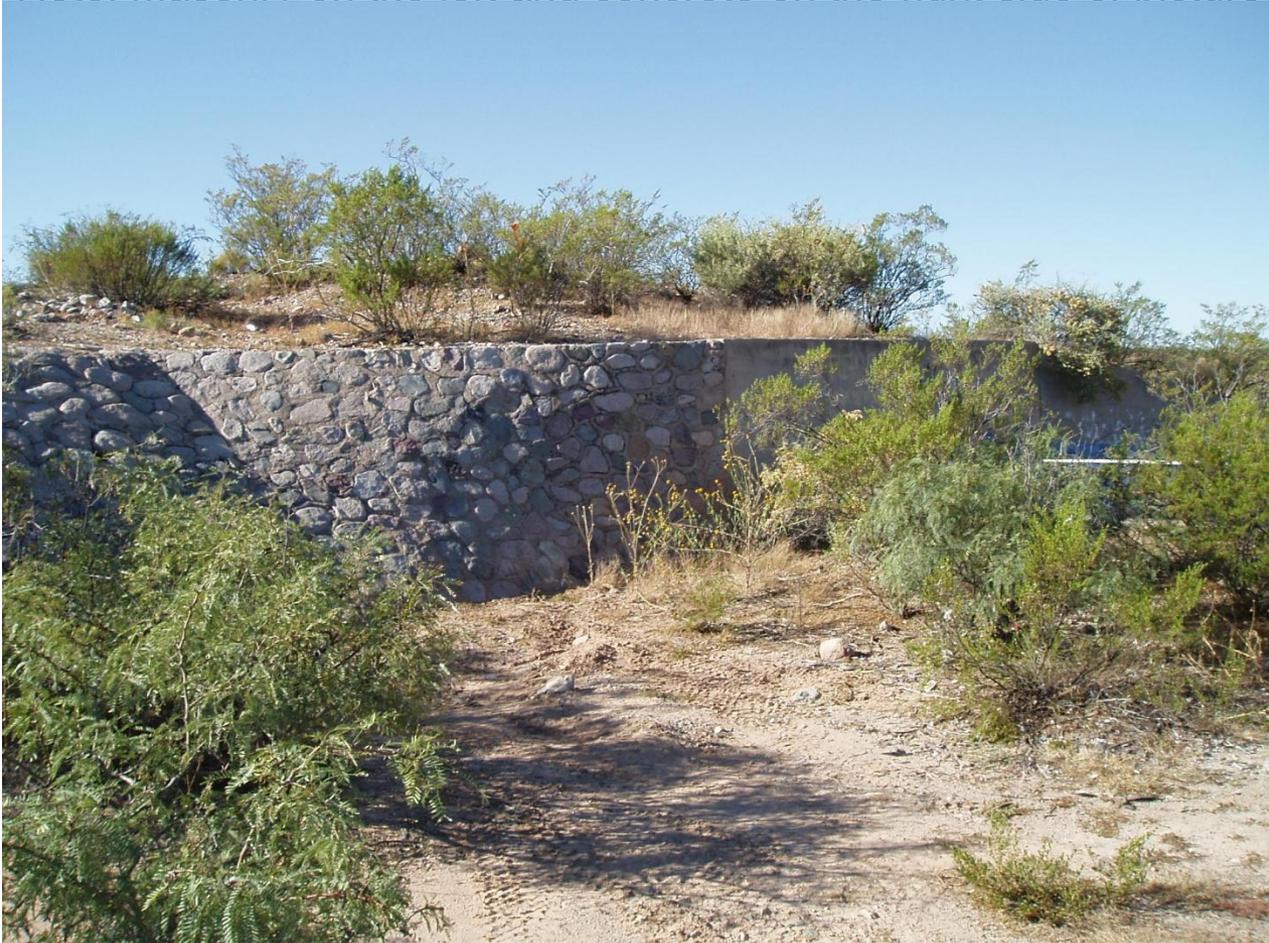
PHOTO: Change of material on left wing wall of left emergency spillway

Note: Masonry on the left and concrete on the right side of picture
