ALAMEDA DAM

CASE STUDY

BUREAU OF LAND MANAGEMENT
DAM SAFETY INSPECTION REPORT
ALAMEDA DAM

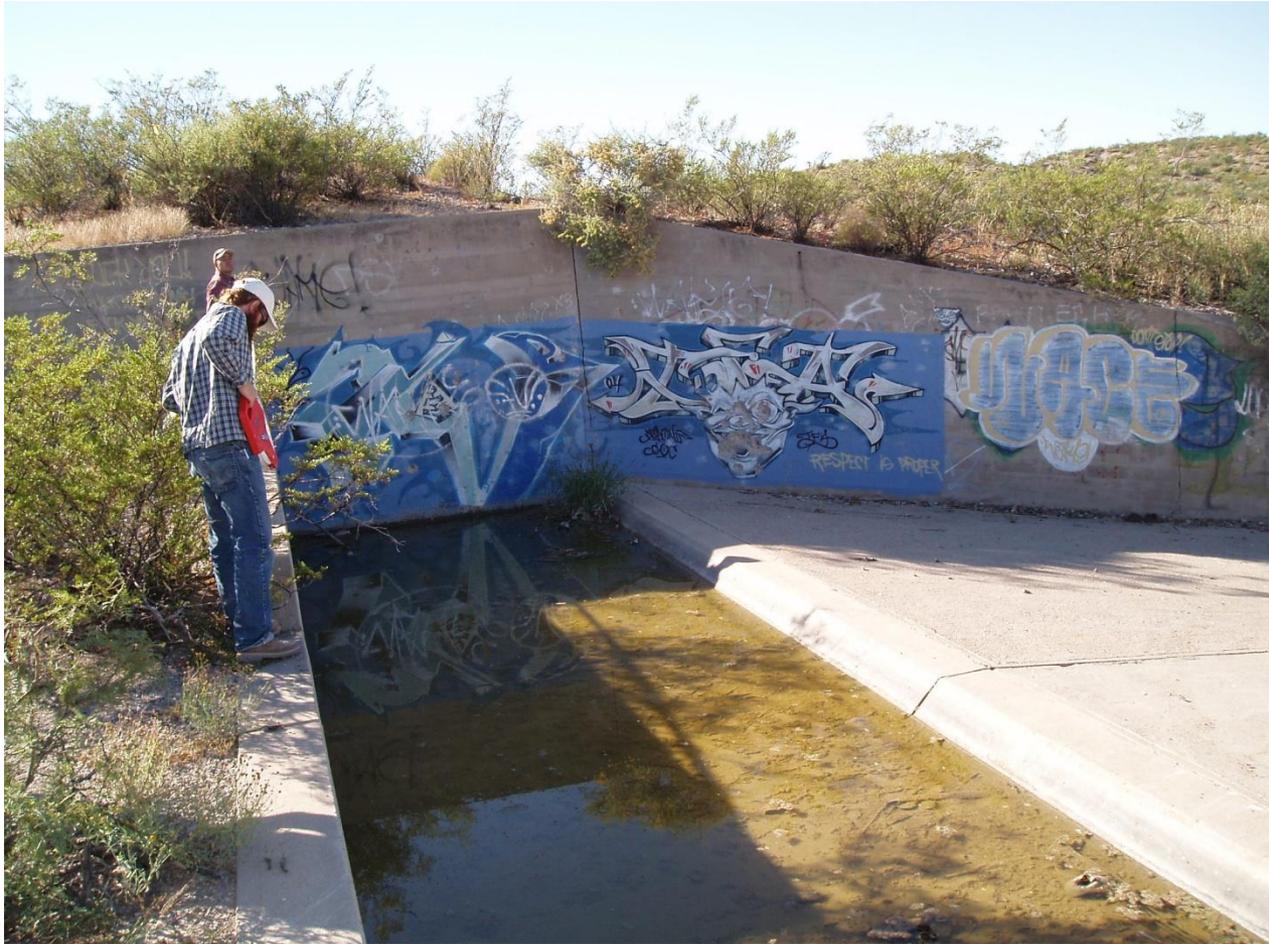
PHOTO: Graffiti on left wall of left emergency spillway

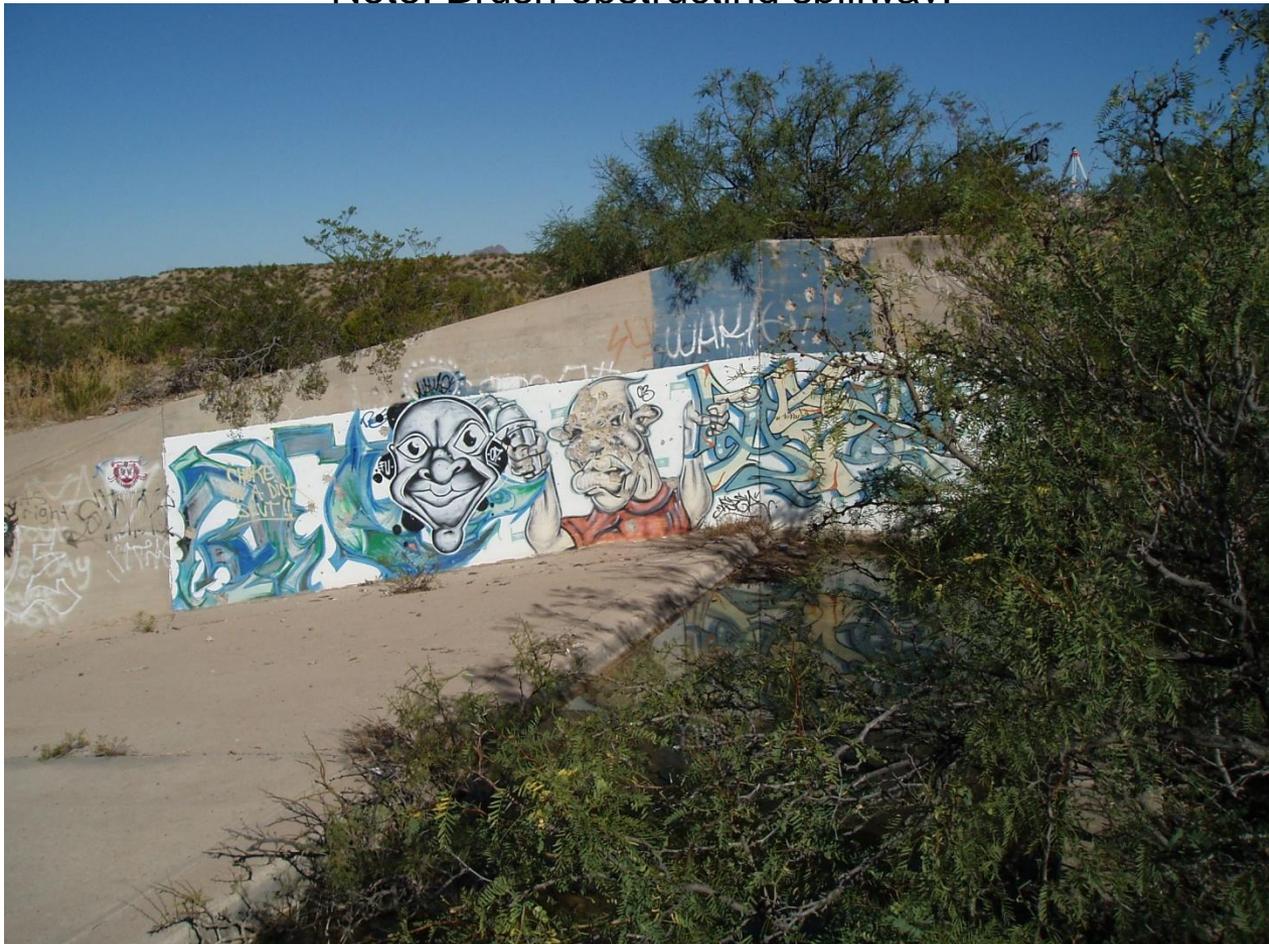
PHOTO: Graffiti on right wall of left emergency spillway

Note: Brush obstructing spillway.

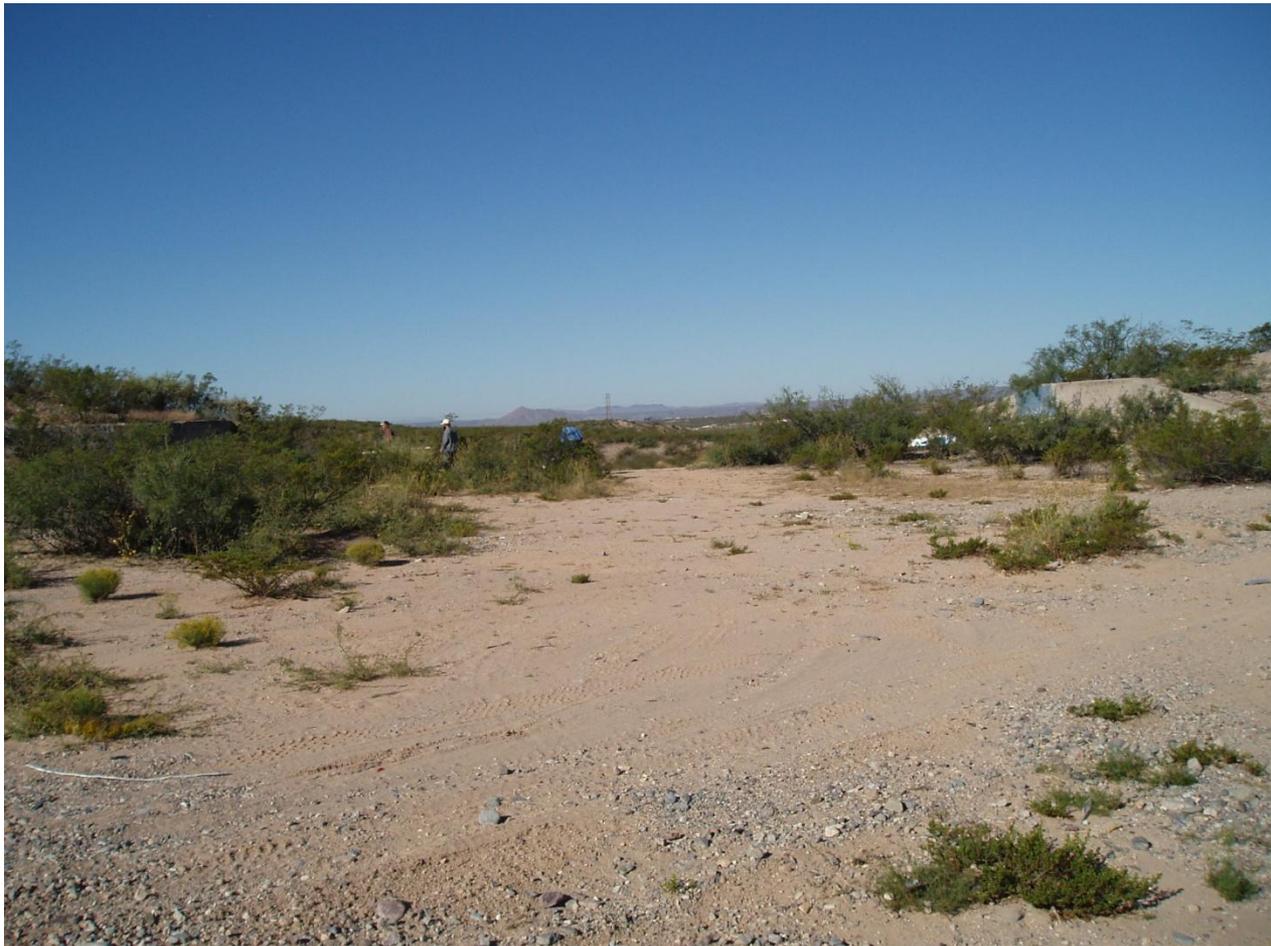
PHOTO: Looking downstream through approach channel of left emergency spillway

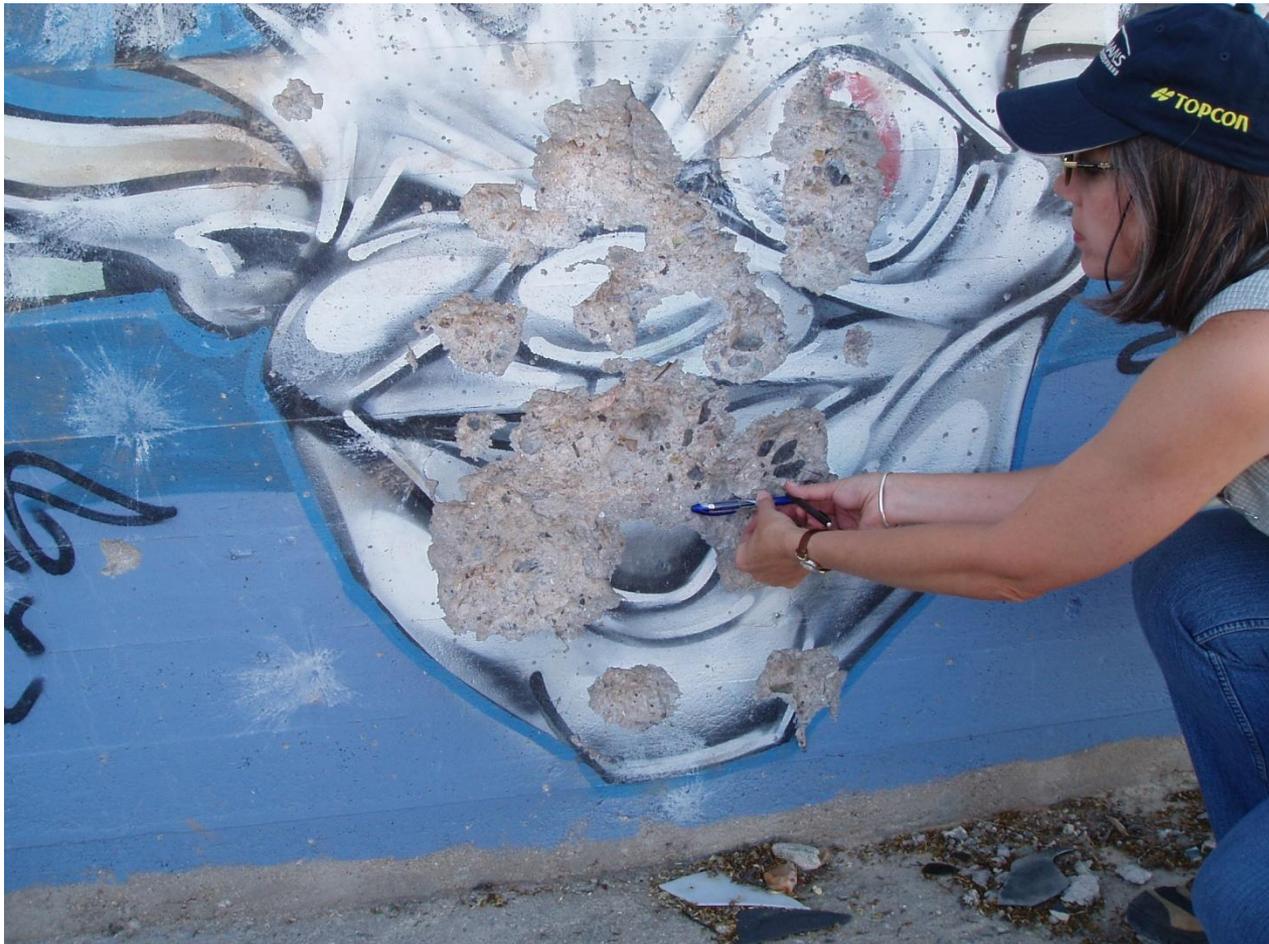
Item No.	Item	N/A	Y	N	CAR RIM	Flag No.	Remarks
a	Spillway Concrete condition						Left emergency spillway
(1)	Spalling		x				Bullet damage
(2)	Cracking		x				Minor
(3)	Erosion		x				Vehicle tracks at outlet
(4)	Scaling		x				
(5)	Exposed reinforcement			x			
(6)	Concrete undercut			x			
(7)	Settlement			x			
(8)	Other: graffiti		x				On both wing walls
(9)	Trees & Brush - Obstructed		x				In approach channel, on wing walls, and veg. in joints

PHOTO: Bullet damage and graffiti on left wall of left emergency spillway

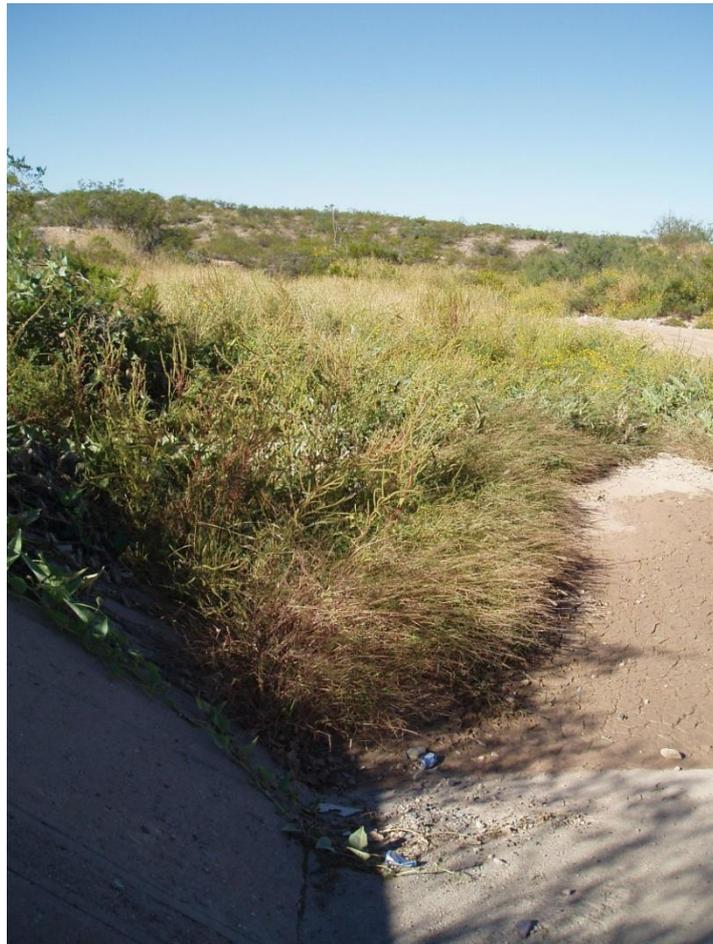
PHOTO: Vegetation and siltation at lower left wall of left emergency spillway

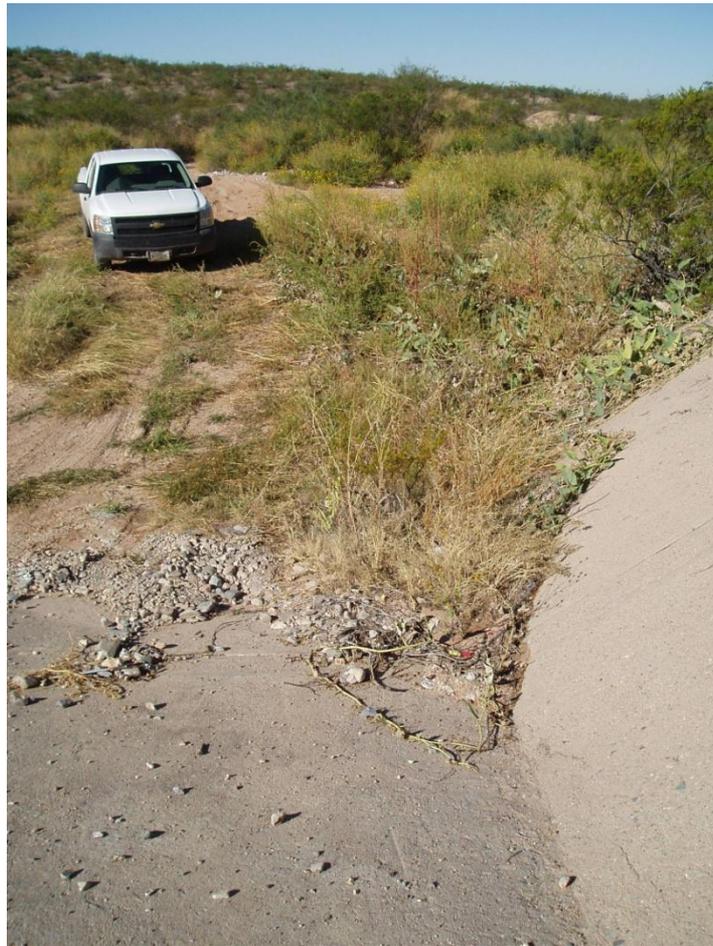
PHOTO: Vegetation and siltation at lower right wall of left emergency spillway

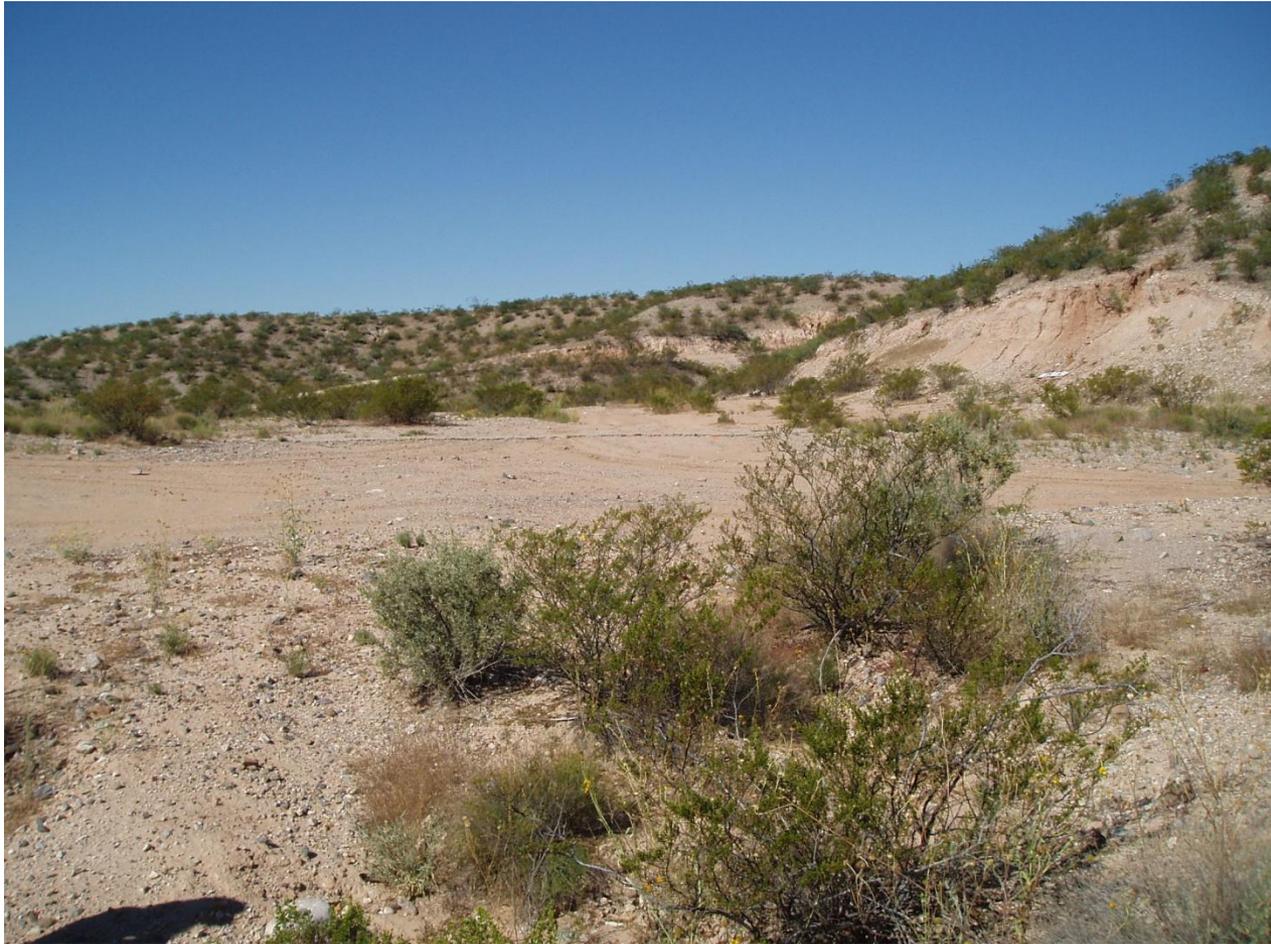
PHOTO: Looking downstream through right emergency spillway

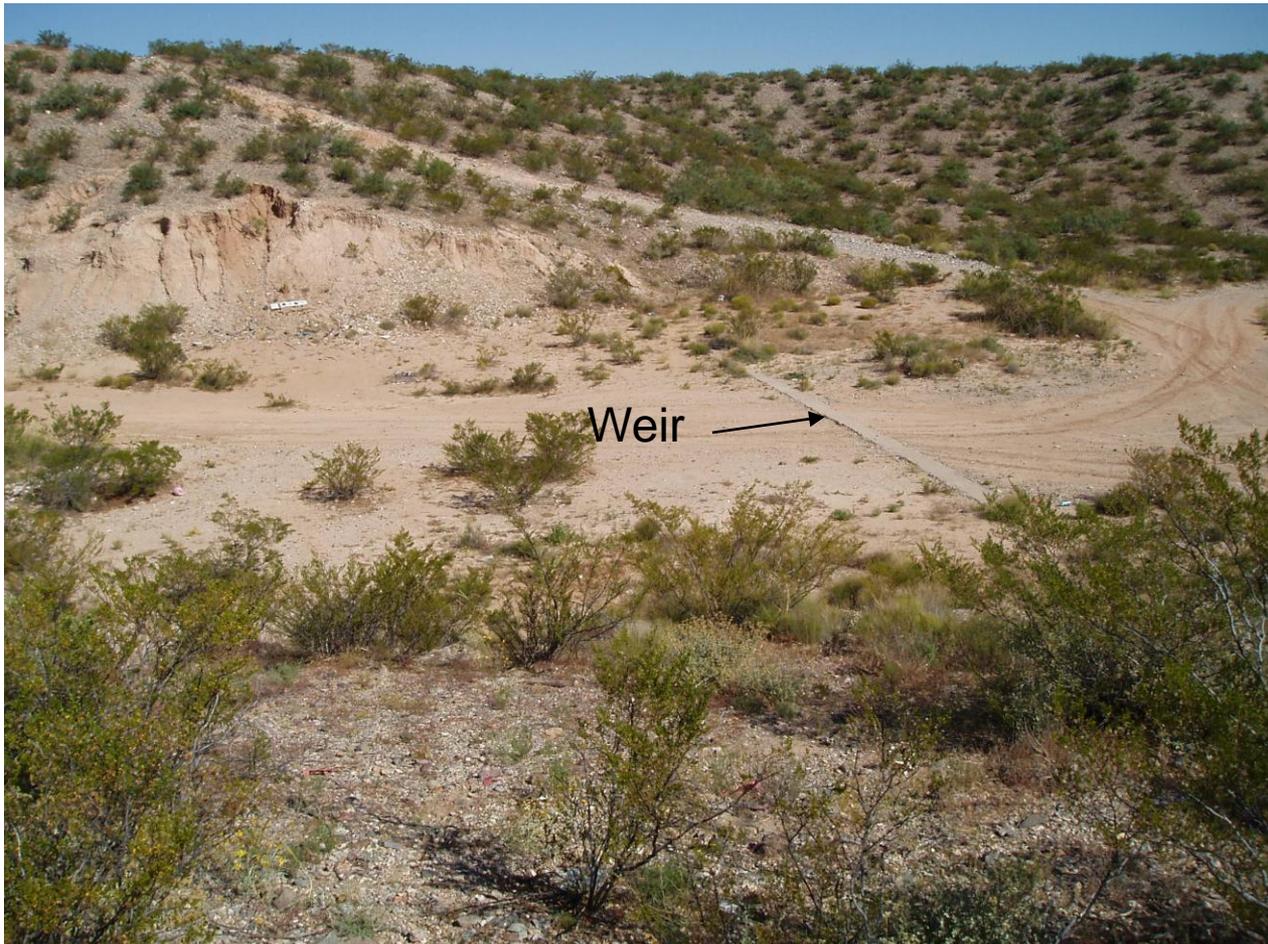
PHOTO: Concrete control weir in right emergency spillway

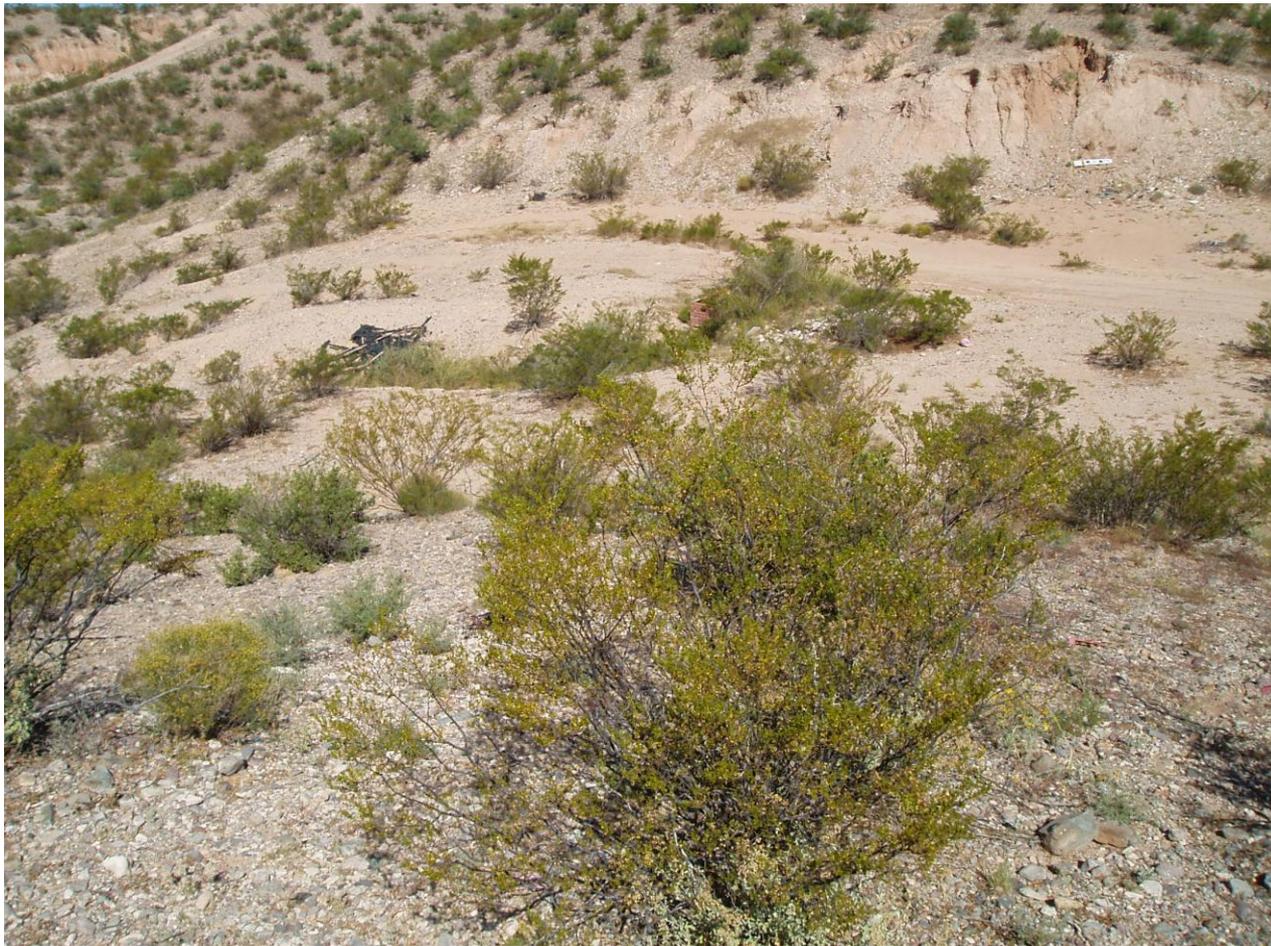
PHOTO: Erosion in right emergency spillway downstream of concrete weir

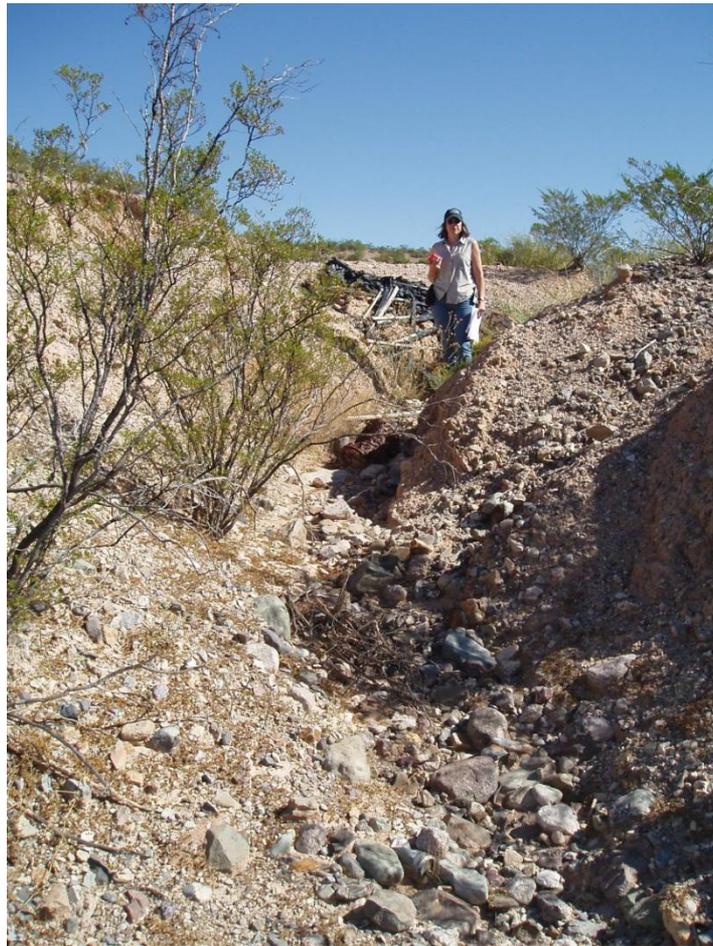
Item No.	Item	N/A	Y	N	CAR RIM	Flag No.	Remarks
d	Excavated earth spillway condition						Right Emergency Spillway
(1)	Slopes eroding		x				
(2)	Slopes sloughing		x				Right side
(3)	Headcutting		x		M		Up to 5' deep
(4)	Trees & brush – obstructed		x				minor
e	Natural earth spillway condition	x					
(1)	Slopes eroding	x					
(2)	Slopes sloughing	x					
(3)	Headcutting	x					
(4)	Trees & brush – obstructed	x

PHOTO: Headcutting up to 5' deep in right emergency spillway 100' downstream of weir
