MINERAL REPORT

Surface Use Determination
For
The Advance #2, Advance #3,
Advance #4 and Advance #5
Mill Site Claims

Clark County, Nevada
T. 25 S., R. 57 E., MDM
Section 26

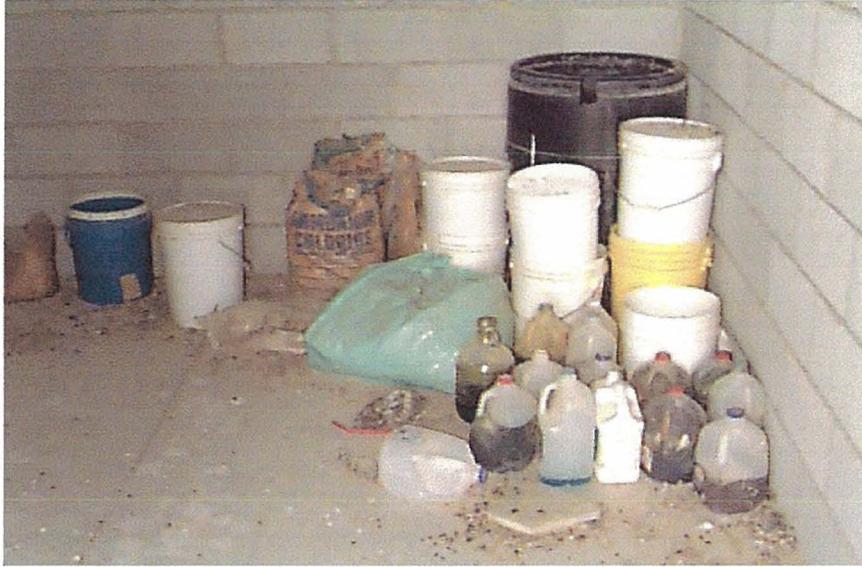
Photo #1 - Taken by J. Mur on 11/12/97. Shows chemicals stored in building on Advance #5 mill site.

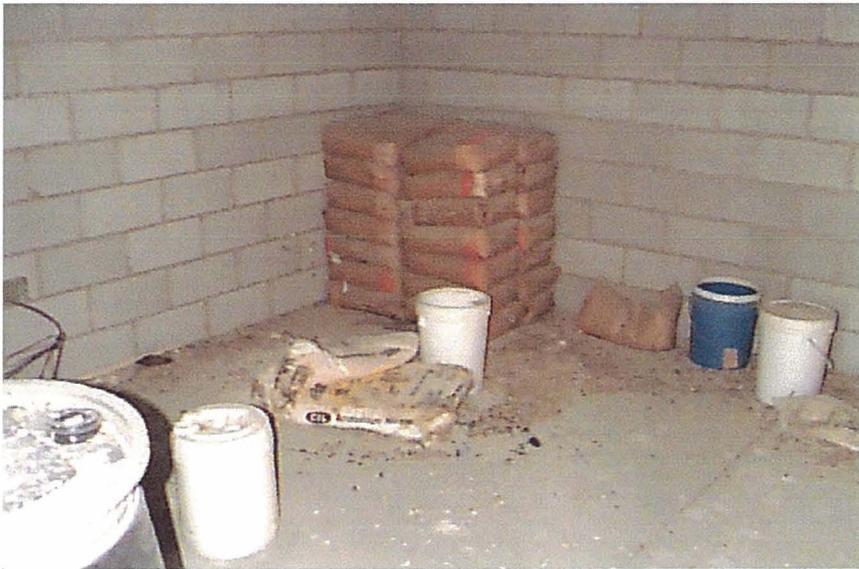
Photo #2 - Taken by J. Mur on 11/12/97. Shows chemicals stored in building on Advance #5 mill site.

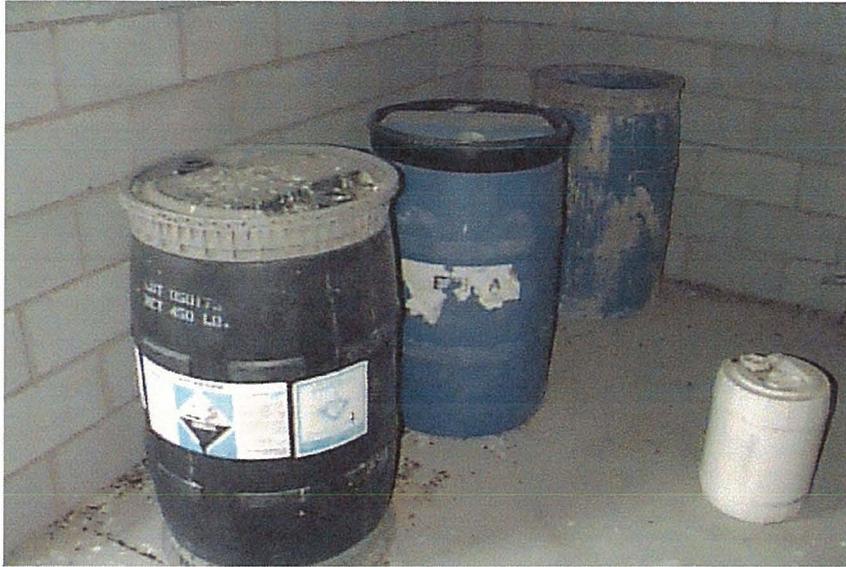
Photo #3 - Taken by J. Mur on 11/12/97. Shows chemicals stored in building on Advance #5 mill site.

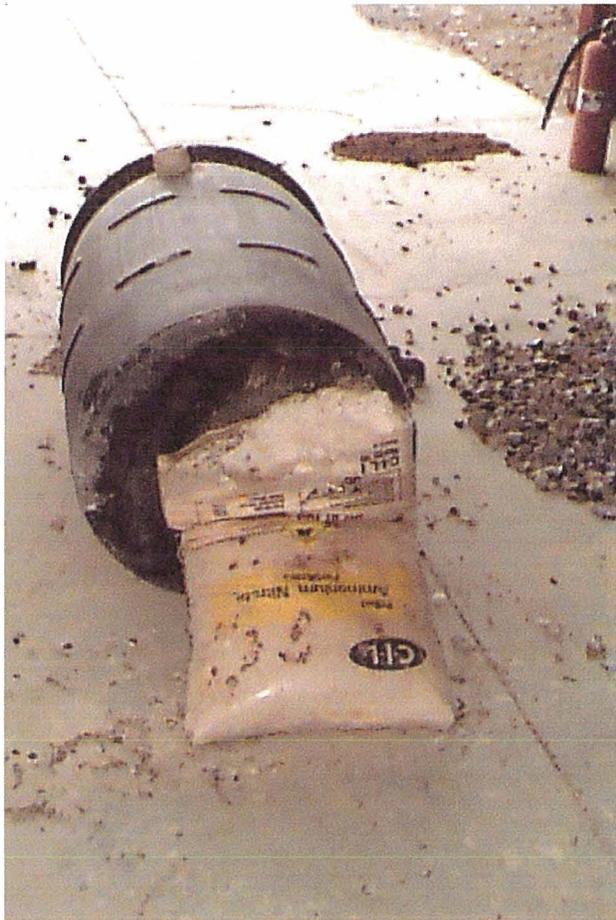
Photo #4 - Taken by J. Mur on 11/12/97. Shows chemicals stored in building on Advance #5 mill site.

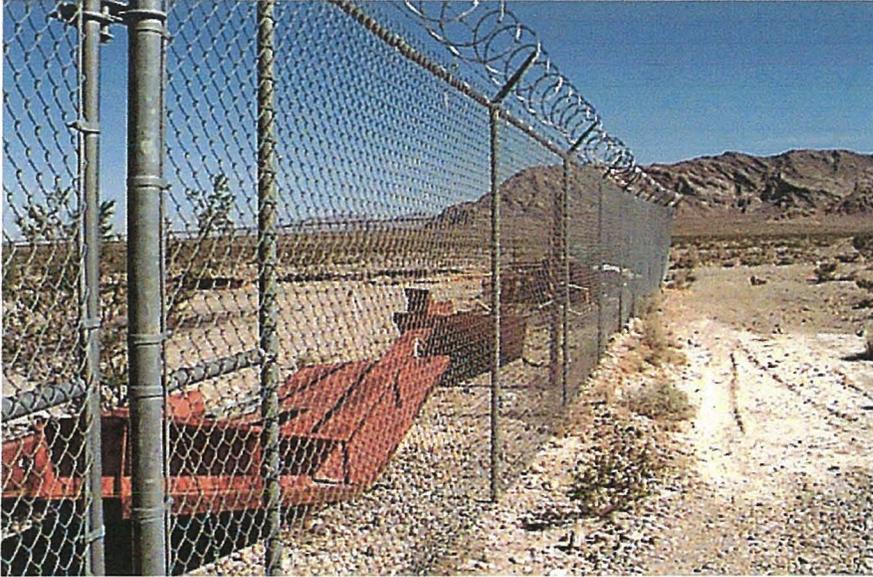
Photo #7 - Taken by E. Seum on 7/15/98. Taken looking north at scrap on the Advance #4 mill site.

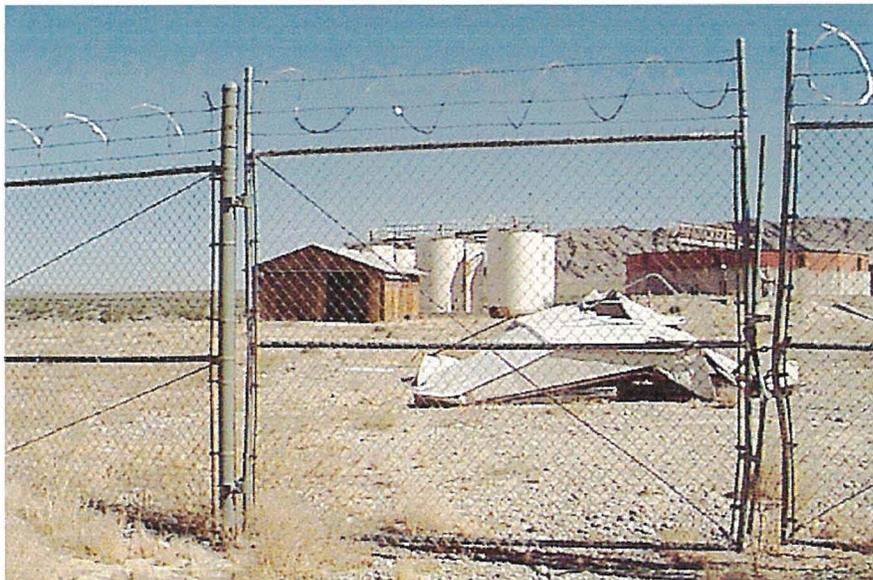
Photo #8 - Taken by E. Seum on 7/15/98. Taken looking north. Shows small building and collapsed metal building on Advance #5, and mixing and thickener tanks on the Advance #4 mill site.

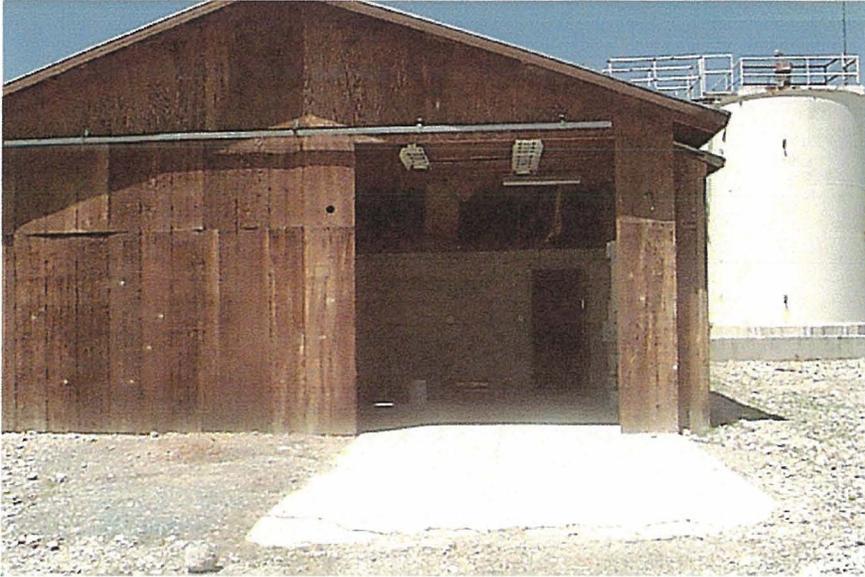
Photo #11 - Taken by E. Seum on 5/13/99. Looking north at small building on the Advance #5 mill site. Building is open.

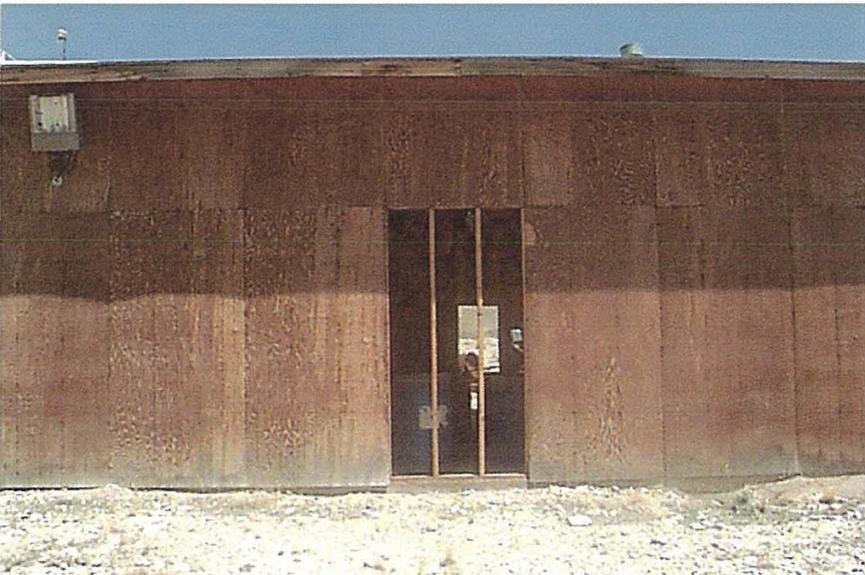
Photo #12 - Taken by E. Seum on 5/13/99. Looking east at small building on the Advance #5 mill site. Part of wall removed.

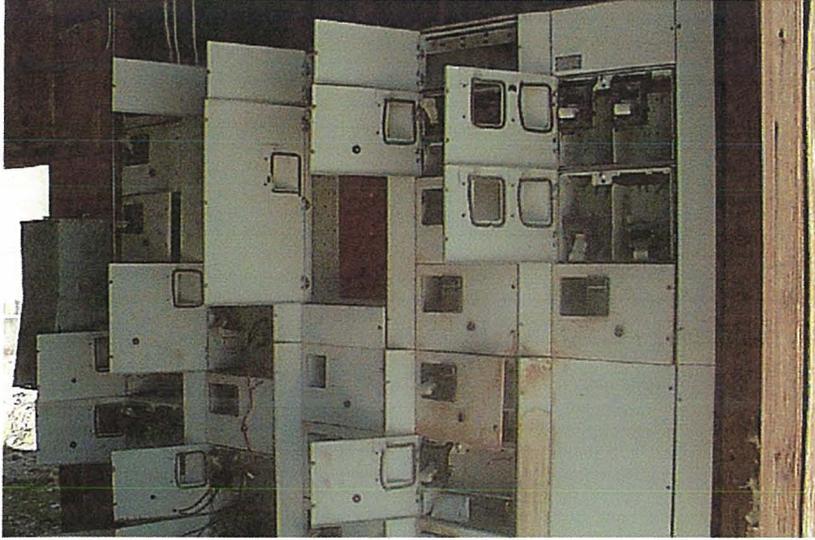
Photo #13 - Taken by E. Seum on 5/13/99. Electrical panel vandalized in building shown in above photo.

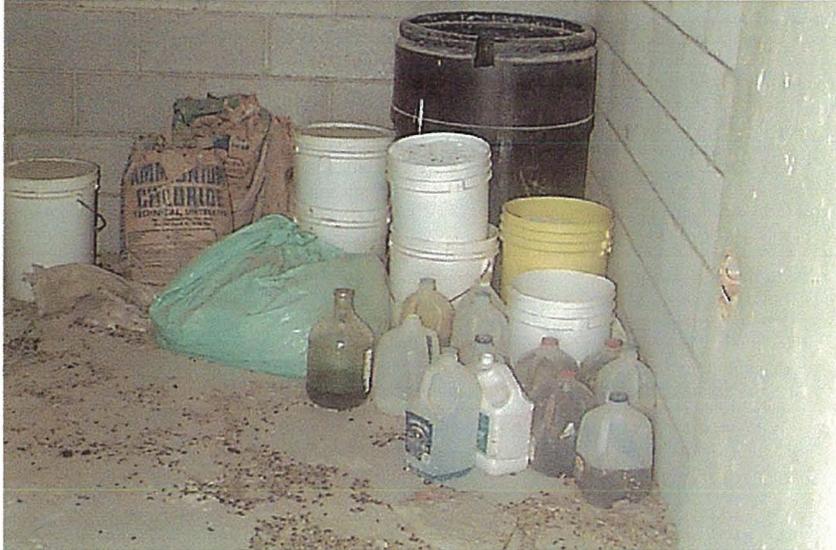
Photo #15 - Taken by E. Seum on 5/13/99. Shows chemicals inside building shown in photos 11 & 12.

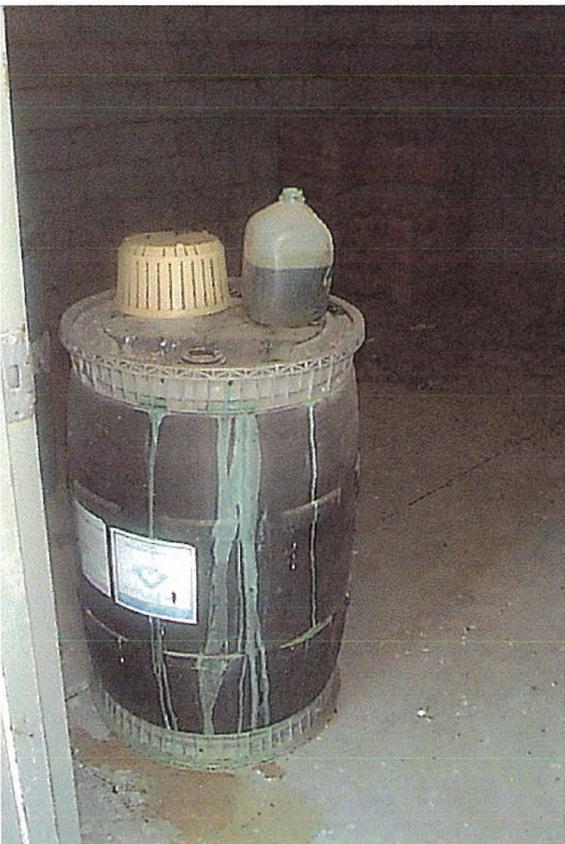
Photo #16 - Taken by E. Seum on 5/13/99. Shows chemicals inside building shown in photos 11 & 12.

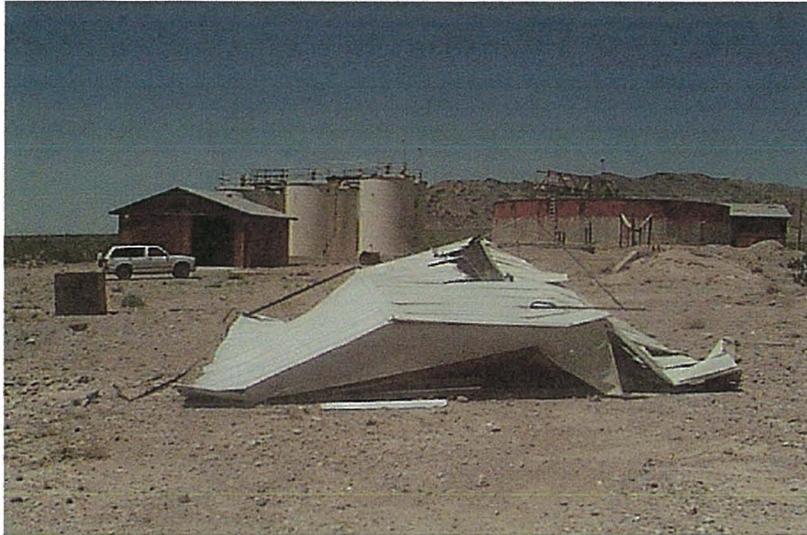
Photo #17 - Taken by E. Seum on 5/13/99. Shows collapsed metal building on the Advance #5 mill site.

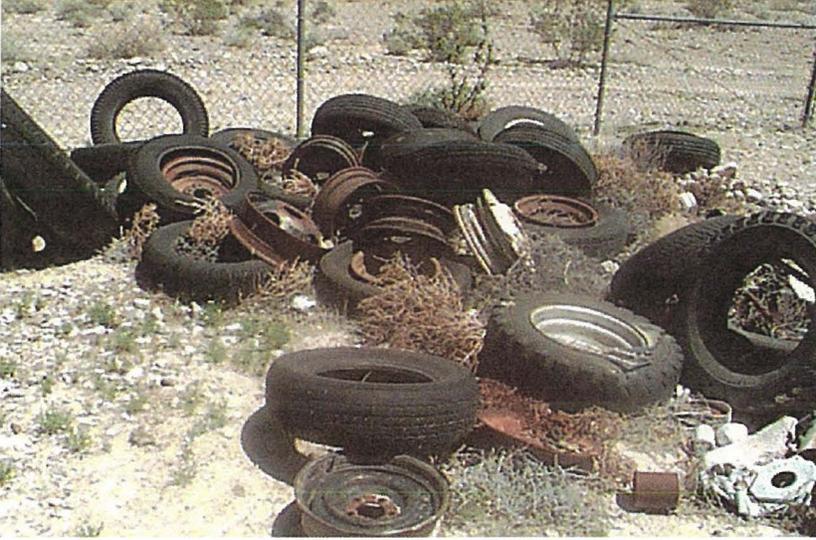
Photo #19 - Taken by E. Seum on 5/13/99. Shows tires strewn on southeast corner of the Advance #5 mill site.

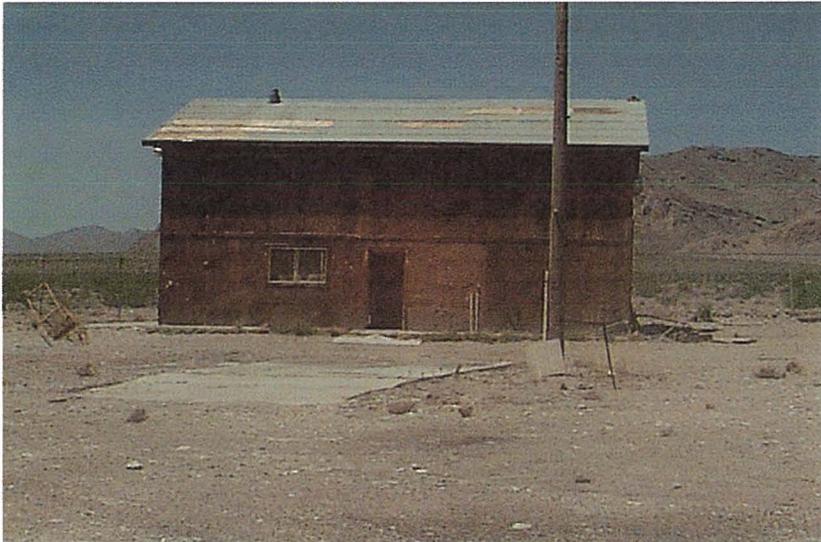
Photo #20 - Taken by E. Seum on 5/13/99. Shows building on the Advance #4 mill site. Door not secured.

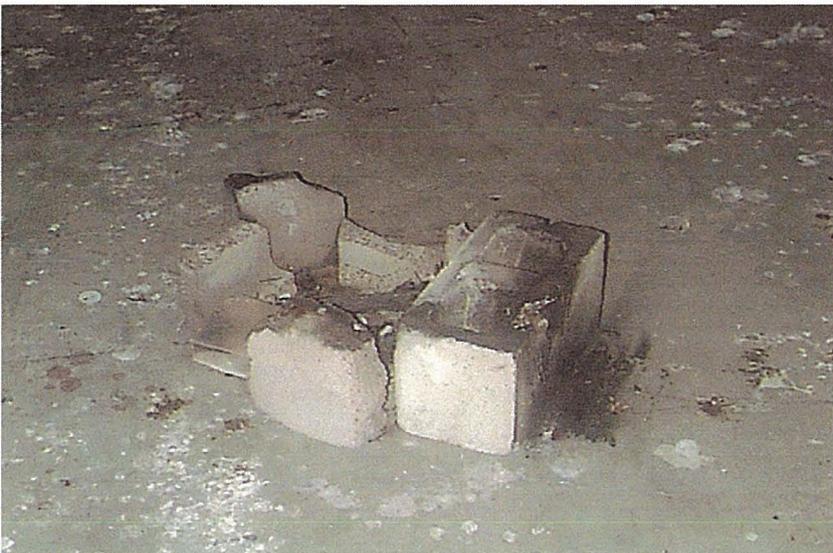
Photo #22 - Taken by E. Seum on 5/13/99. Shows fire ring in building in photo #20 on the Advance #4 mill site.

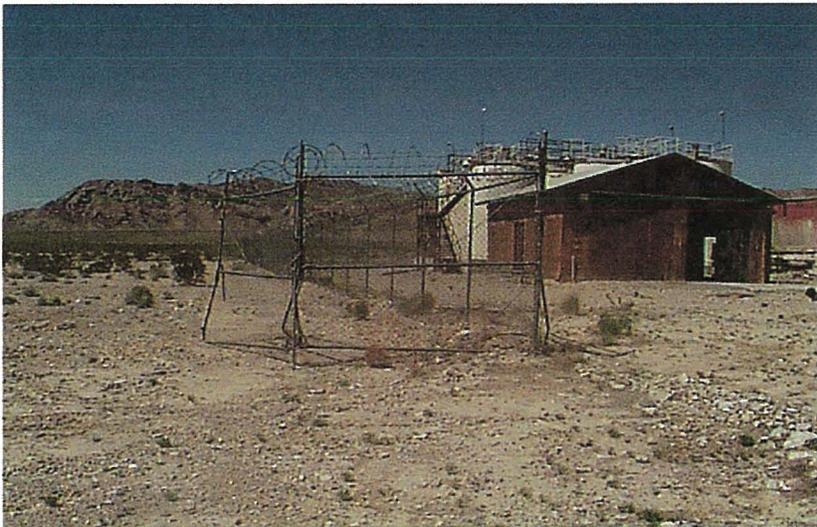
Photo #26 - Taken by E. Seum on 5/13/99. Shows gate broken open on the Advance #5 mill site.

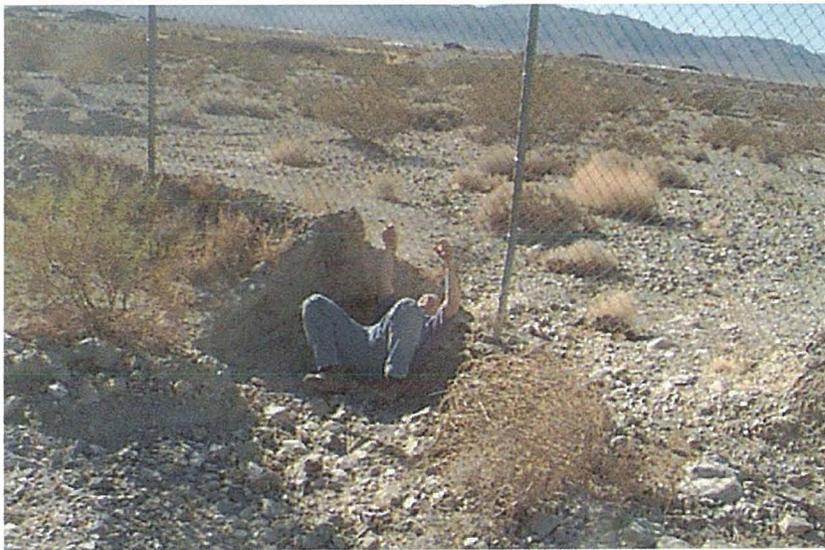
Photo #28 - Taken by J. Mur on 1/6/00. Shows gap in fence being used to access site even though gates are in place.

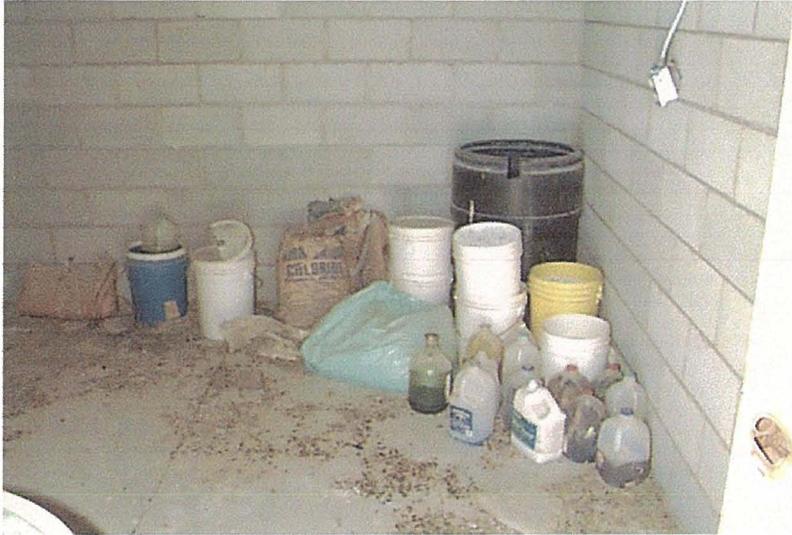
Photo #29 - Taken by J. Mur on 1/6/00. Shows chemicals stored in building on the Advance #5 mill site. Building not secured.

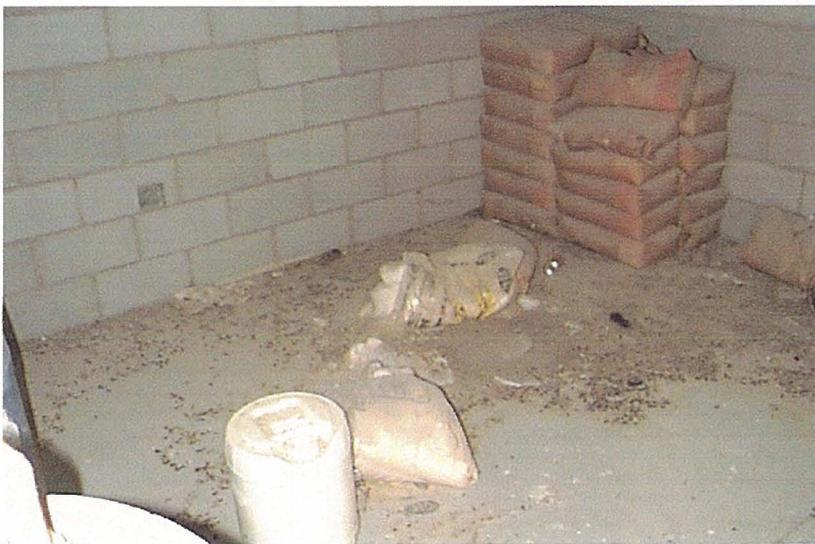
Photo #30 - Taken by J. Mur on 1/6/00. Shows chemicals stored in building on the Advance #5 mill site. Building not secured.

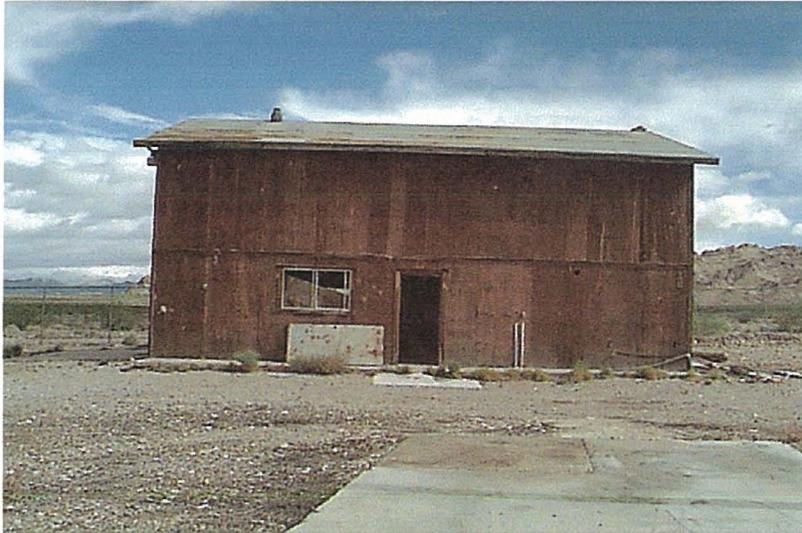
A fenced compound is located on the Advance #4 and #5 mill site claims. A large wooden building sits on the Advance #4 mill site claim. The doors are open, windows broken out and insulation is coming down (photos 31-33). A couple of old couches and a large amount of bird droppings are in the building (photo 34). Six 50,000 gallon mixer tanks and a 50 foot thickener tank sit on the southwest portion of the Advance #4 (photos 35, 37, 39). The interiors of the tanks do not show signs of ever having been used (photos 38, 40). A water well is located on the southeast corner of the Advance #4, outside of the fenced area (photo 41). A buried line from the well goes to the Advance #4 (photo 42). Two abandoned cars are sitting just outside the northeast corner of the fence on the Advance #4 (photo 36).

Photo #31 - Taken by E. Seum on 4/18/00. Looking north at unsecured building on the Advance #4 mill site.

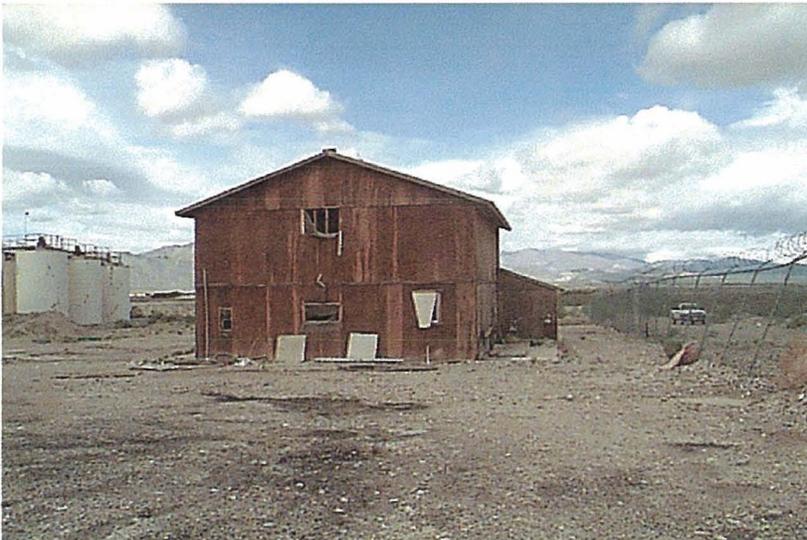
Photo #32 - Taken by E. Seum on 4/18/00. Looking west at unsecured building on the Advance #4 mill site.

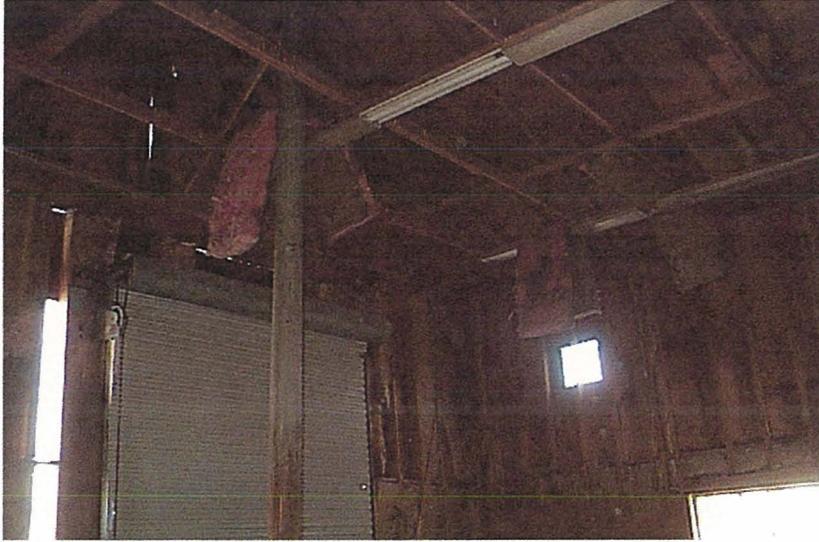
Photo #33 - Taken by E. Seum on 4/18/00. Shows insulation hanging down inside building shown in photos 31 & 32.

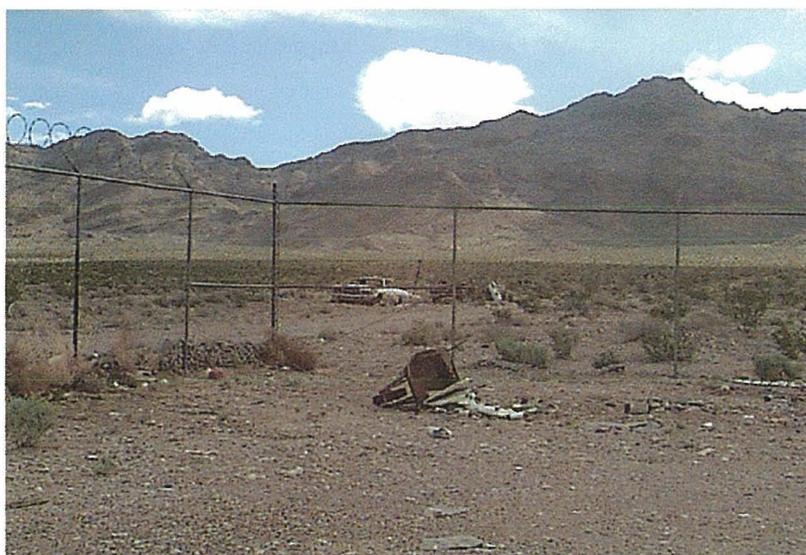
Photo #36 - Taken by E. Seum on 4/18/00. Looking east at junk vehicles on the Advance #4 mill site.

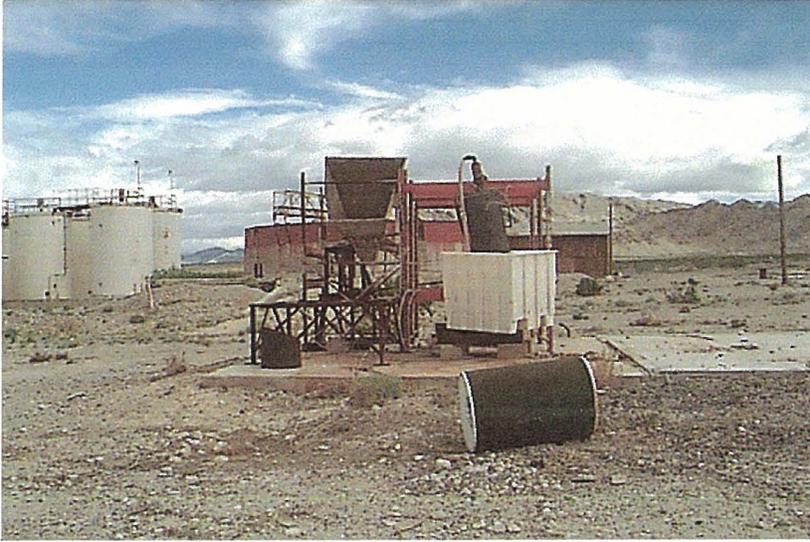
A wooden building is located on the northwest corner of the Advance #5 (photo 44). Chemicals stored in the building include acetic acid, ammonium hydroxide, ammonium chloride and a number of unknowns (photos 47, 48). An electrical panel along the east wall of the building has been vandalized (photo 46). There is a hole in the west wall of the building (photo 45). A small hopper and electro wining cell sits just to the southeast of the building (photo 43).

Photo #43 - Taken by E. Seum on 4/18/00. Shows hopper and electro wining unit located on the Advance #5 mill site.

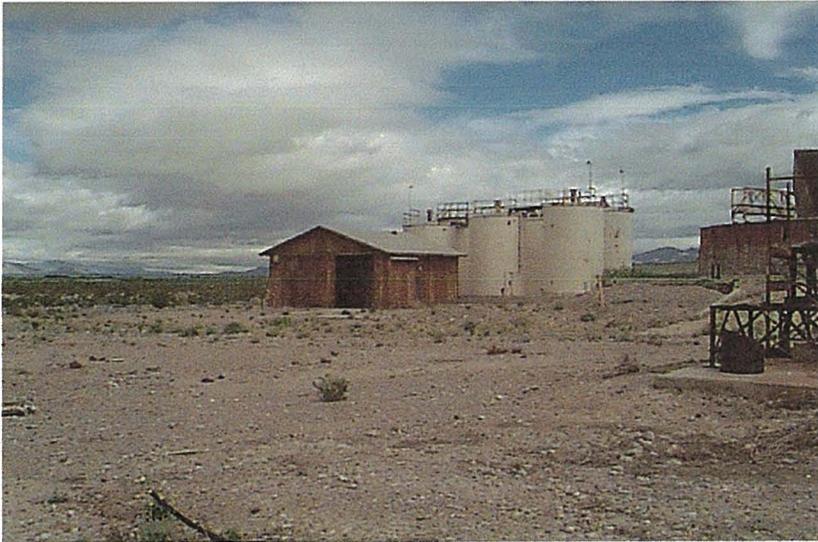
Photo #44 - Taken by E. Seum on 4/18/00. Shows small building located on the Advance #5 mill site.

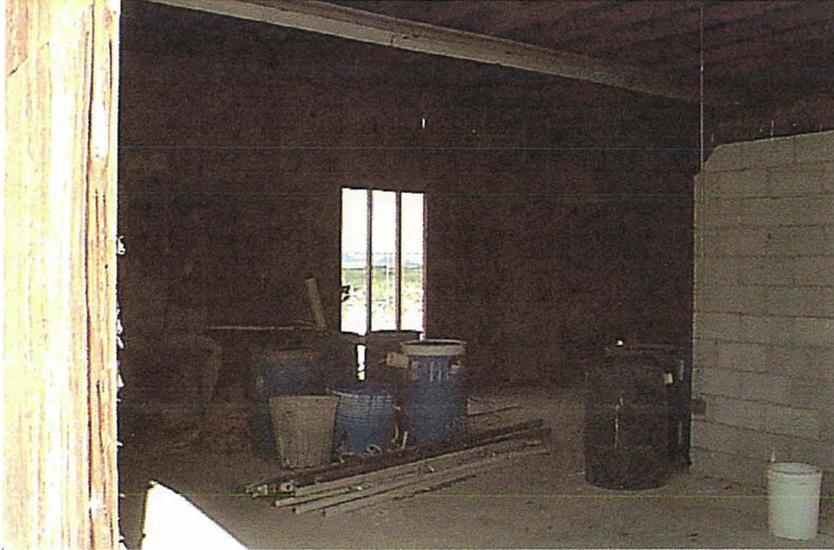
Photo #45 - Taken by E. Seum on 4/18/00. Shows interior of small building in photo #44. Part of exterior wall missing.

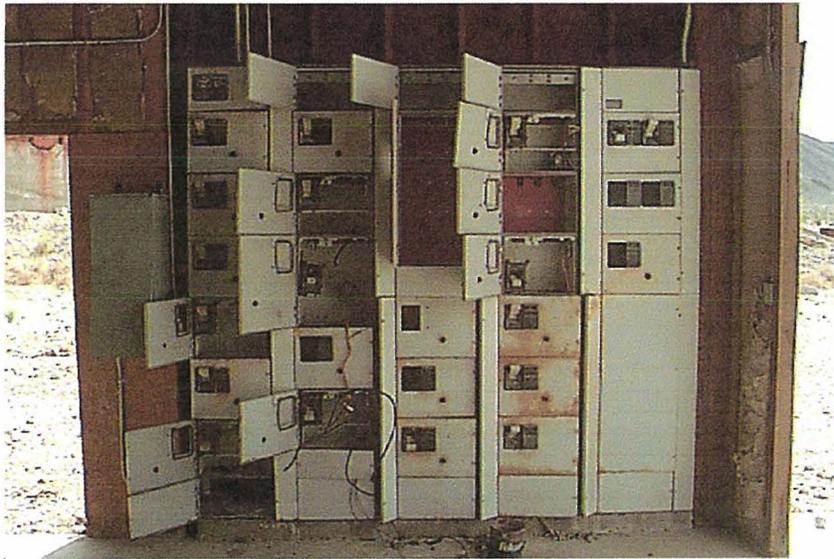
Photo #46 - Taken by E. Seum on 4/18/00. Shows vandalized electrical panel in small building in photo #44.

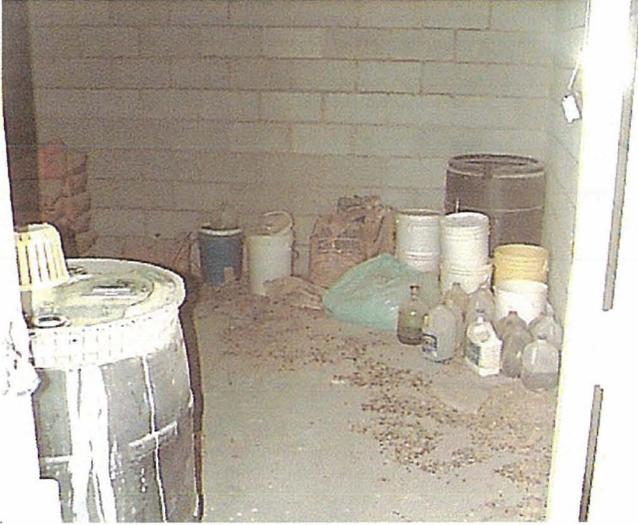
Photo #47 - Taken by E. Seum on 4/18/00. Shows chemicals stored in small building in photo #44.

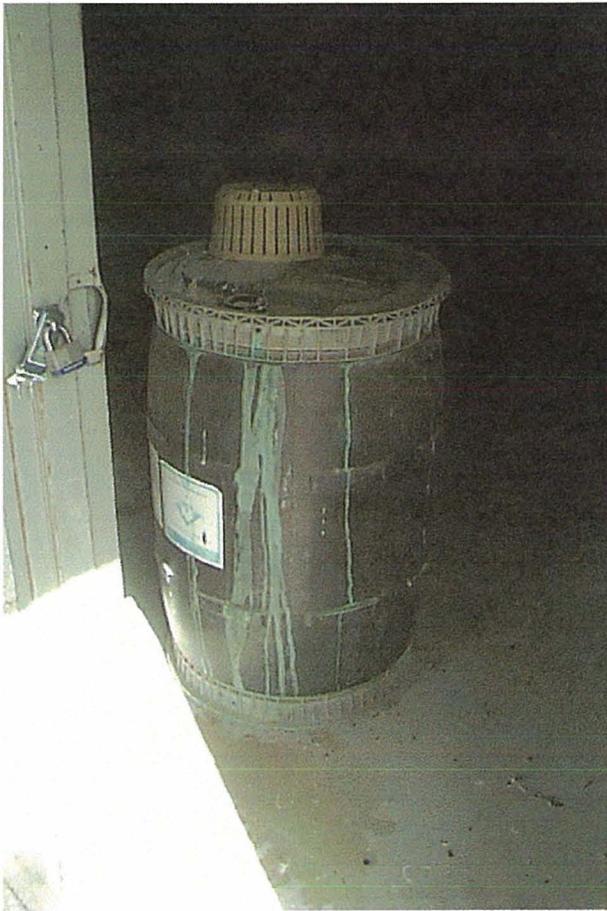
Photo #48 - Taken by E. Seum on 4/18/00. Shows barrel of acetic acid stored in small building in photo #44.
