UNITED STATES  
DEPARTMENT OF THE INTERIOR  
BUREAU OF LAND MANAGEMENT

**MINERAL REPORT**  
Surface Use Determination  
For The  
ERI Mill Site #1, ERI Mill Site #2, ERI Mill Site #3, ERI #39, ODM #21  
Mill Site and Lode Claims

Clark County, Nevada  
T. 28 S., R. 64 E., MDM  
Section 33, SW¼

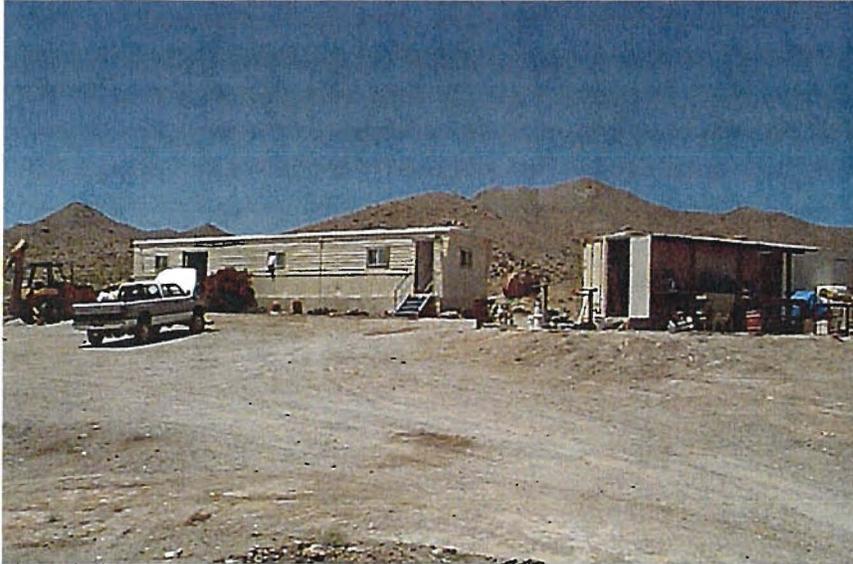
Photo #1 - Taken by J. Mur on 6/25/98. Shows office trailer on left, and lab on right. Both located on the ERI Mill Site #2 mill site.

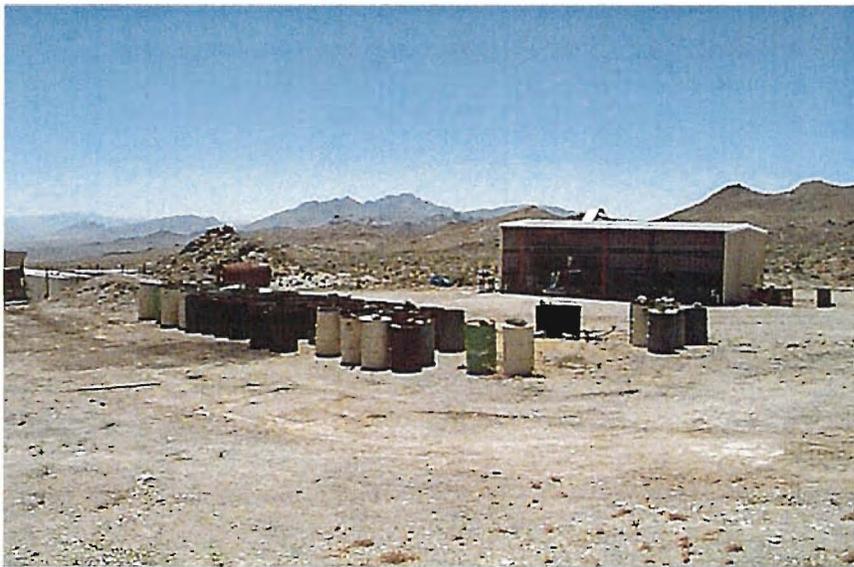
Photo #2 - Taken by J. Mur on 6/25/98. Shows shop and barrels of mineral materials. Located on the ERI Mill Site #1 mill site.

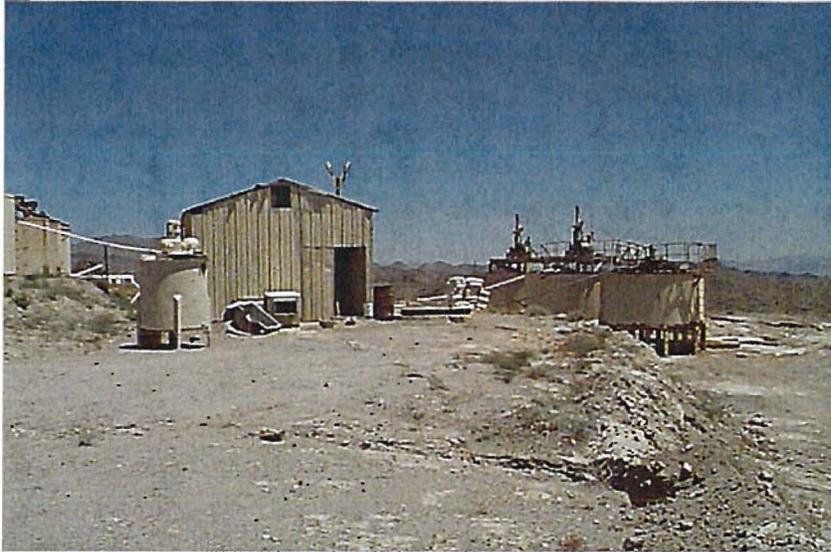
Photo #5 - Taken by J. Mur on 6/25/98. Shows building used for storage and mixing tanks. Located on the ERI Mill Site #1 mill site.

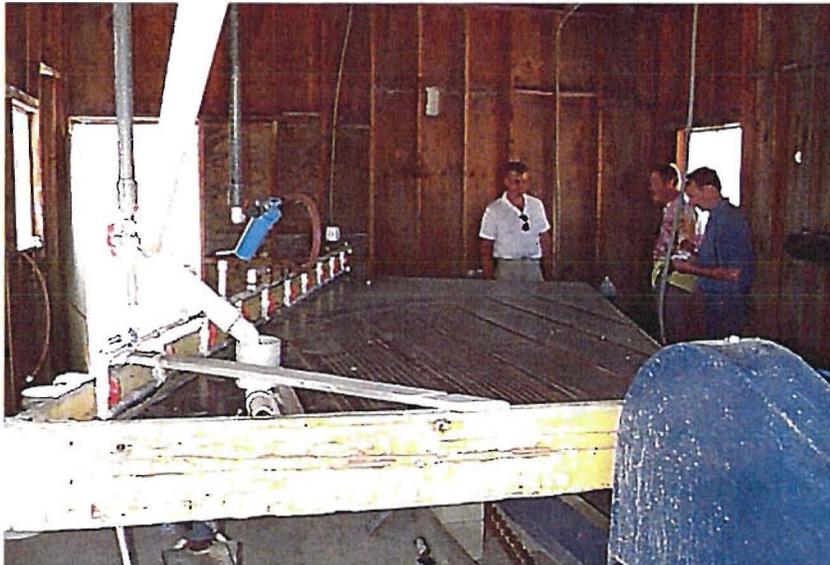
Photo #6 - Taken by J. Mur on 6/25/98. Shows jig table stored inside building shown in photo #5. Located on the ERI Mill Site #1 mill site.

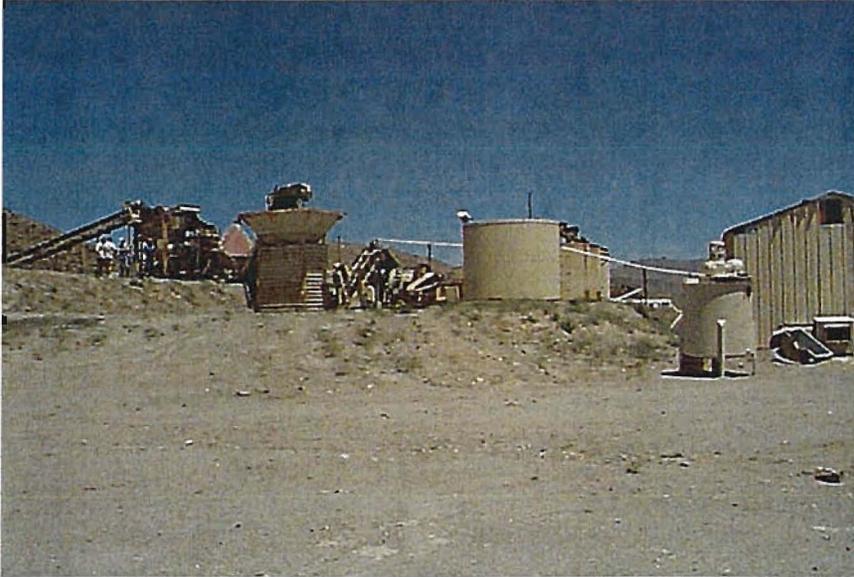
Photo #7 - Taken by J. Mur on 6/25/98. Shows mixing tanks and part of the processing circuit. Located on the ERI Mill Site #1 mill site.

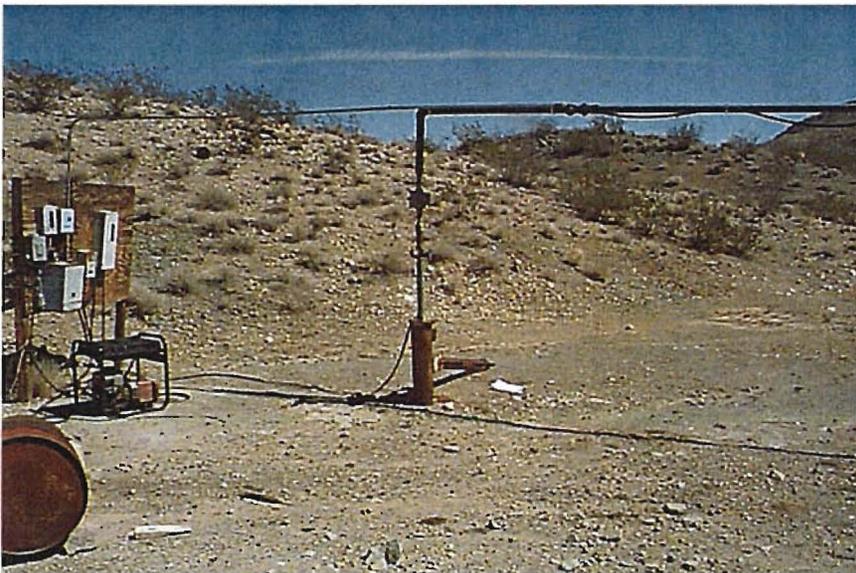
Photo #8 - Taken by J. Mur on 9/27/00. Shows well head. Located on the ODM #20 lode claim.

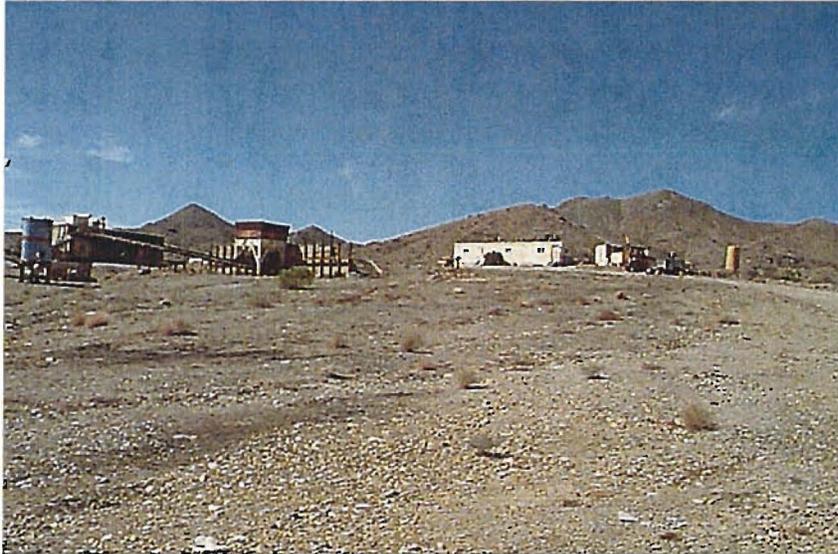
Photo #9 - Taken by J. Mur on 9/27/00. Shows upper end of processing circuit, with the office and lab in the background. Located on the ERI Mill Site #1 & #2 mill sites.

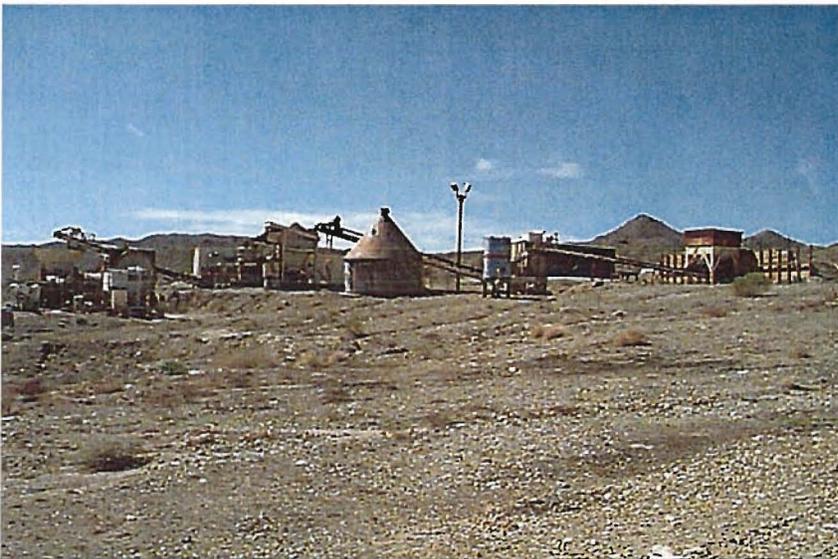
Photo #10 - Taken by J. Mur on 9/27/00. Shows the various crushers, beltlines, etc. making up the processing circuit. Located on the ERI Mill Site #1 mill site.

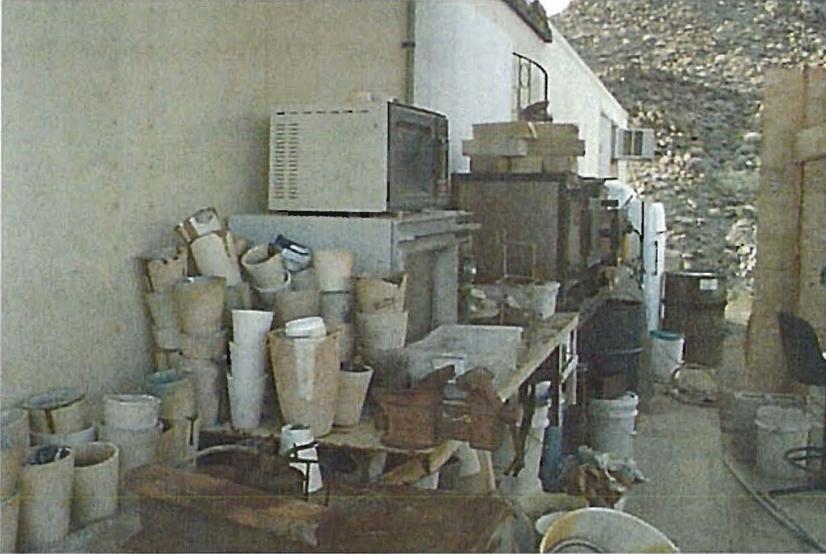
Photo #13 - Taken by J. Mur on 10/30/00. Shows area adjacent to the lab. Located on the ERI Mill Site #2 mill site.

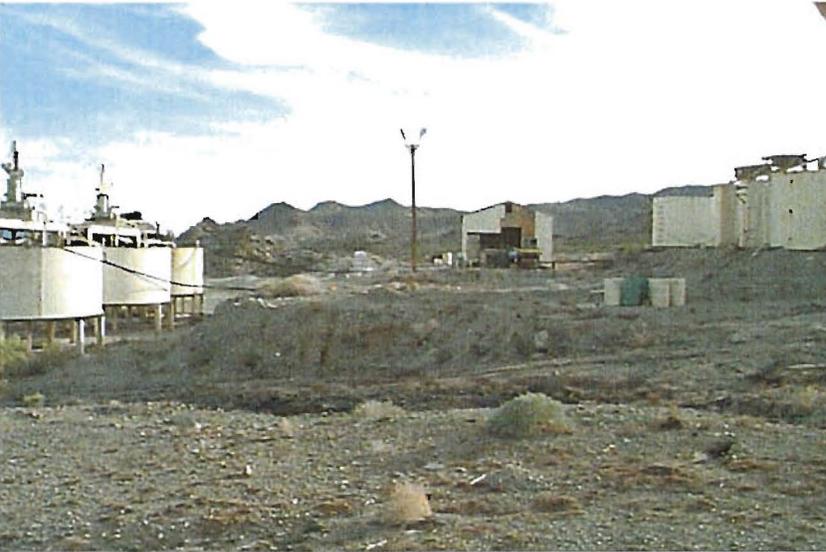
Photo #14 - Taken by J. Mur on 10/30/00. Shows mixing tanks and storage building. Located on the ERI Mill Site #1 mill site.

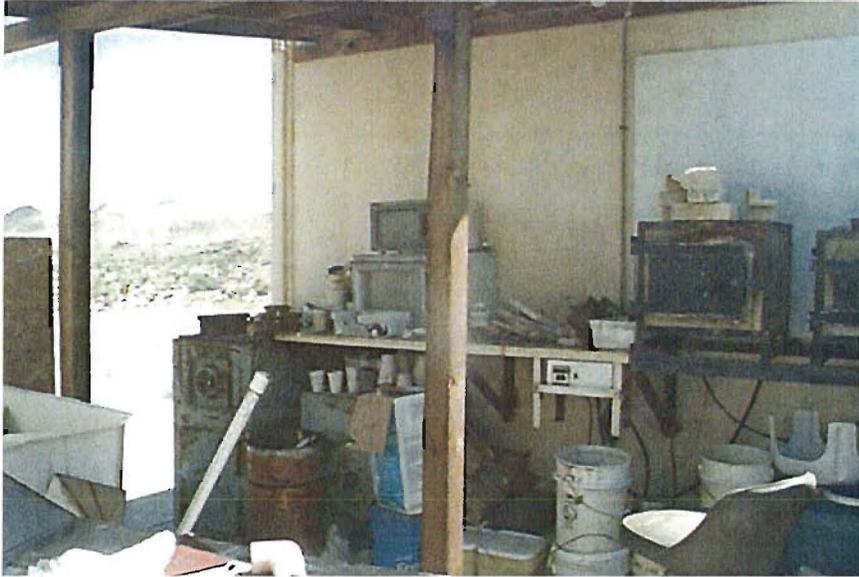
Photo #17 - Taken by J. Mur on 5/30/01. Shows items outside of the lab. Located on the ERI Mill Site #2 mill site.

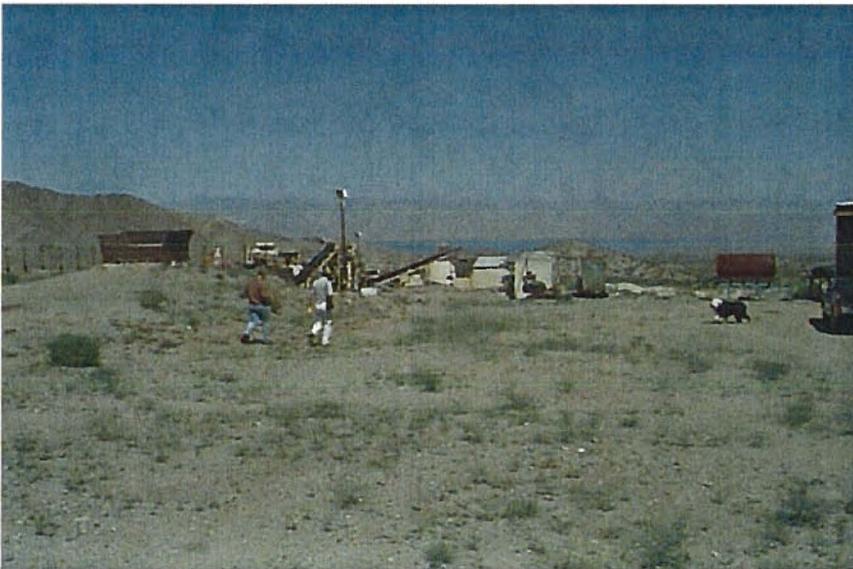
Photo #18 - Taken by J. Mur on 5/30/01. Shows part of processing equipment, and generating plant. Located on the ERI Mill Site #1 mill site.

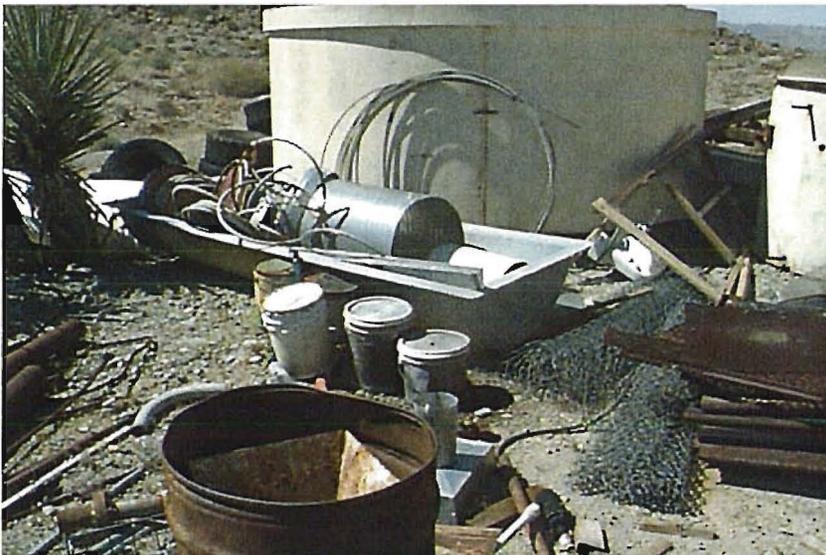
Photo #20 - Taken by J. Mur on 5/30/01. Shows parts stored on the ERI Mill Site #2 mill site.

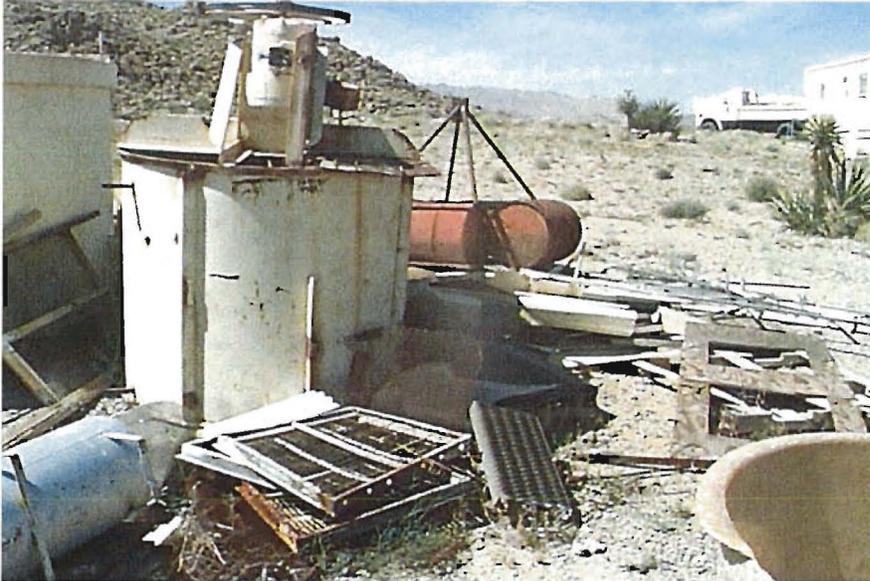
Photo #21 - Taken by J. Mur on 5/30/01. Shows parts stored on the ERI Mill Site #2 mill site.

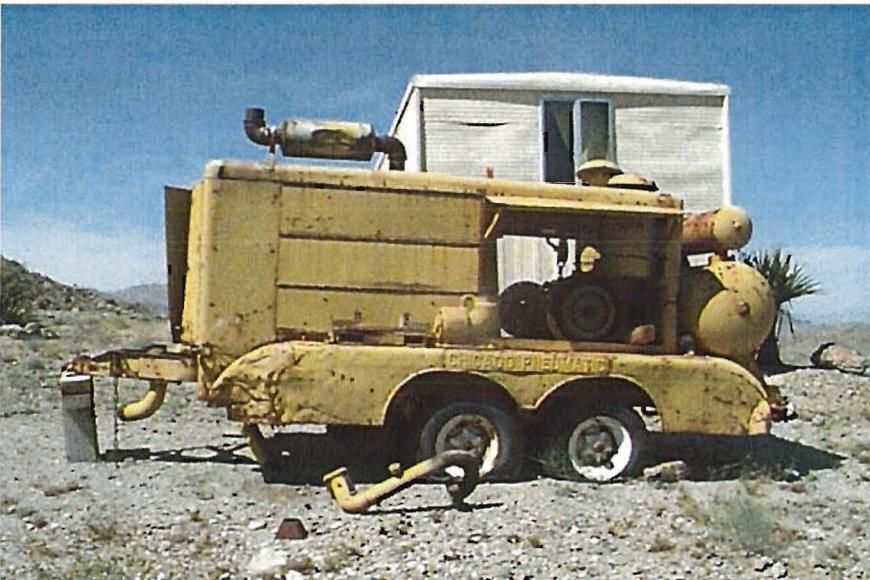
Photo #22 - Taken by J. Mur on 5/30/01. Shows air compressor for underground mining. Located on the ERI Mill Site #2 mill site.

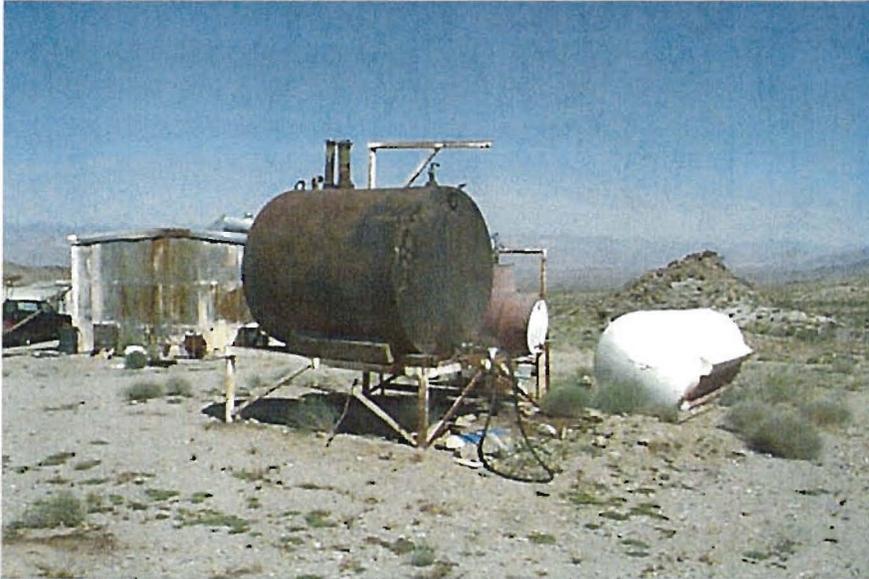
Photo #23 - Taken by J. Mur on 5/30/01. Shows diesel storage tank located on the ERI Mill Site #1 mill site.

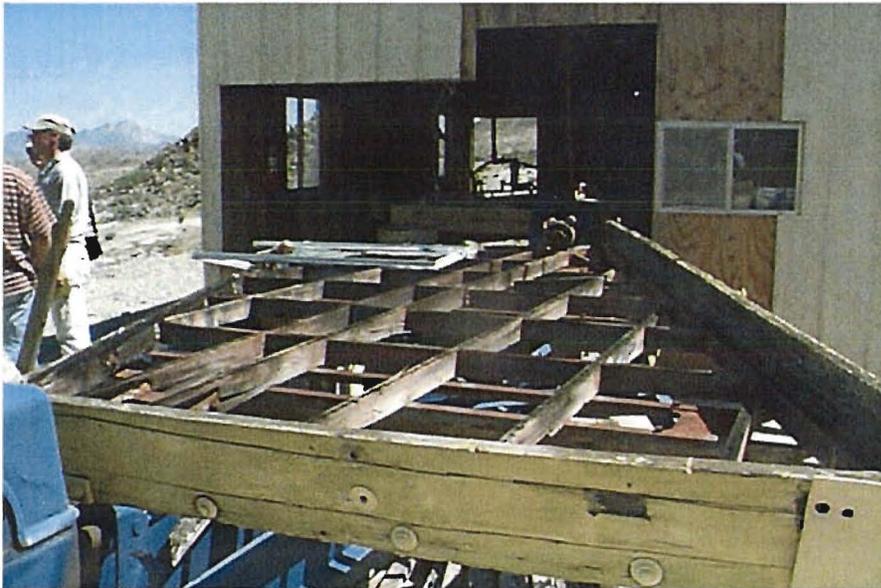
Photo #24 - Taken by J. Mur on 5/30/01. Shows jig table frame stored on the ERI Mill Site #1 mill site.

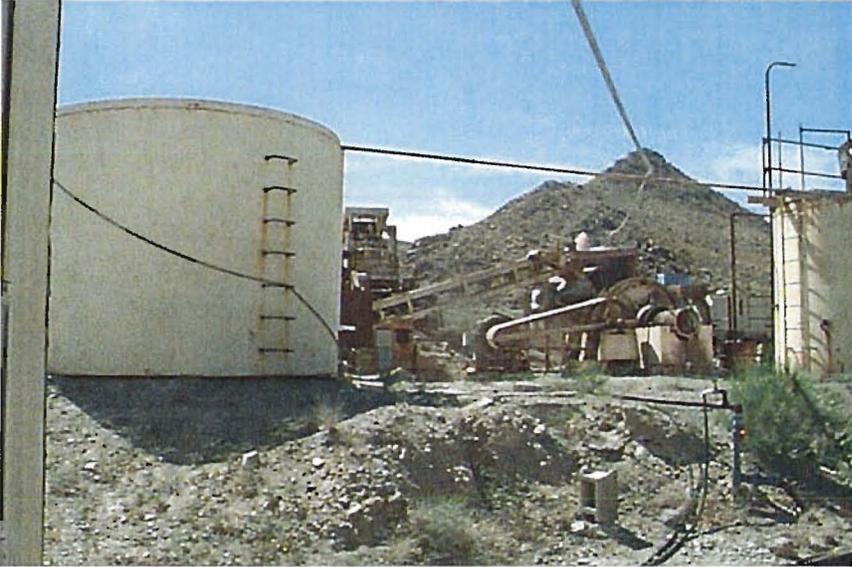
Photo #25 - Taken by J. Mur on 5/30/01. Shows part of the processing equipment on the ERI Mill Site #1 mill site.

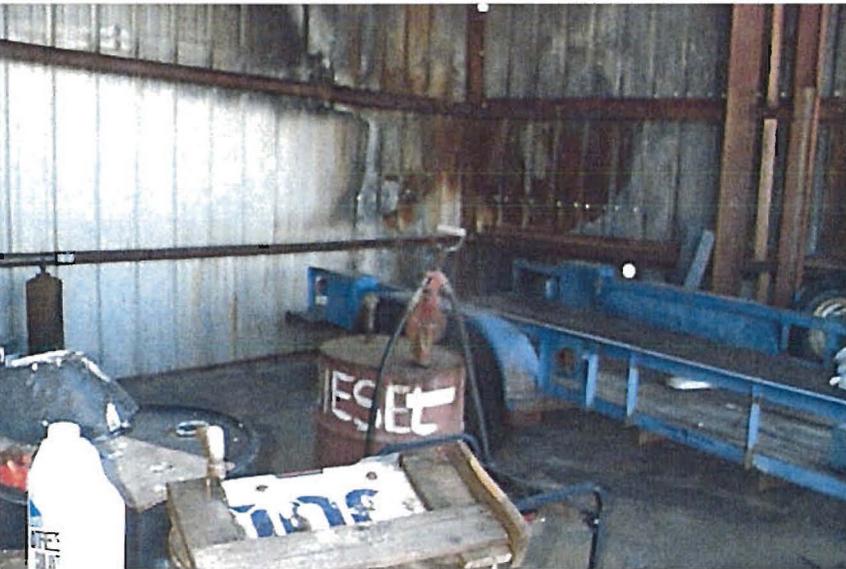
Photo #26 - Taken by J. Mur on 5/30/01. Shows trailer and diesel barrel in shop area on the ERI Mill Site #1 mill site.

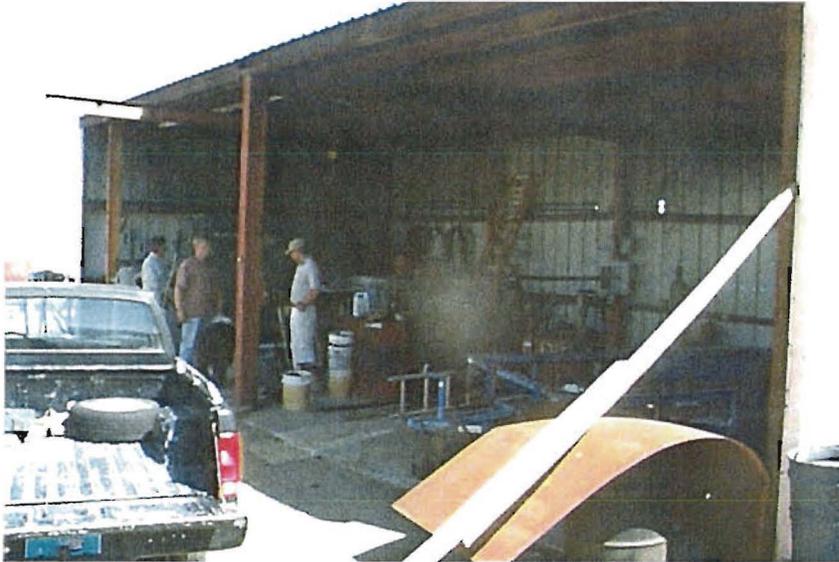
Photo #27 - Taken by J. Mur on 5/30/01. Shows interior of shop area on the ERI Mill Site #1 mill site.

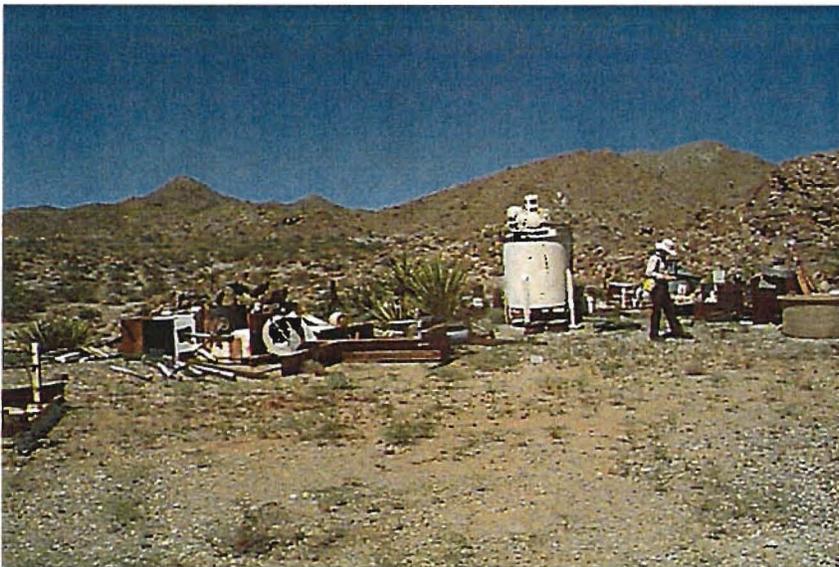
Photo #28 - Taken by E. Seum on 7/11/01. Shows items stored on the ERI Mill Site #2 mill site. See also photos 19, 20, 21.

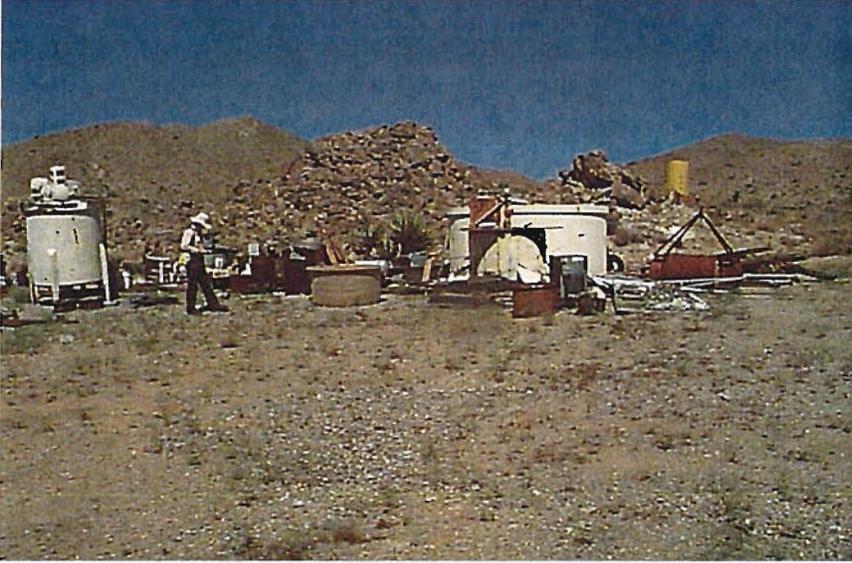
Photo #29 - Taken by E. Seum on 7/11/01. Shows more items, to the right of above picture, stored on the ERI Mill Site #2 mill site.

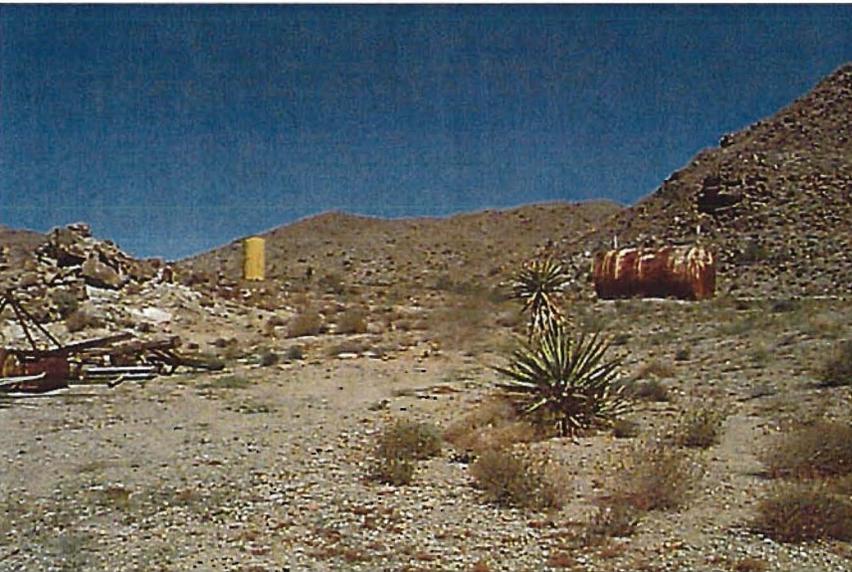
Photo #30 - Taken by E. Seum on 7/11/01. Shows water storage tanks on the upper end of the ERI Mill Site #2 mill site.

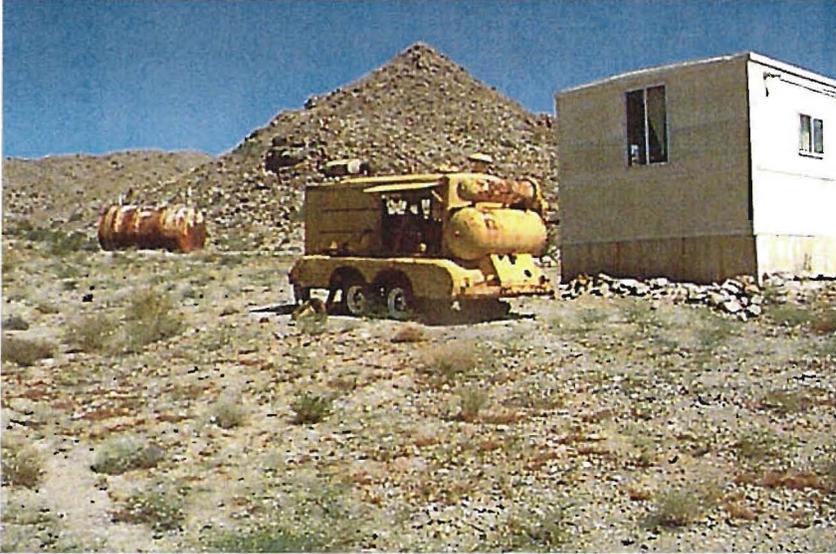
Photo #31 - Taken by E. Seum on 7/11/01. Shows air compressor for underground mining on the ERI Mill Site #2 mill site. See also photo #22. Note the tires are still flat.

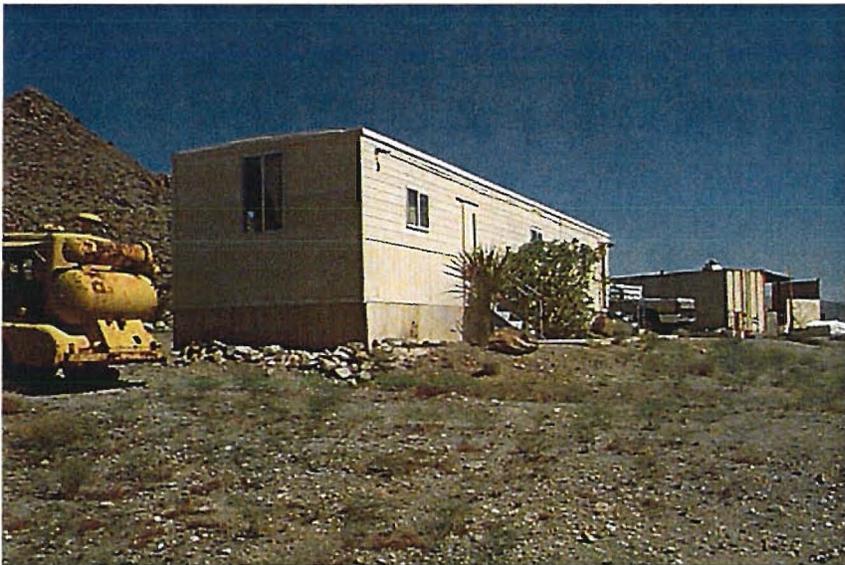
Photo #32 - Taken by E. Seum on 7/11/01. Shows office trailer on the ERI Mill Site #2 mill site.

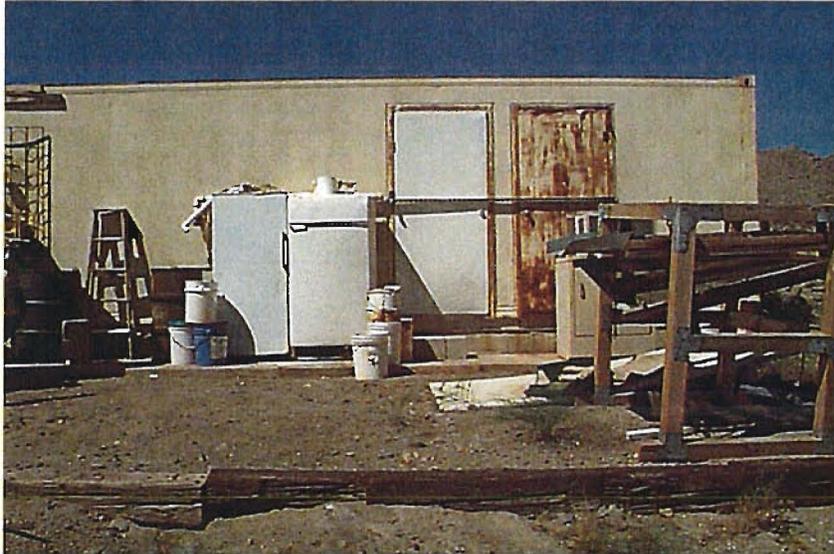
Photo #33 - Taken by E. Seum on 7/11/01. Shows refrigerators outside lab, used for storage. Located on the ERI Mill Site #2 mill site.

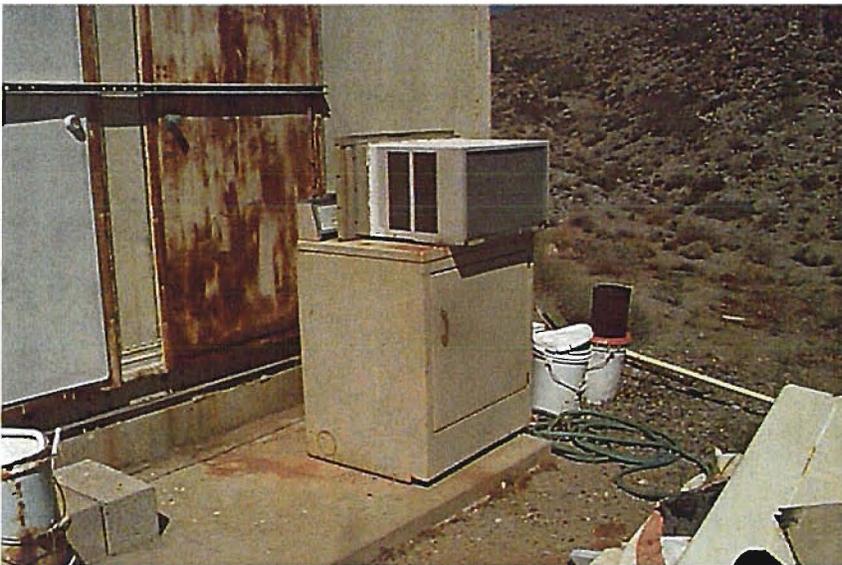
Photo #34 - Taken by E. Seum on 7/11/01. Shows air conditioner and dryer stored on the ERI Mill Site #2 mill site.

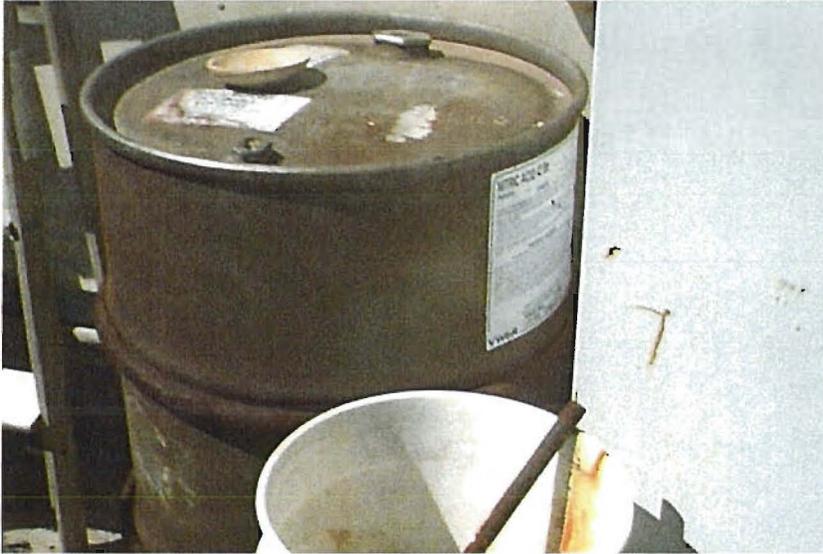
Photo #35 - Taken by E. Seum on 7/11/01. Shows barrel labeled nitric acid sitting outside the lab on the ERI Mill Site #2 mill site.

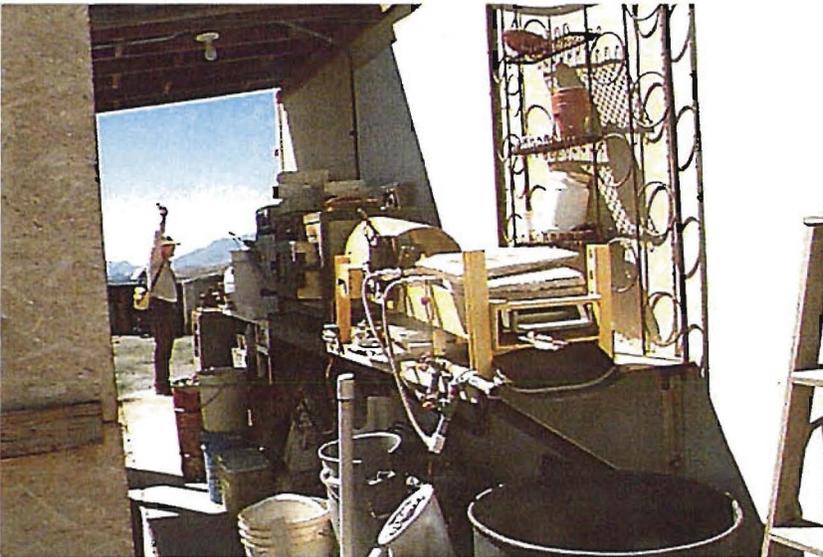
Photo #36 - Taken by E. Seum on 7/11/01. Shows more items outside the lab on the ERI Mill Site #2 mill site.

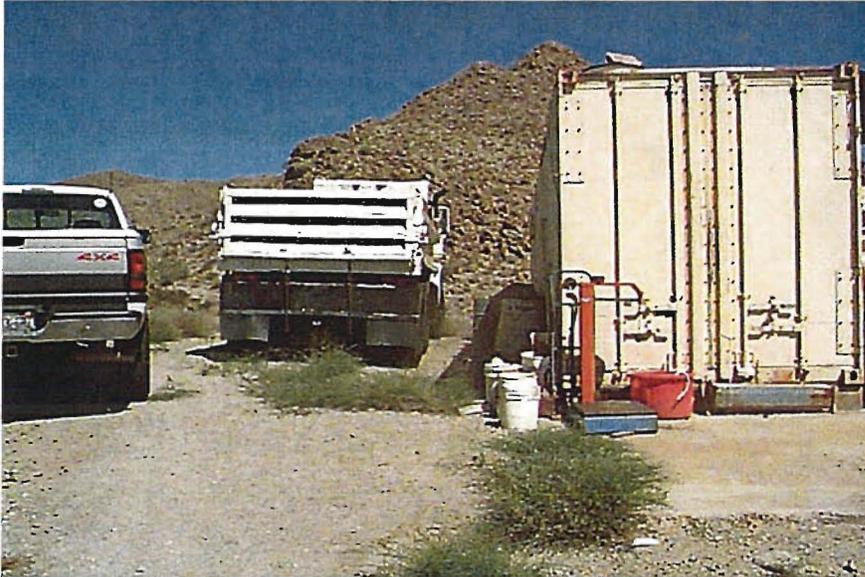
Photo #39 - Taken by E. Seum on 7/11/01. Shows dump truck parked next to lab on the ERI Mill Site #2 mill site.

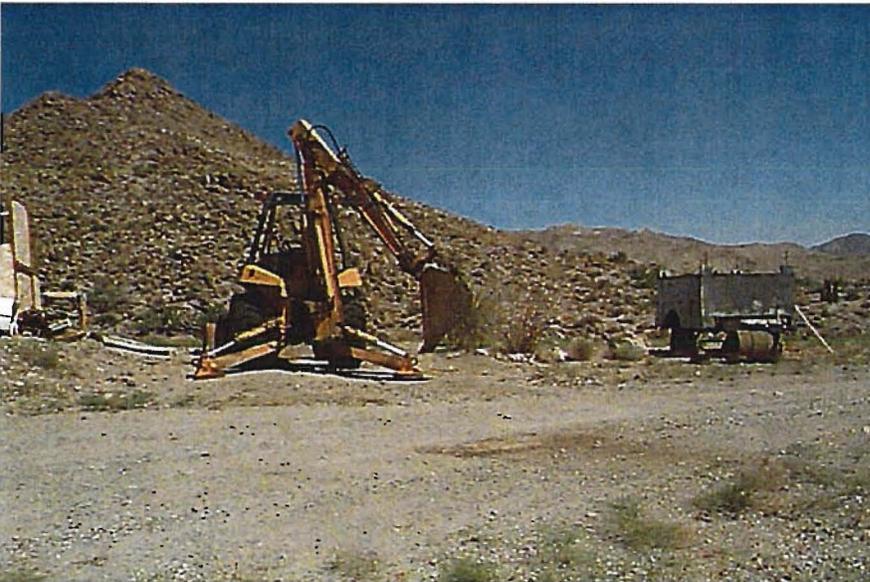
Photo #40 - Taken by E. Seum on 7/11/01. Shows backhoe and small trailer, stored on the ERI Mill Site #2 mill site.

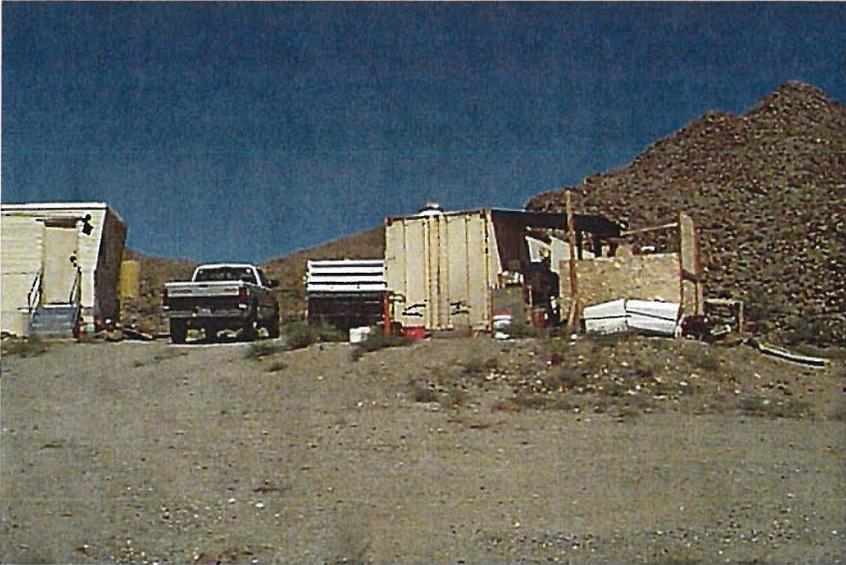
Photo #41 - Taken by E. Seum on 7/11/01. Looking west at the end of the lab on the ERI Mill Site #2 mill site.

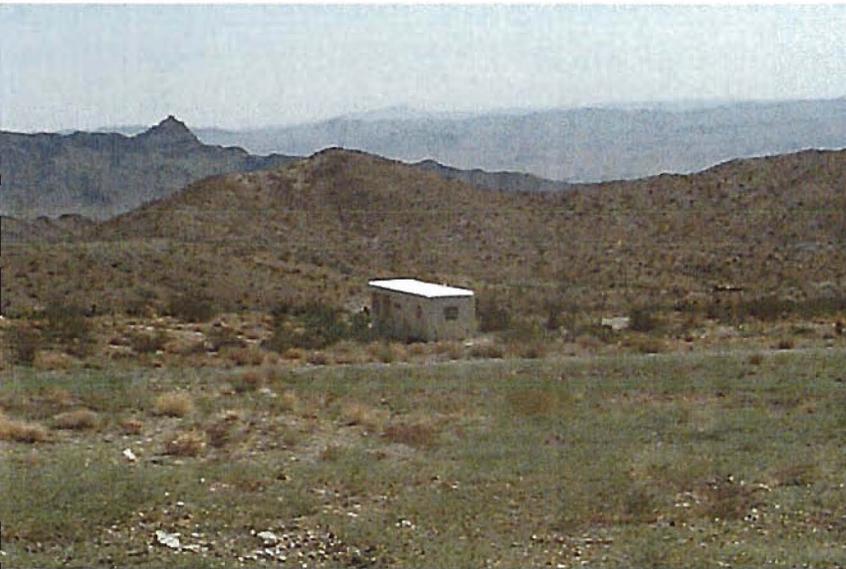
Photo #42 - Taken by E. Seum on 7/11/01. Looking at the watchman's trailer on the ERI Mill Site #3 mill site.

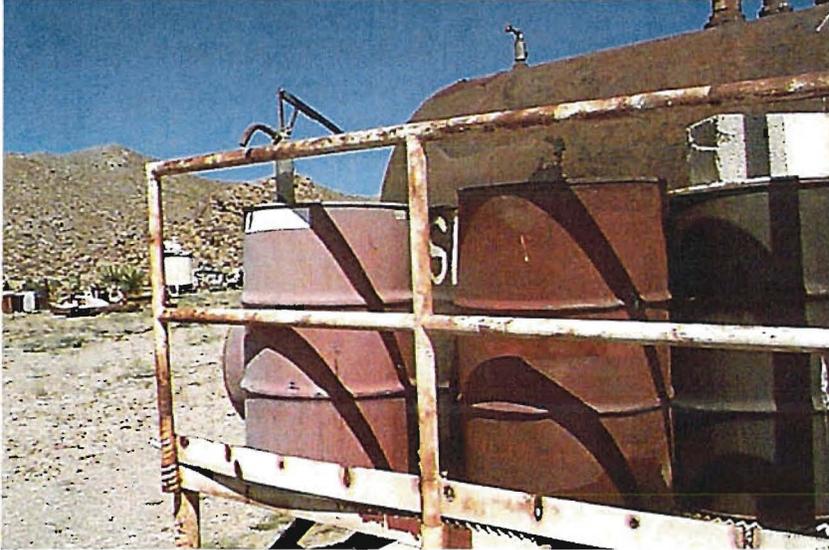
Photo #43 - Taken by E. Seum on 7/11/01. Looking at barrels of hydraulic oil on the ERI Mill Site #1 mill site.

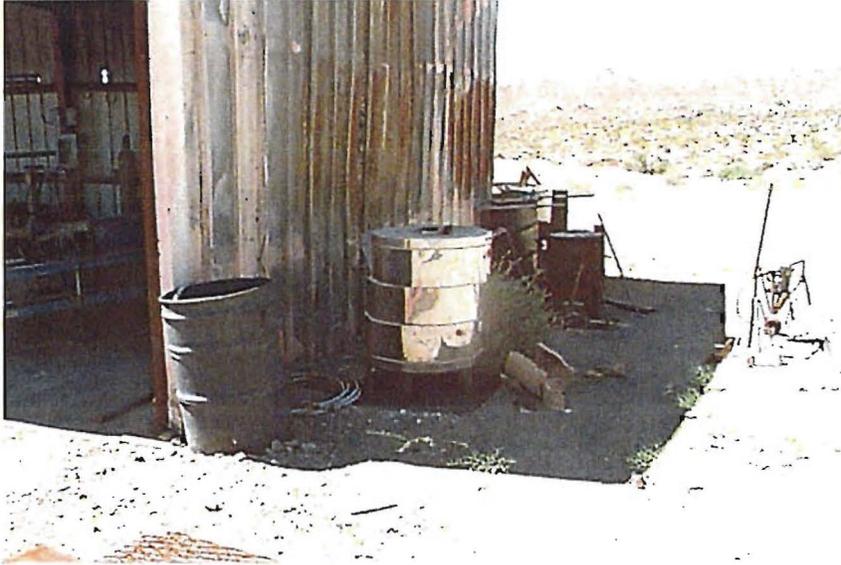
Photo #45 - Taken by E. Seum on 7/11/01. Shows furnace outside the shop area on the ERI Mill Site #1 mill site.

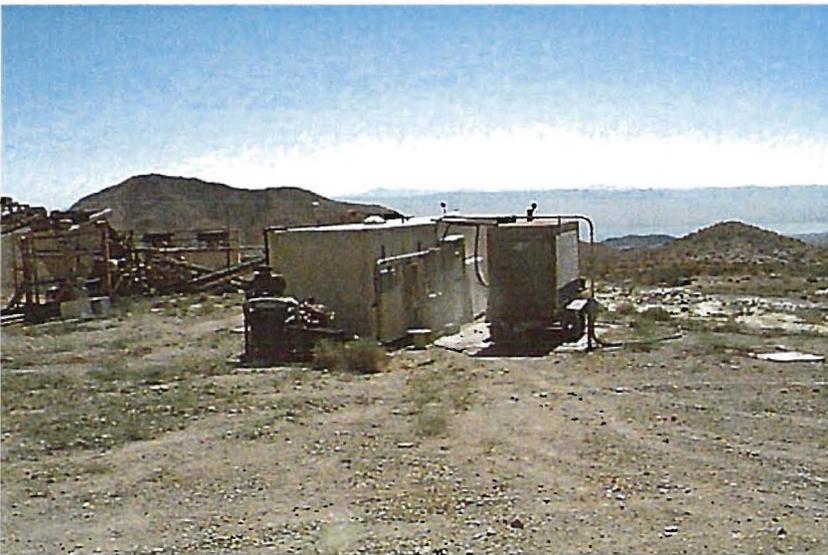
Photo #48 - Taken by E. Seum on 7/11/01. Shows generator and power facility on the ERI Mill Site #1 mill site.

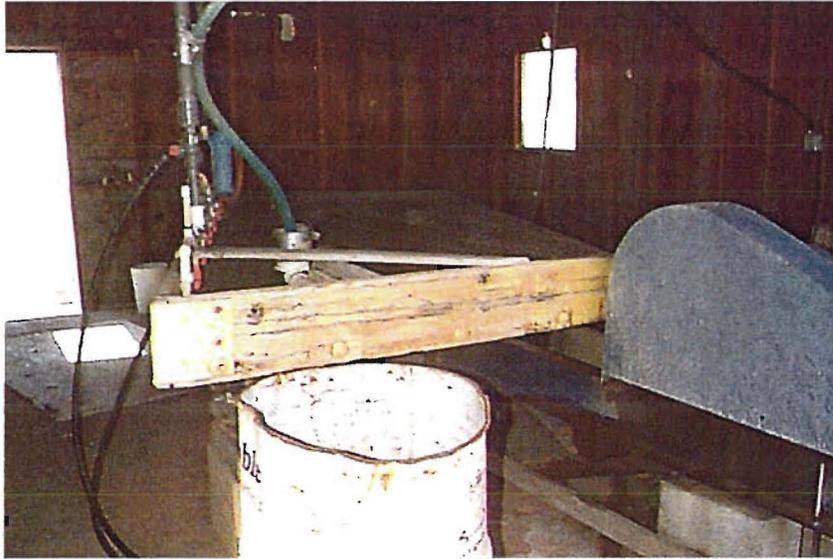
Photo #51 - Taken by E. Seum on 7/11/01. Shows jig table in the storage building, in above photo. On the ERI Mill Site #1 mill site.

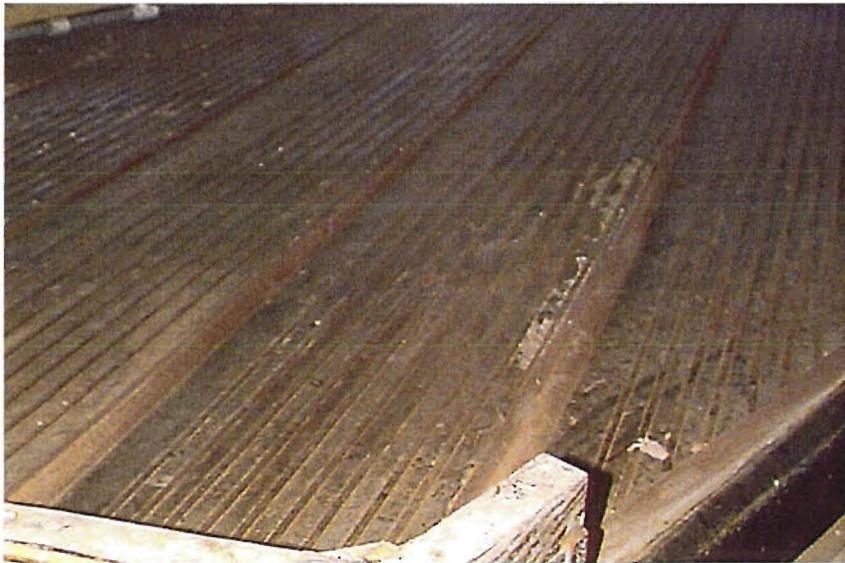
Photo #52 - Taken by E. Seum on 7/11/01. Close-up of jig table surface. On the ERI Mill Site #1 mill site.

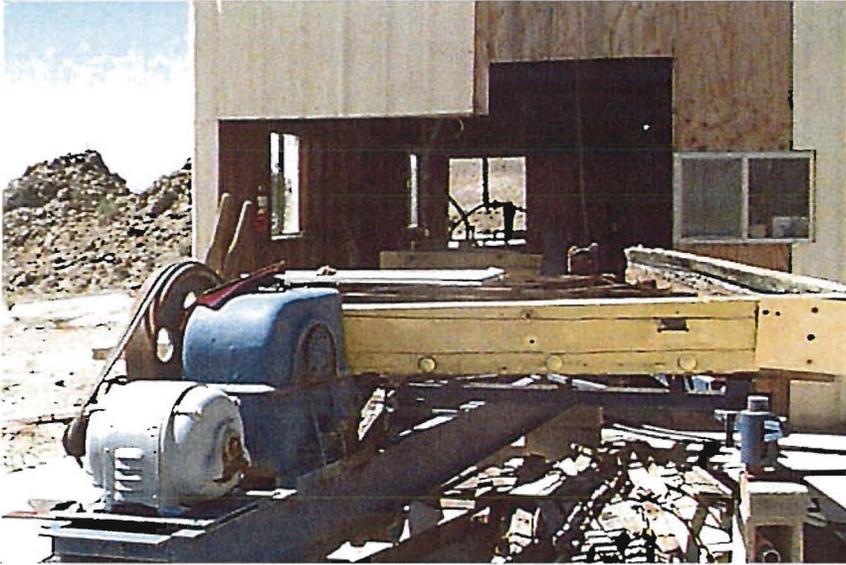
Photo #53 - Taken by E. Seum on 7/11/01. Shows unsurfaced jig table on the ERI Mill Site #1 mill site. See also photo 24.

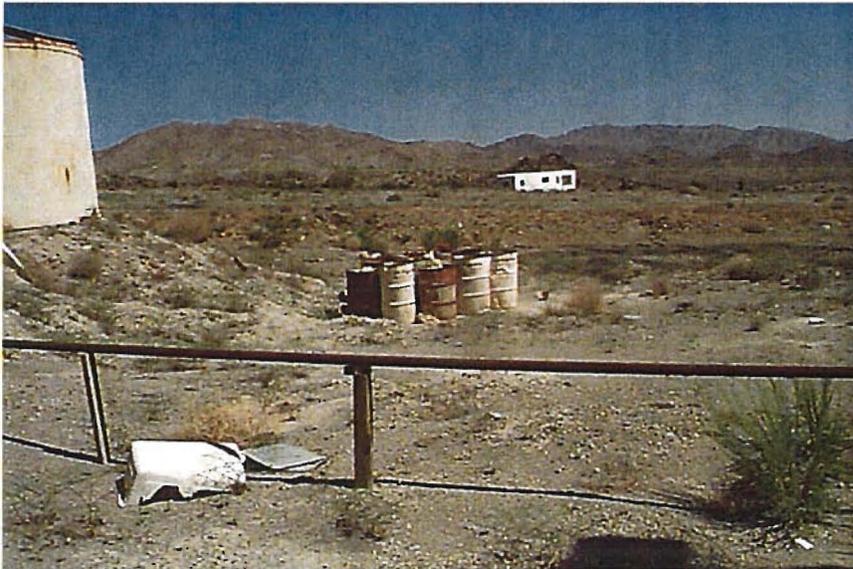
Photo #54 - Taken by E. Seum on 7/11/01. Shows barrels of mineral materials on the ERI Mill Site #1 mill site. Watchman's trailer in background on ERI Mill Site #3 mill site.

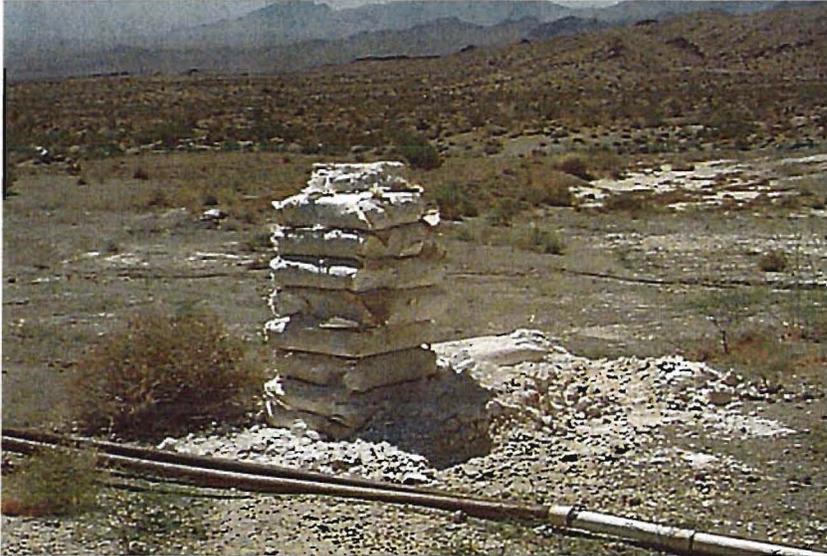
Photo #55 - Taken by E. Seum on 7/11/01. Shows deteriorating bags of lime on the ERI Mill Site #1 mill site.

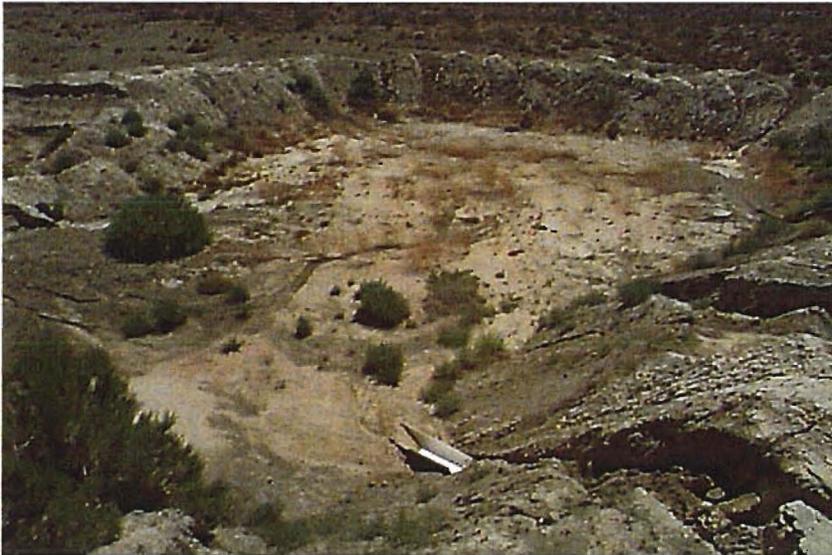
Photo #56 - Taken by E. Seum on 7/11/01. Shows pond on the ERI Mill Site #1 mill site.

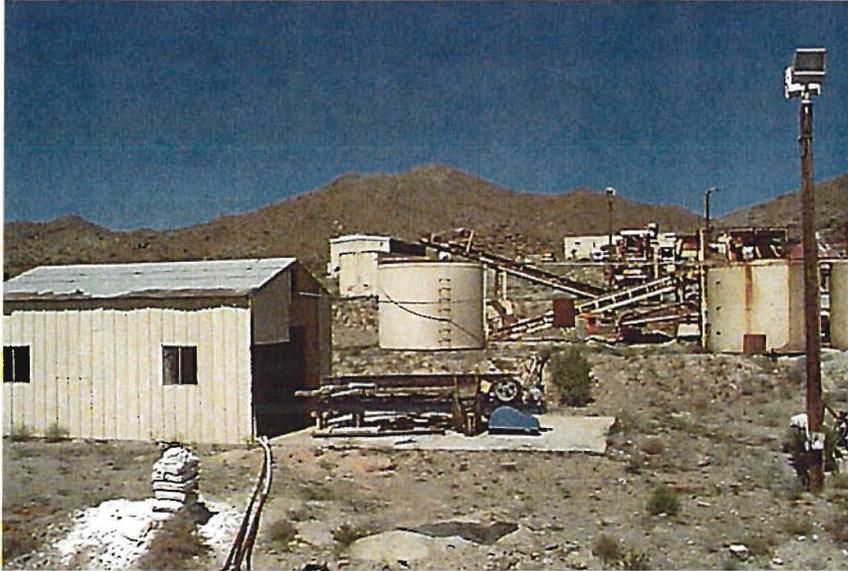
Photo #57 - Taken by E. Seum on 7/11/01. Looking west at equipment and storage building on the ERI Mill Site #1 mill site.

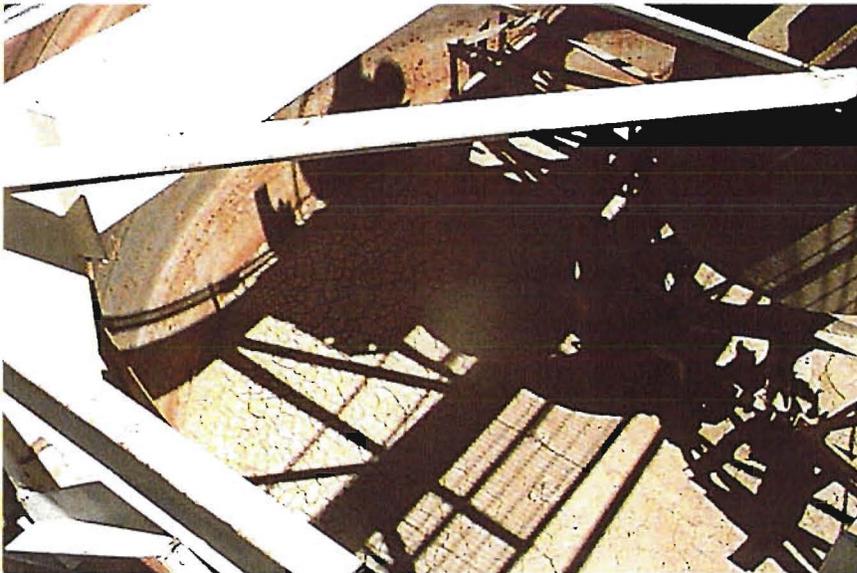
Photo #58 - Taken by E. Seum on 7/11/01. Looking inside one of the mixing tanks shown in the above photo. On the ERI Mill Site #1 mill site.

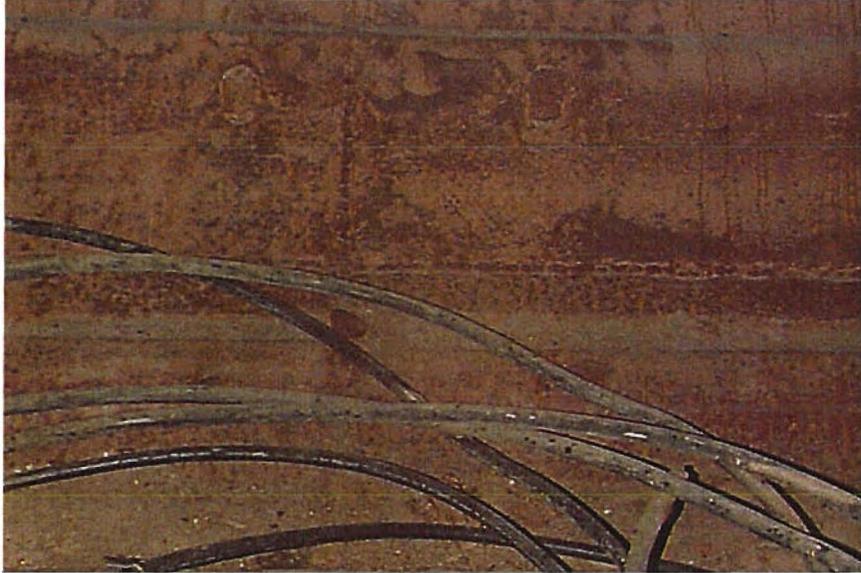
Photo #59 - Taken by E. Seum on 7/11/01. Looking inside of a ball mill on the ERI Mill Site #1 mill site.
