UNITED STATES  
DEPARTMENT OF THE INTERIOR  
BUREAU OF LAND MANAGEMENT

**MINERAL REPORT**  
Surface Use Determination  
For The  
ERI Mill Site #1, ERI Mill Site #2, ERI Mill Site #3, ERI #39, ODM #21  
Mill Site and Lode Claims

Clark County, Nevada  
T. 28 S., R. 64 E., MDM  
Section 33, SW¼

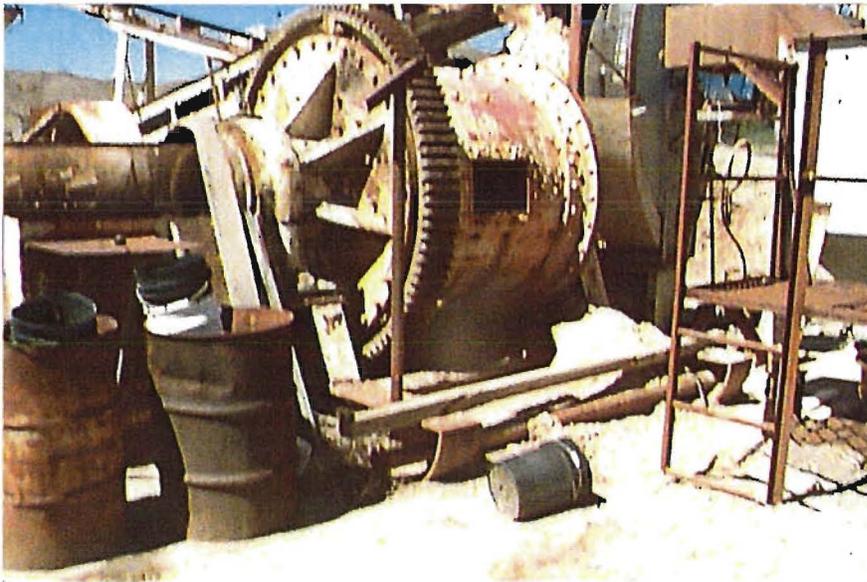
Photo #60 - Taken by E. Seum on 7/11/01. Looking at the exterior of the ball mill shown in the above photo. On the ERI Mill Site #1 mill site.

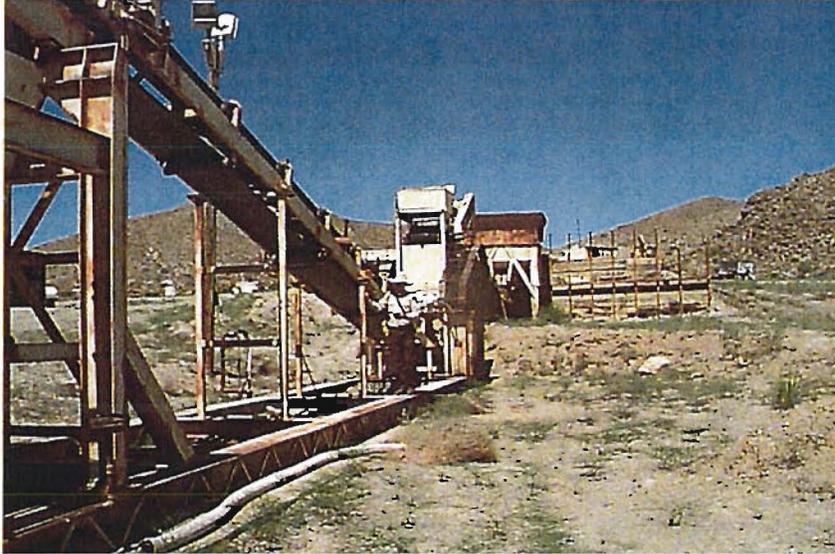
Photo #61 - Taken by E. Seum on 7/11/01. Looking west, along a belt line leading from a screen and crusher. On the ERI Mill Site #1 mill site.

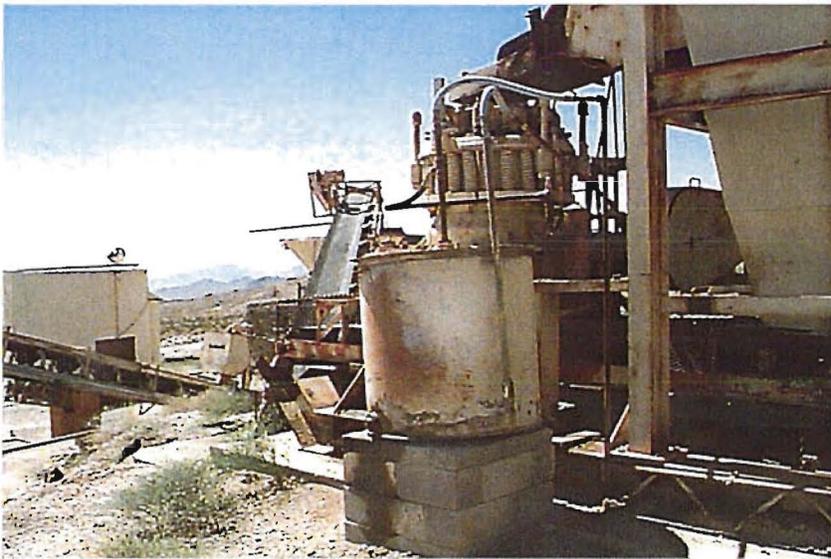
Photo #62 - Taken by E. Seum on 7/11/01. Looking at more of the processing equipment on the ERI Mill Site #1 mill site.

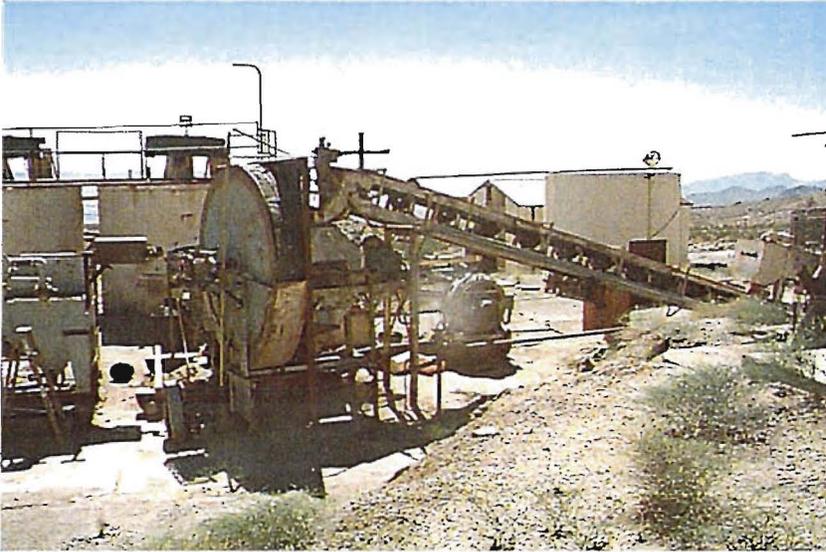
Photo #63 - Taken by E. Seum on 7/11/01. Shows more of the circuit located on the ERI Mill Site #1 mill site.

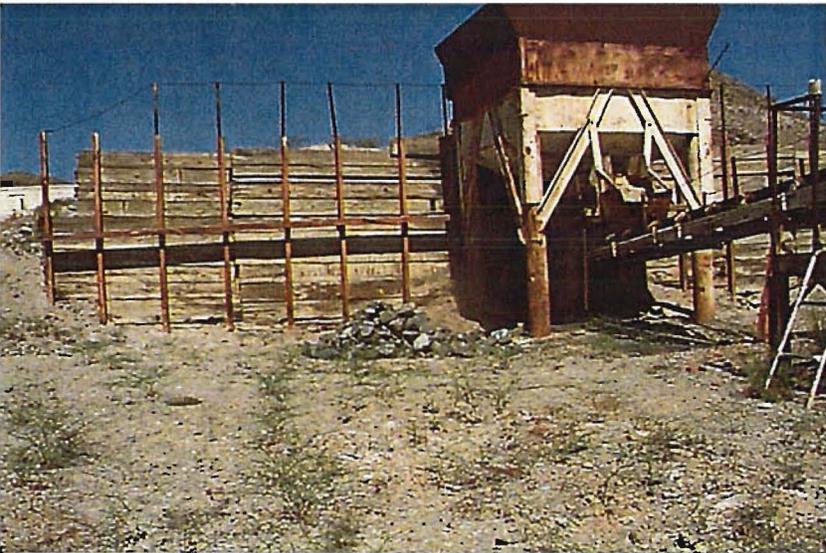
Photo #64 - Taken by E. Seum on 7/11/01. Shows upper hopper/screen with small pile of mineral material next to it. On the ERI Mill Site #1 mill site.

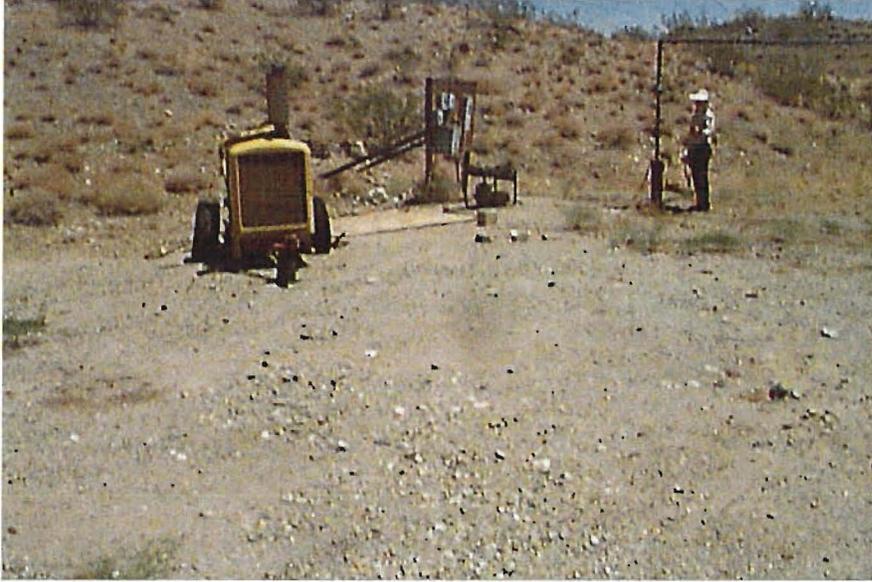
Photo #65 - Taken by E. Seum on 7/11/01. Shows well head and generator on the ODM #20 lode claim.

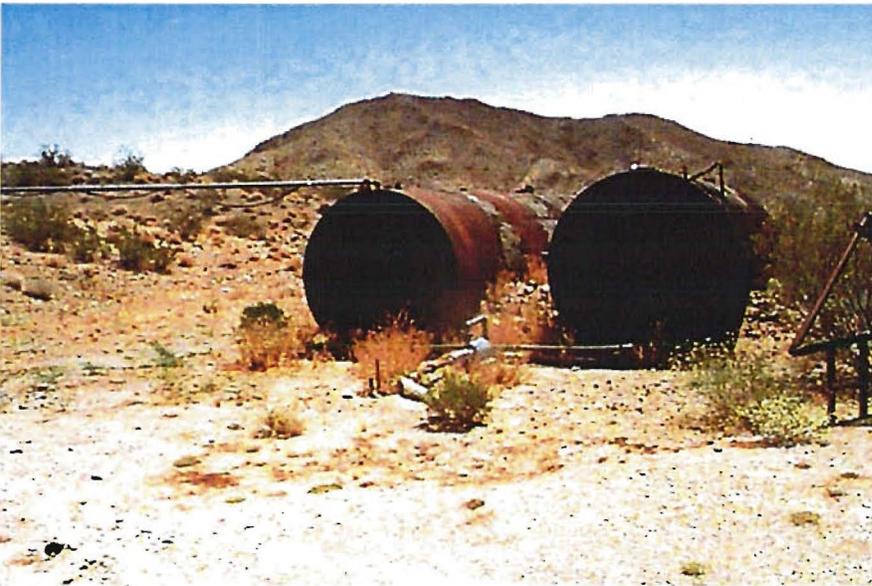
Photo #66 - Taken by E. Seum on 7/11/01. Shows storage tanks on the ODM #20 lode claim.

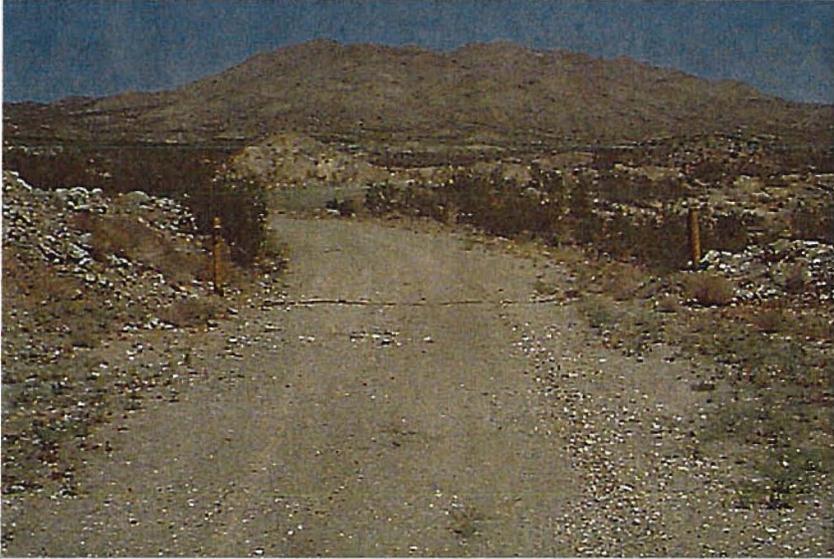
Photo #67 - Taken by E. Seum on 7/11/01. Shows cable located on the ODM #21 lode claim.

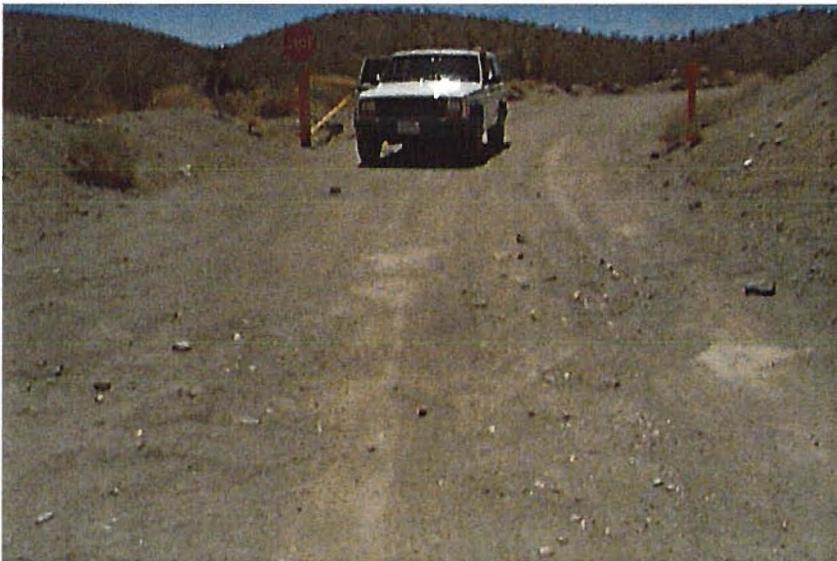
Photo #68 - Taken by E. Seum on 7/11/01. Shows gate located on the ERI #39 lode claim.

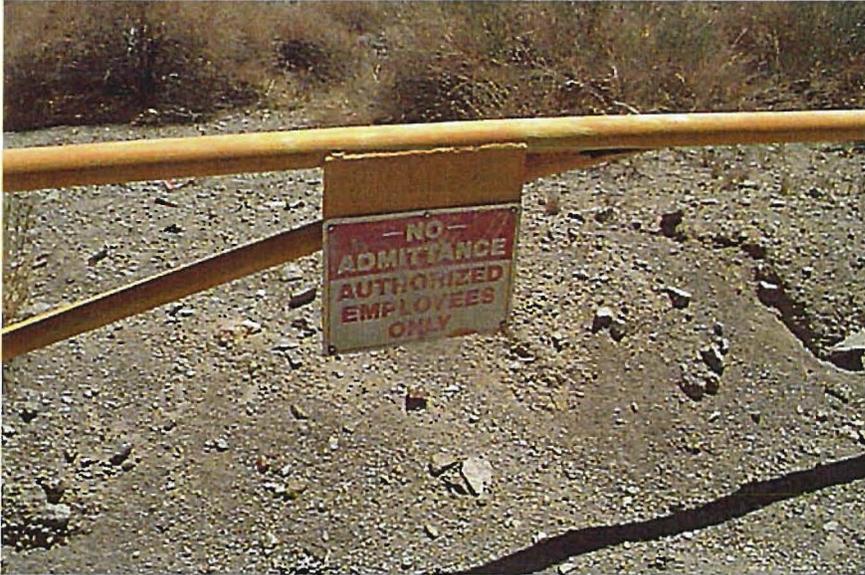
Photo #69 - Taken by E. Seum on 7/11/01. Shows sign on gate located on the ERI #39 lode claim.

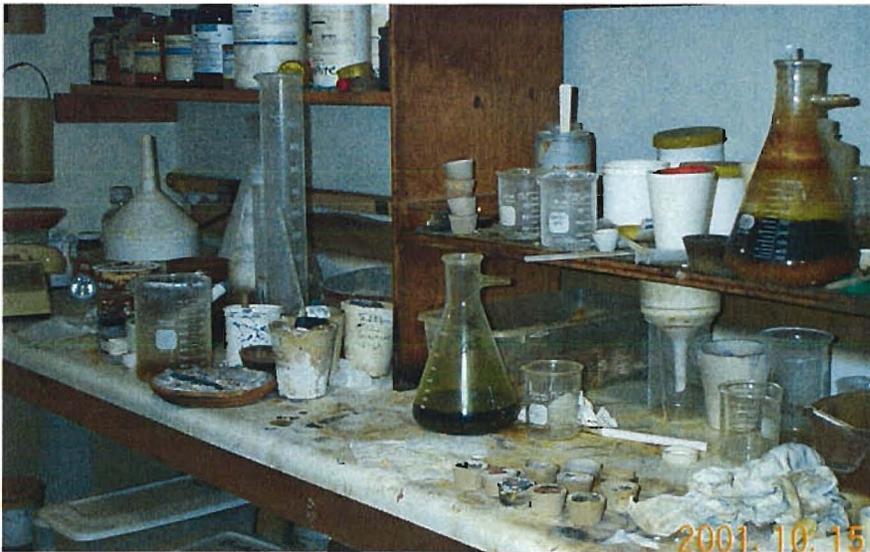
Photo #70 - Taken by J. Mur on 10/15/01. Shows interior of lab on the ERI Mill Site #2 mill site claim.

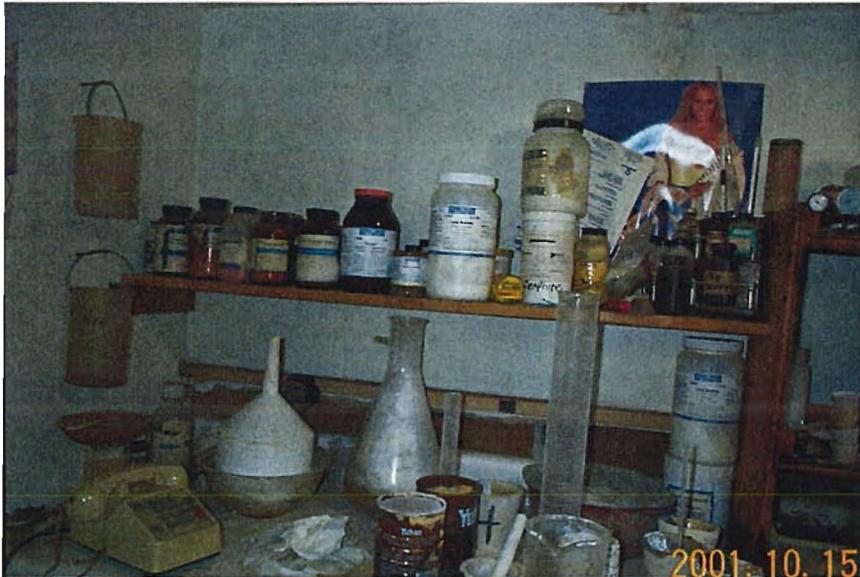
Photo #71 - Taken by J. Mur on 10/15/01. Shows interior of lab on the ERI Mill Site #2 mill site claim.

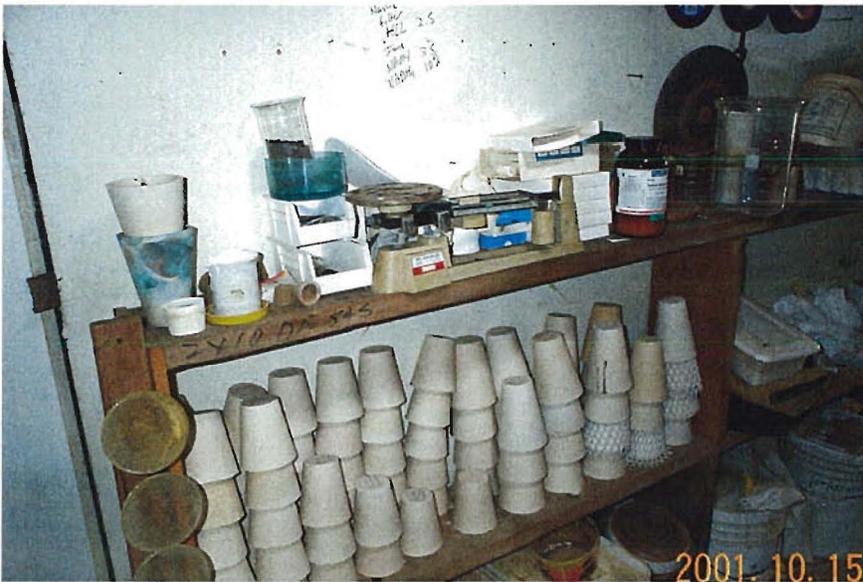
Photo #72 - Taken by J. Mur on 10/15/01. Shows interior of lab on the ERI Mill Site #2 mill site claim.

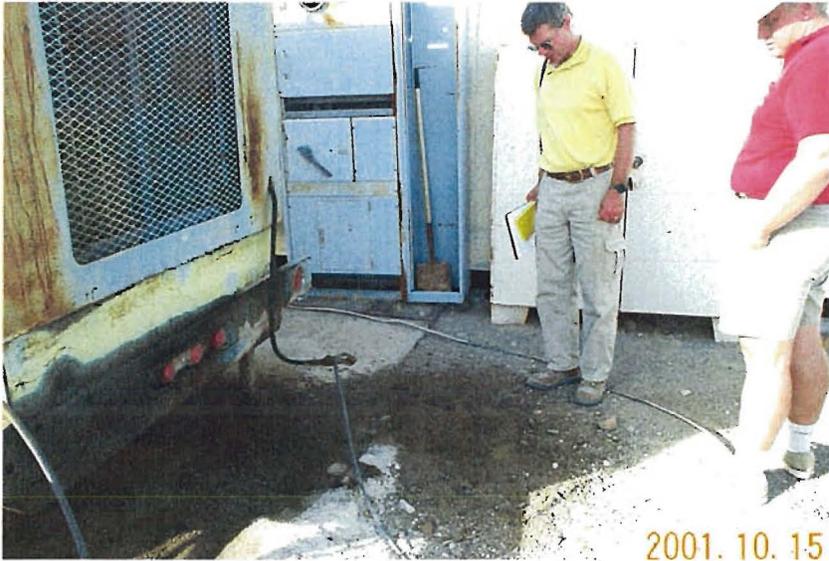
The October 15, 2001 inspection noted that there had been no processing or signs of use since the July 2001 inspection. Problems were noted with hydrocarbon spills and open containers of materials. The inspection of January 10, 2002 found the cable across the road locked. No one was on site during the inspection. The only signs of recent activity involved the attempt to clean-up the hydrocarbon contaminated areas. A few barrels of mineral materials were on site. An unsecured refrigerator sitting outside the lab building contained chemicals, including cyanide.

Photo #77 - Taken by J. Mur on 10/15/01. Shows fuel contamination of ground at base of the generator on the ERI Mill Site #1 mill site claim.

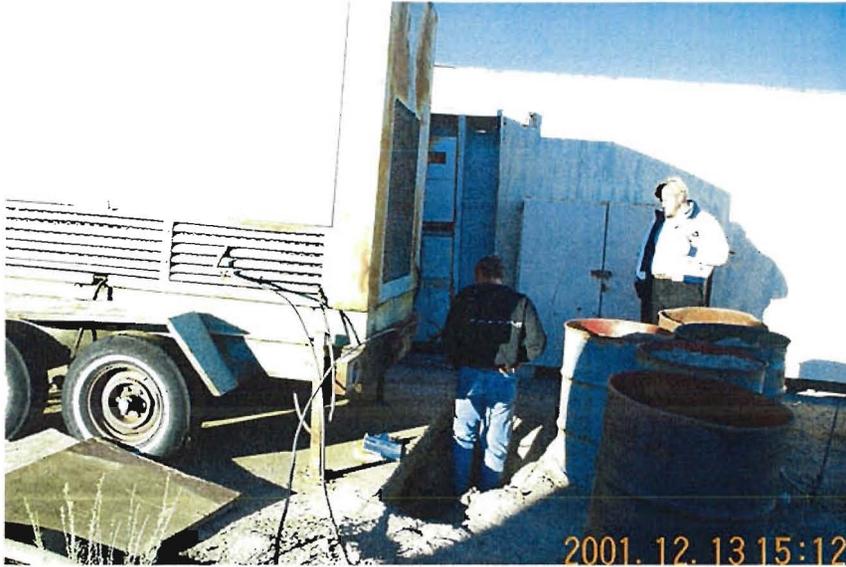
Photo #83- Taken by J. Mur on 12/13/01. Generator on the ERI Mill Site #1 mill site claim. Ground in front of tanks has been sampled for hydrocarbon contamination.

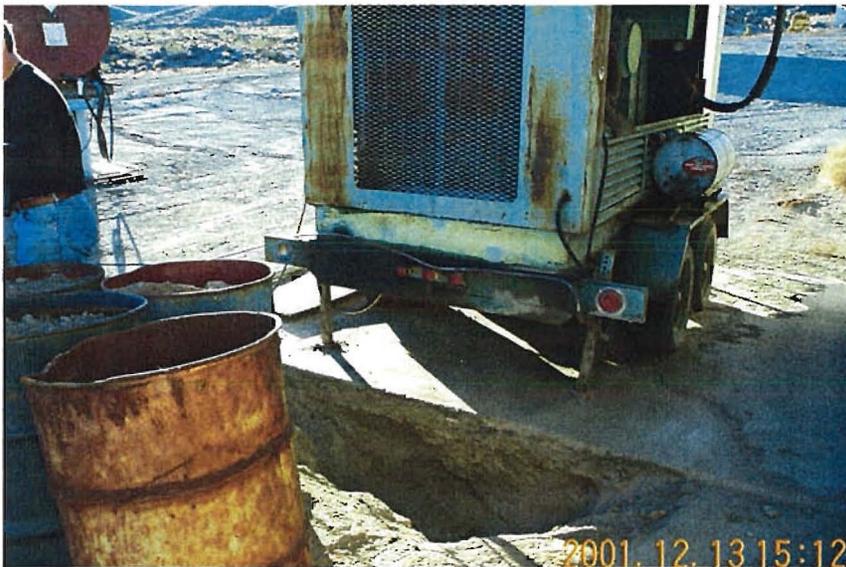
Photo #84- Taken by J. Mur on 12/13/01. Close-up of area shown in above photo on the ERI Mill Site #1 mill site claim.

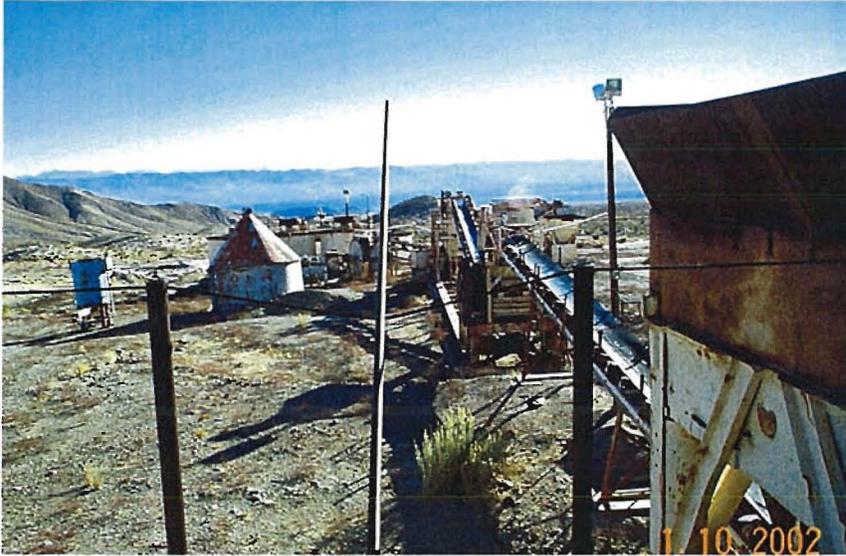
Photo #93 - Taken by E. Seum on 1/10/02. Looking east along beltline for processing area on the ERI Mill Site #1 mill site claim.

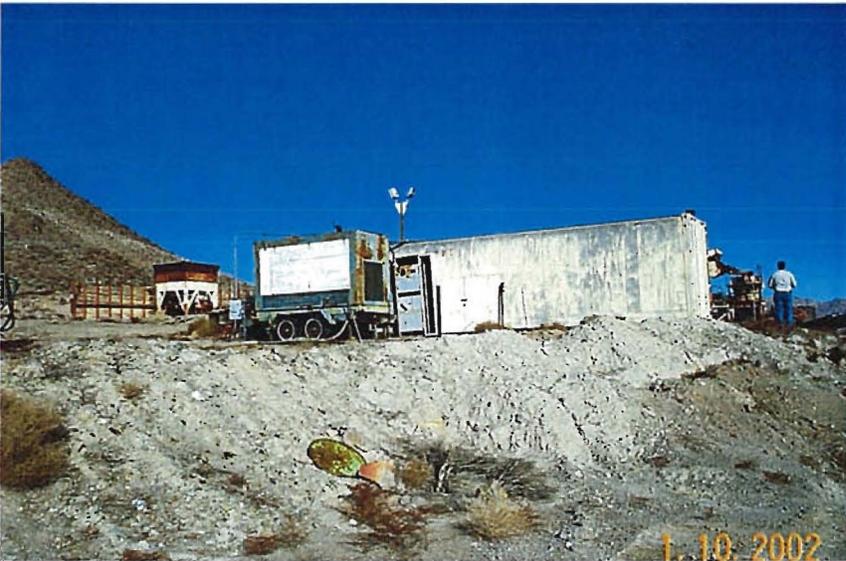
Photo #94 - Taken by E. Seum on 1/10/02. Shows generator and power facility on the ERI Mill Site #1 mill site claim.

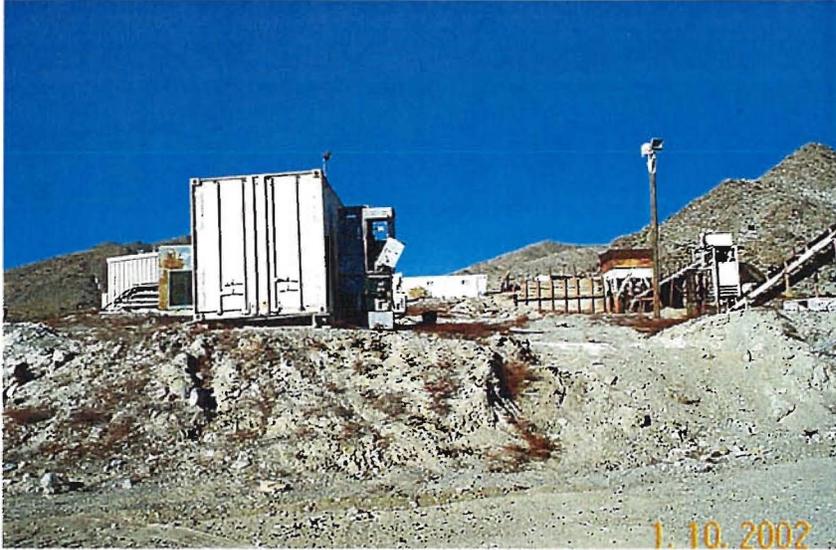
Photo #95 - Taken by E. Seum on 1/10/02. Shows power facility and some of the processing equipment on the ERI Mill Site #1 mill site claim.

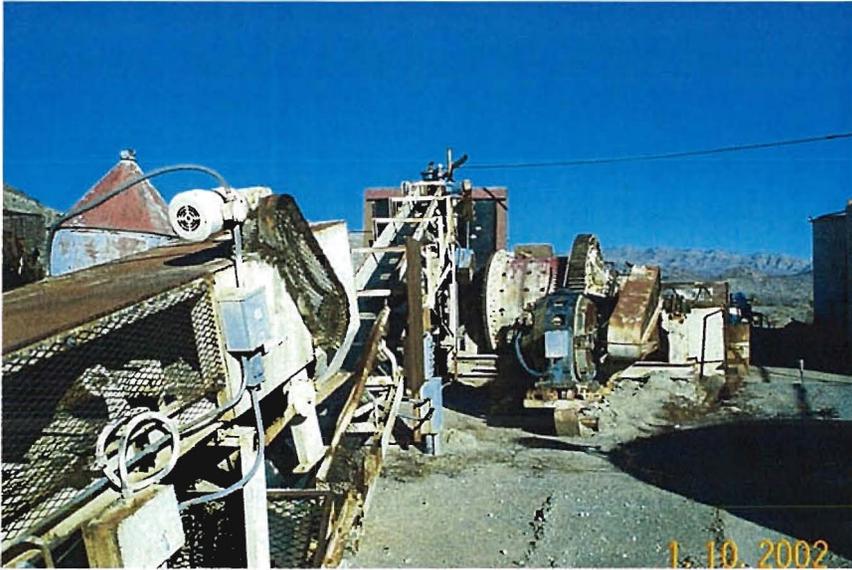
Photo #97 - Taken by E. Seum on 1/10/02. Looking at the lower end of the processing equipment on the ERI Mill Site #1 mill site claim.

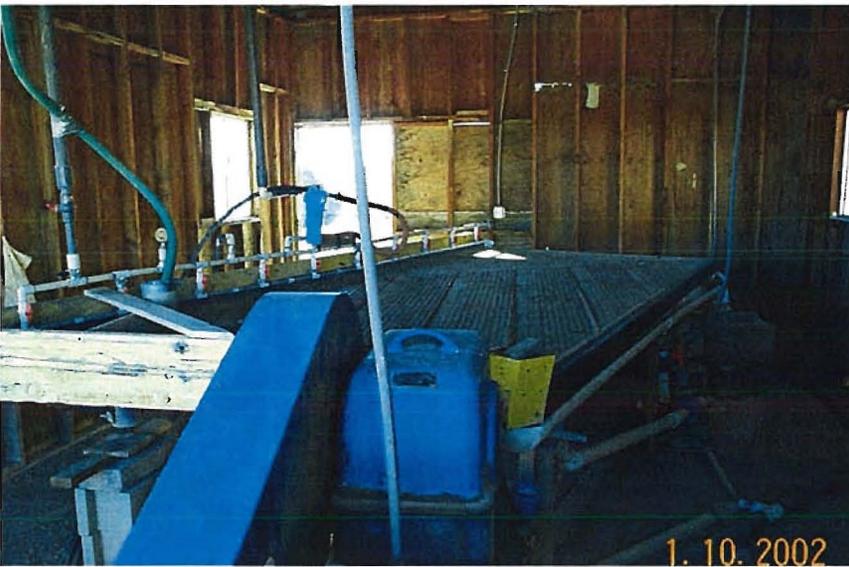
Photo #98 - Taken by E. Seum on 1/10/02. Looking at a jig table inside storage building on the ERI Mill Site #1 mill site claim.

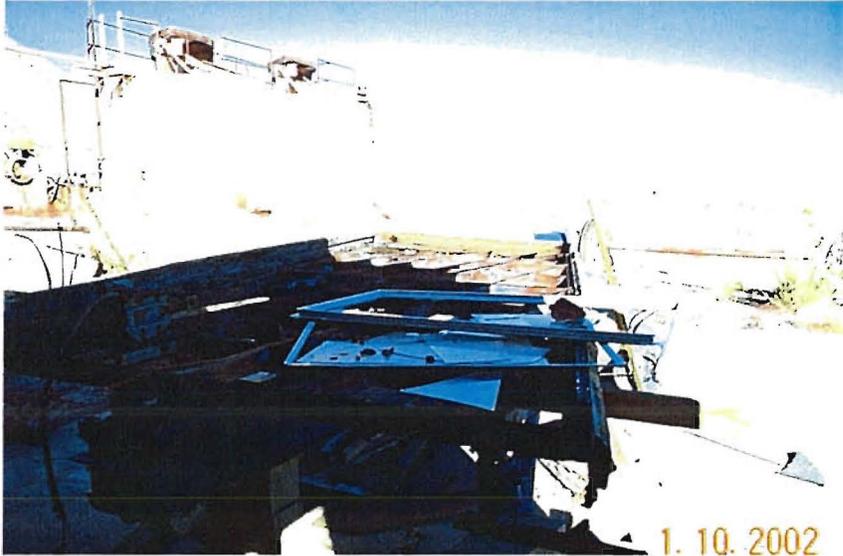
Photo #99 - Taken by E. Seum on 1/10/02. Shows unsurfaced jig table outside the storage building on the ERI Mill Site #1 mill site claim.

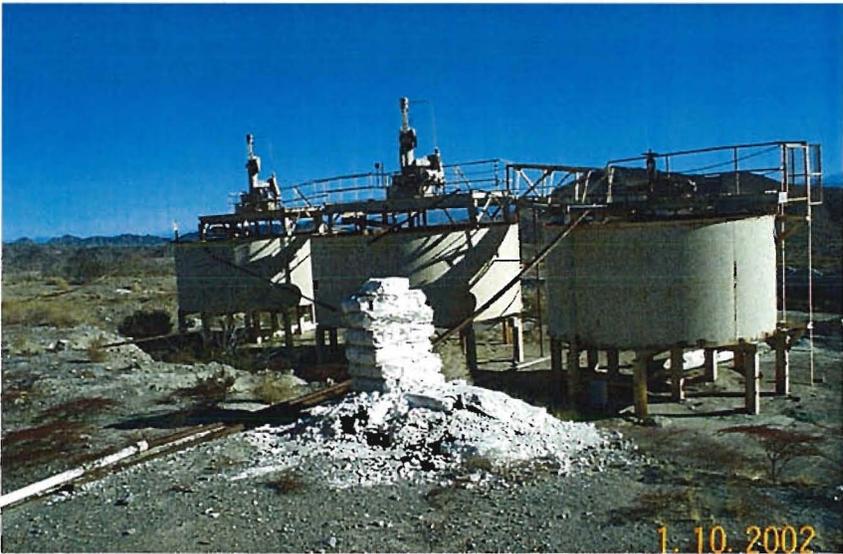
Photo #100 - Taken by E. Seum on 1/10/02. Shows deteriorating bags of lime next to mixing tanks on the ERI Mill Site #1 mill site claim.

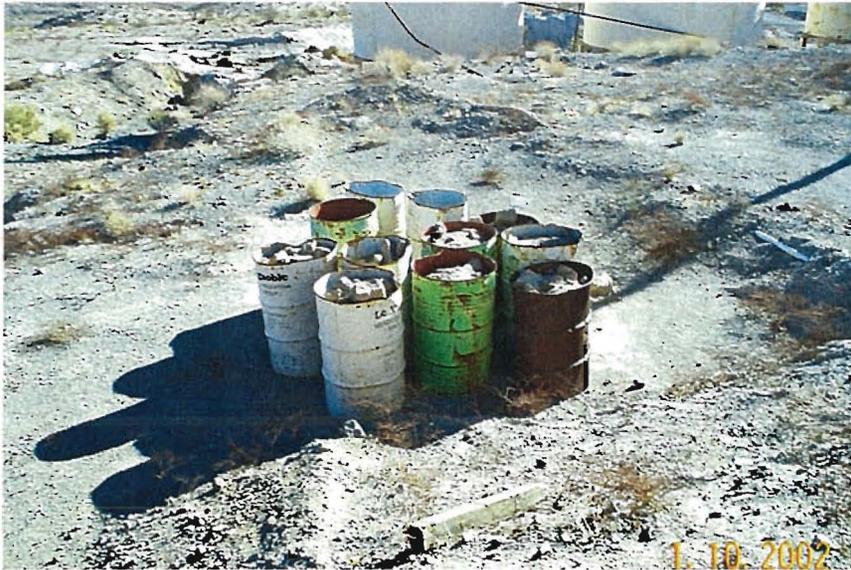
Photo #101 - Taken by E. Seum on 1/10/02. Shows barrels of mineral materials on the ERI Mill Site #1 mill site claim.

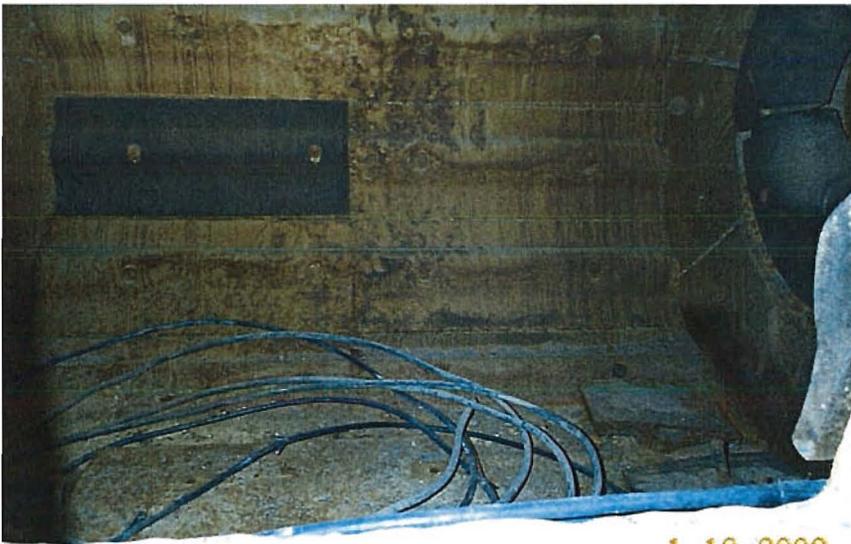
Photo #102 - Taken by E. Seum on 1/10/02. Shows inside of ball mill located in the processing circuit on the ERI Mill Site #1 mill site claim.
