UNITED STATES
DEPARTMENT OF THE INTERIOR
BUREAU OF LAND MANAGEMENT

MINERAL REPORT
Surface Use Determination
For
The Eagle 1
Mill Site Claim

LANDS INVOLVED
Clark County, Nevada
T. 26 S., R. 64 E., MDM
Section 14, NW¼SE¼
Approximately 1.06 Acres

May 24, 2001
(Date)

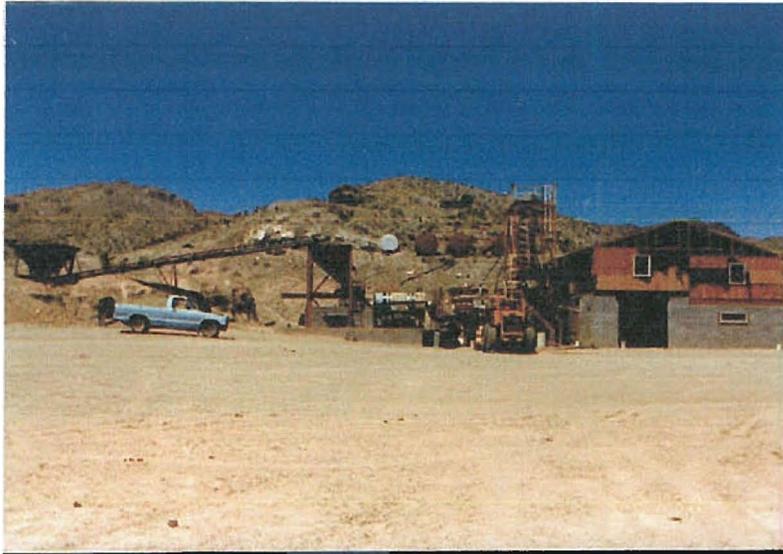
35). The remnants of a processing circuit sits adjacent to, and on the south side of the building (photos 1-3, 7, 10-11,13, 21-22, 33-34). The circuit was also on the site prior to Peña (photos 1-3). A rod mill and some separating tables are all that are left of the circuit (photos 21, 23-24, 30-31, 33). Several tanks for water, and one for fuel storage sit on the hill, west of the wooden building (photos 2, 11, 13, 17, 26, 28). Parts of mining equipment and other debris are located on the north and west sides of the building (photos 18-20, 27).

Photo #1 - Taken 6/21/90 by E. Seum. Shows equipment and building on site at that time.

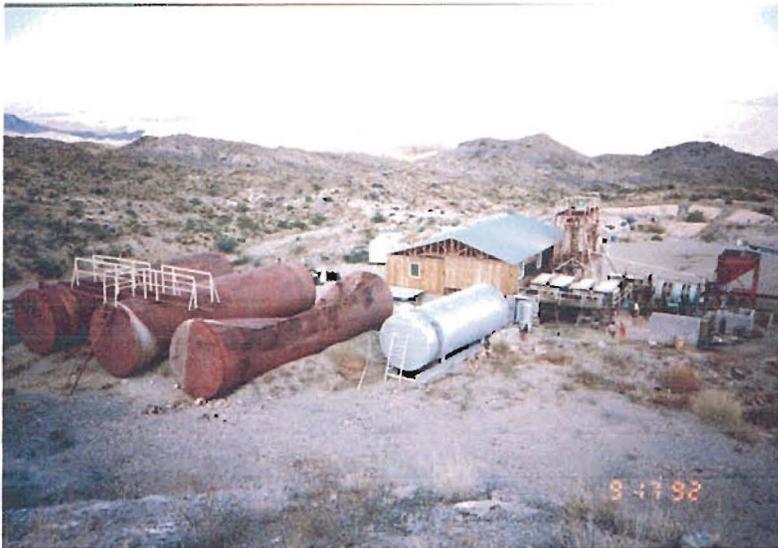
Photo #2 - Taken 9/17/92 by G. Miller. Looking down at tanks, building and equipment.

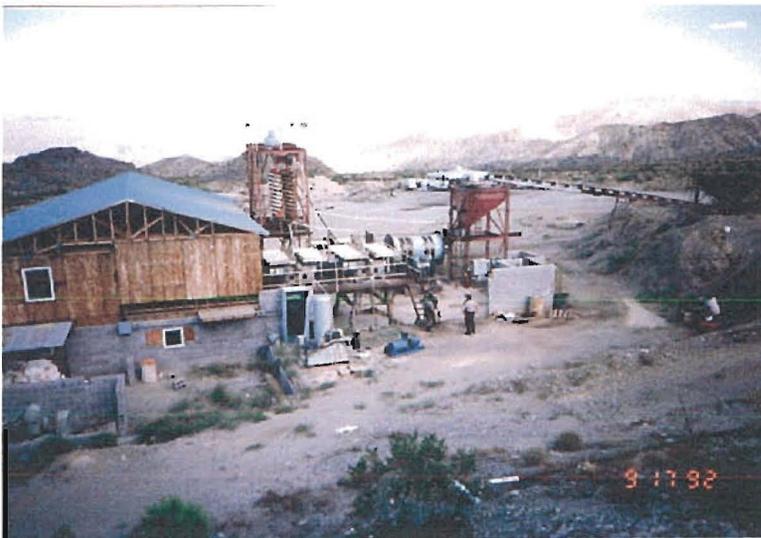
Photo #3 - Taken 9/17/92 by G. Miller. Looking down at equipment next to the building.

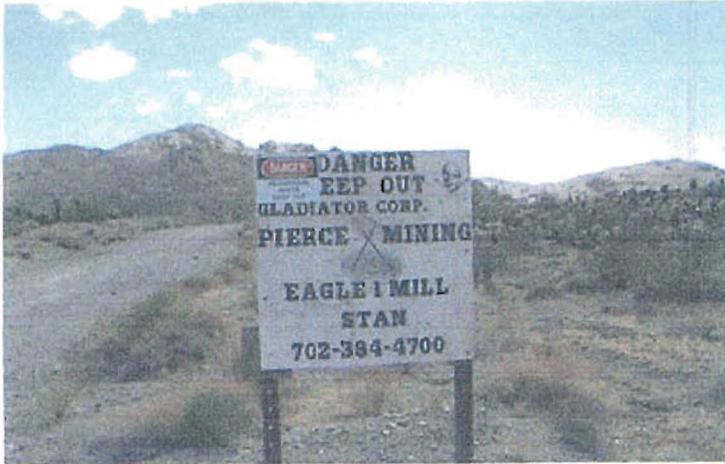
Photo #4 - Taken 8/19/98 by J. Mur. Shows sign at entrance to Eagle 1 claim.

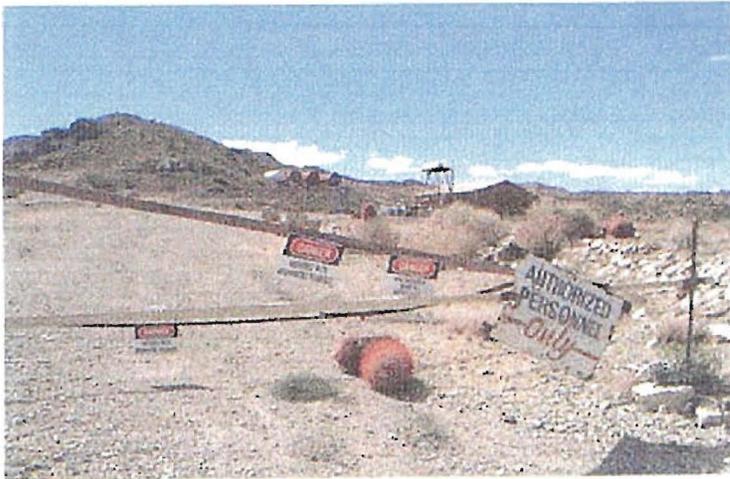
On April 19, 2000 an examination of the Eagle 1 mill site claim, NMC703827, was made by Edward Seum, a geologist from the Las Vegas Field Office. David Pierce, the operator, was present during the inspection. Mr. Pierce represented the claimant, Frank F. Peña. A locked gate blocks access to the claim (photos 5, 25). Prior to amending the claim boundaries in 1998, the gate was located on the Eagle 1 mill site claim. With the 1998 amendment, it is no longer on the claim.

Photo #5 - Taken 8/19/98 by J. Mur. Shows gate blocking the entrance to the Eagle 1 claim.

The notice of noncompliance should require the removal of the locked cable blocking access to the area, the wooden building, inoperable mining equipment and other items stored on the site.

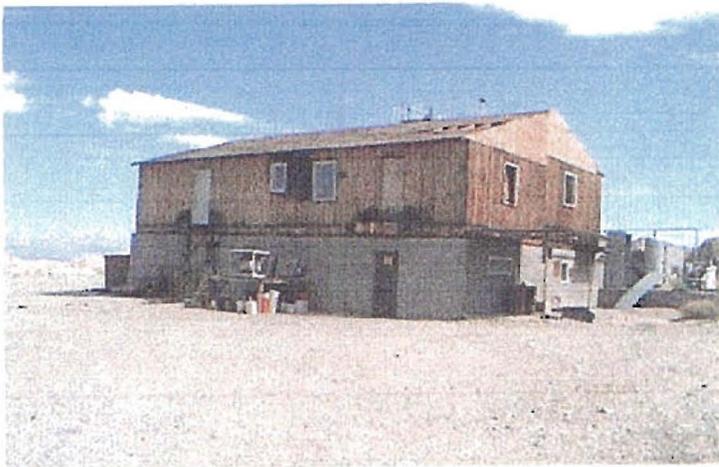
A wooden building, in deteriorating condition is located on the claim (photos 6-8, 10-16, 21-22, 29, 33-35). The building was on the site prior to Peña filing his claim (photos 1-3). The building has damage to the windows and holes in the roof (photos 21-22, 29, 33-

Photo #6 - Taken 8/19/98 by J. Mur. Looking southeast at the building on the Eagle 1 claim. Note holes in roof and broken rear windows.

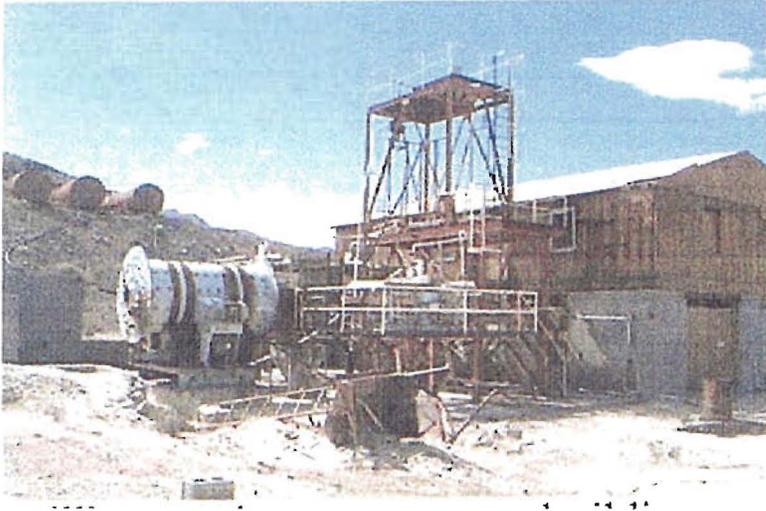
Photo #7 - Taken 8/19/98 by J. Mur. Shows equipment on south side of building on the Eagle 1 claim.

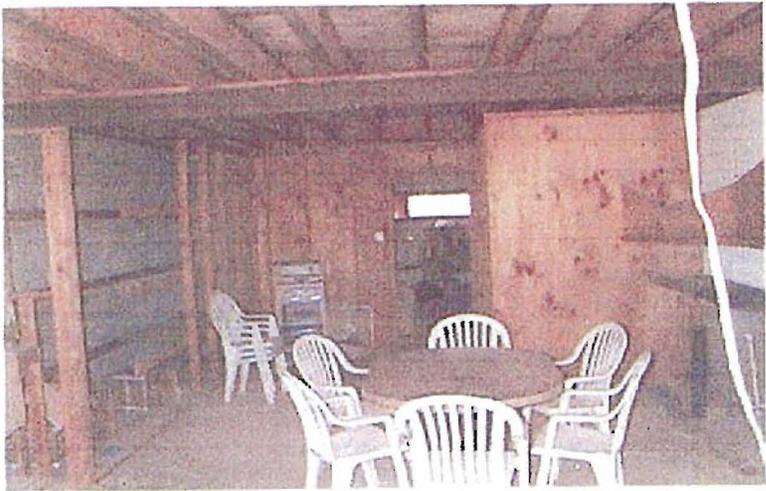
Photo #8 - Taken 8/19/98 by J. Mur. Shows interior of building on the Eagle 1 claim.

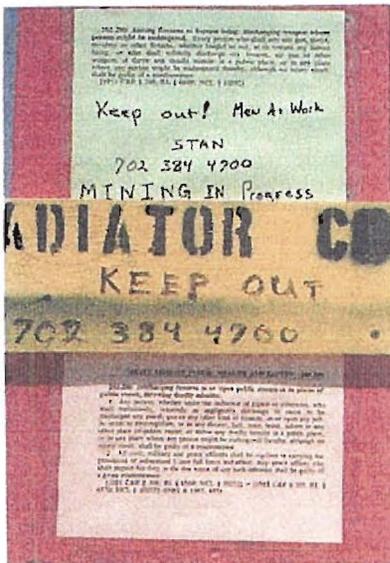
Photo #9 - Taken 8/26/99 by J. Mur. Shows sign near gate leading into the Eagle 1 claim.

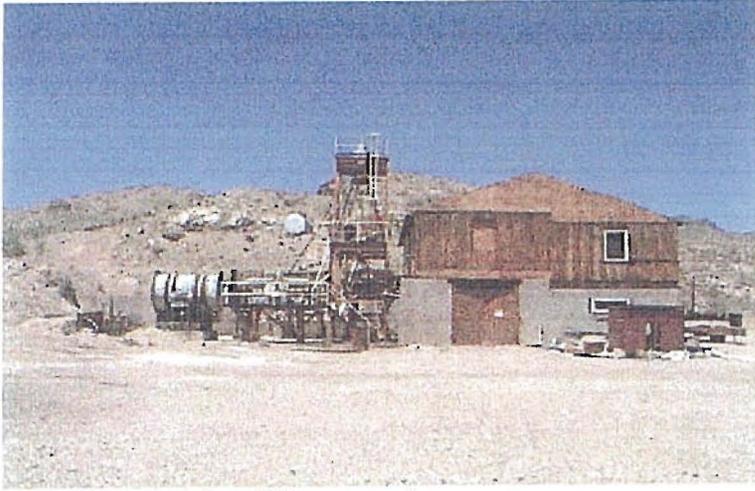
Photo #10 - Taken 8/26/99 by J. Mur. Looking west at building on the Eagle 1 claim. Compare with photo 1.

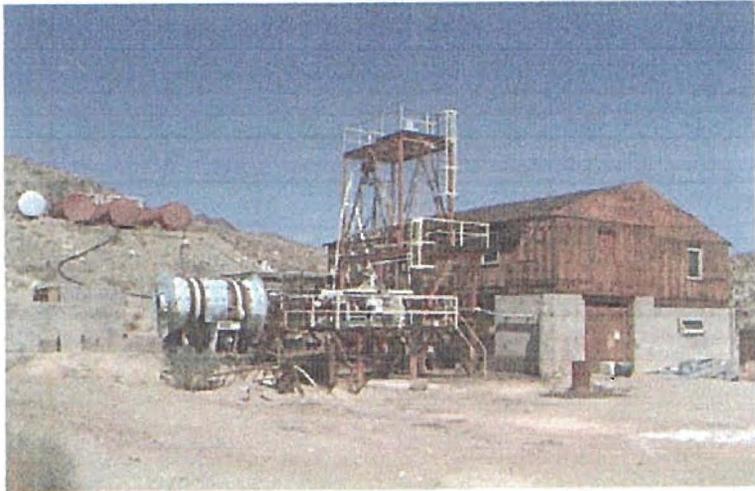
Photo #11 - Taken 7/26/00 by J. Mur. Looking northwest at equipment adjacent to building on Eagle 1 claim. Compare with photos 7 & 10.

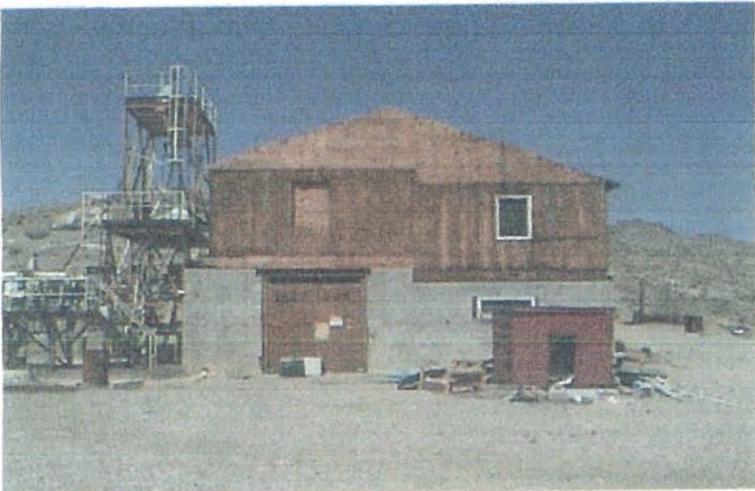
Photo #12 - Taken 7/26/00 by J. Mur. Looking west at building on Eagle 1 claim. Compare with photo 10.

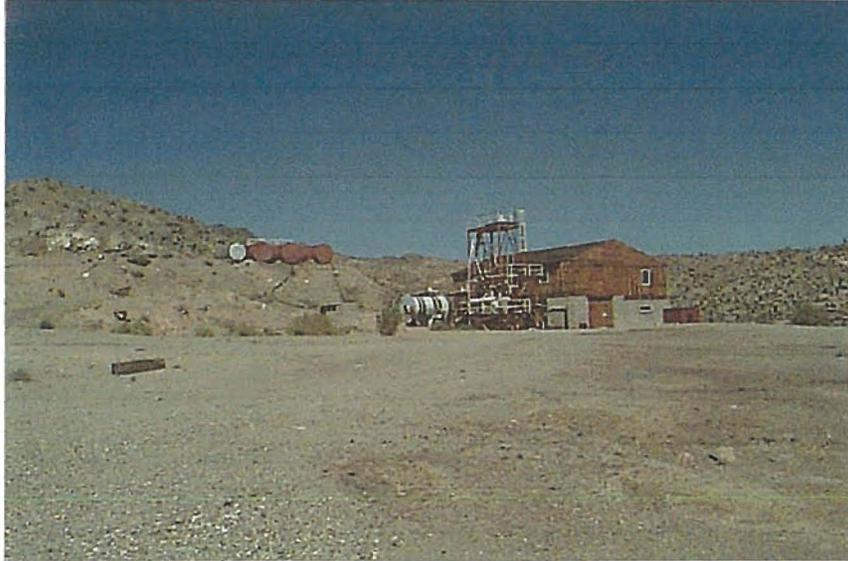
Photo #13 - Taken 4/19/00 by E. Seum. Taken looking west at wooden building and equipment on the Eagle 1 claim. Compare with photo 10.

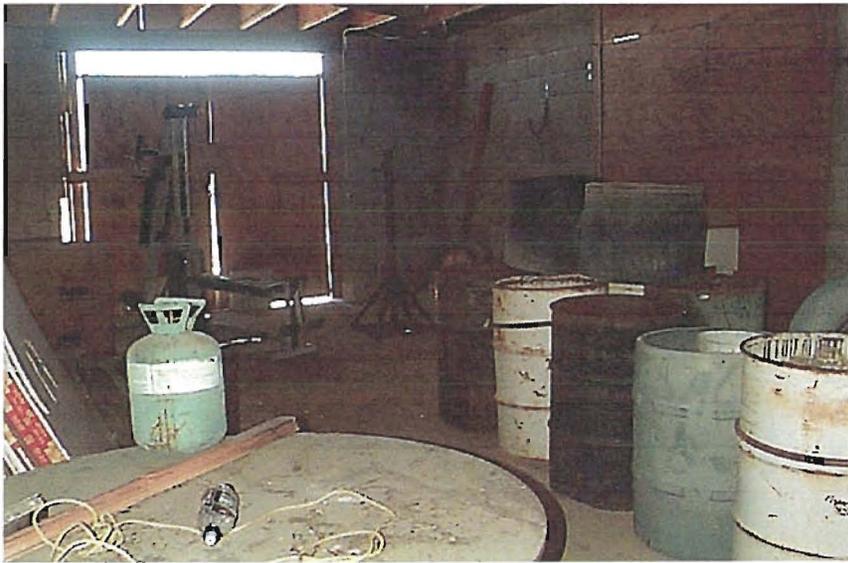
Photo #14 - Taken 4/19/00 by E. Seum. Shows items inside the wooden building on the Eagle 1 claim.

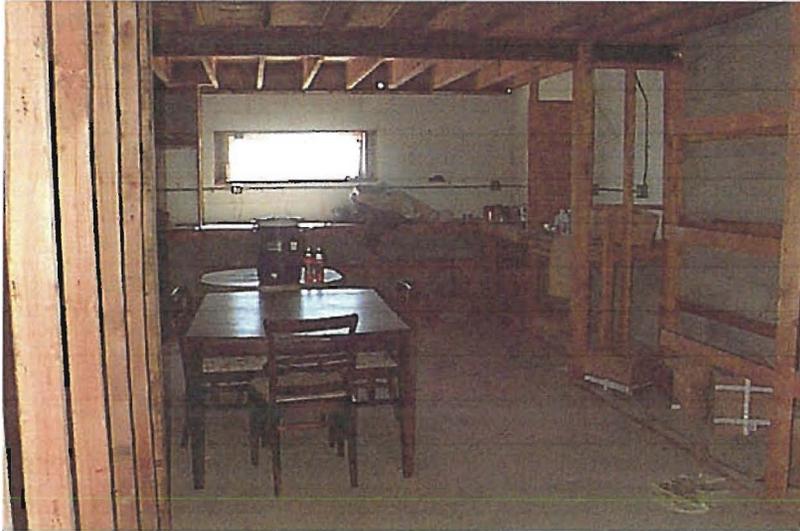
Photo #15 - Taken 4/19/00 by E. Seum. Taken inside the wooden building on the Eagle 1 claim.

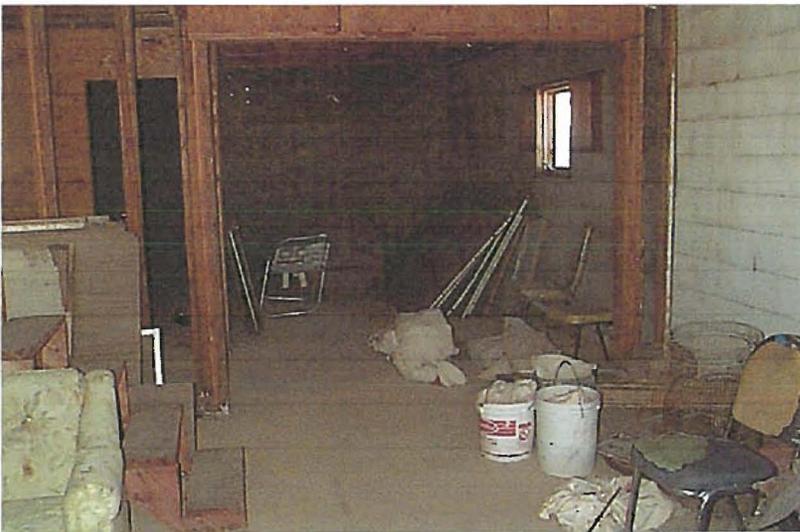
Photo #16 - Taken 4/19/00 by E. Seum. Shows more items in the wooden building on the Eagle 1 claim.

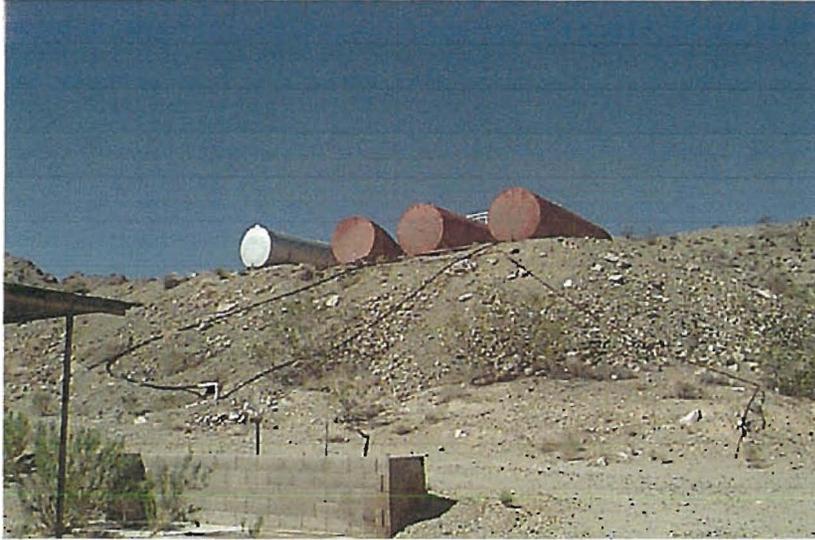
Photo #17 - Taken 4/19/00 by E. Seum. Taken looking west at empty water and fuel tanks on the Eagle 1 claim.

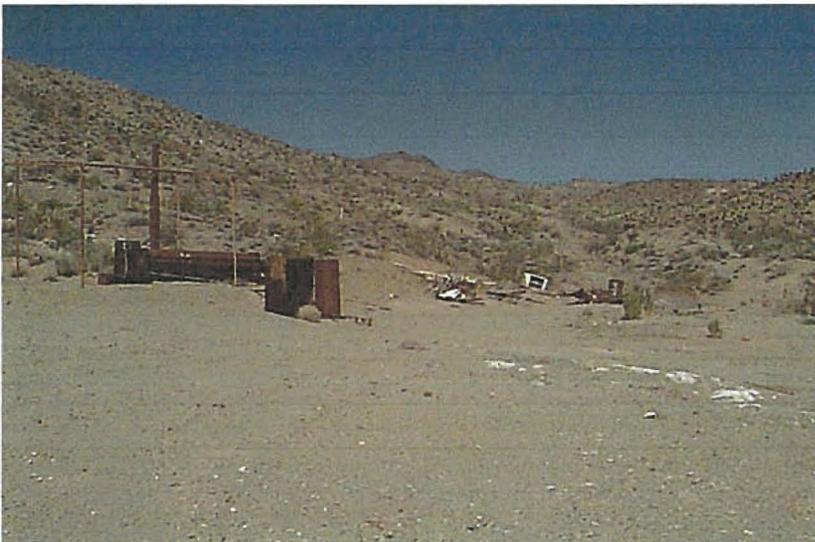
Photo #18 - Taken 4/19/00 by E. Seum. Shows miscellaneous items on the north side of the Eagle 1 claim.

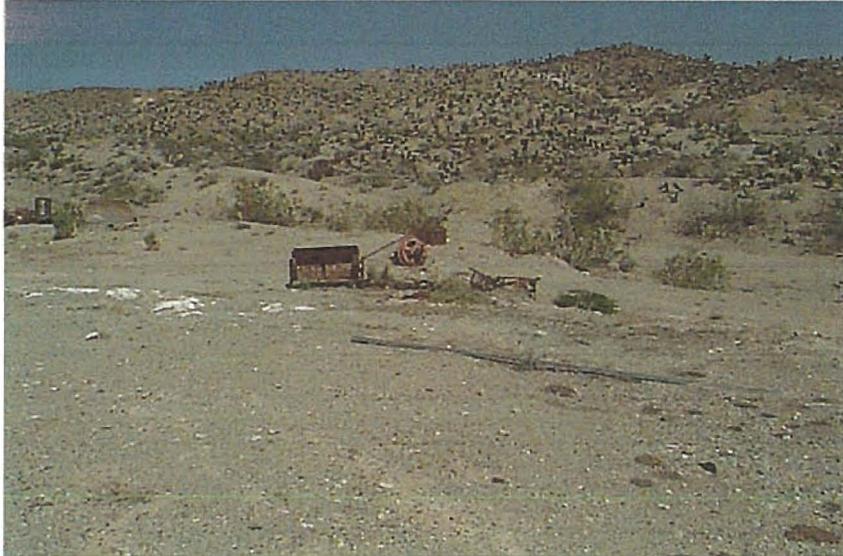
Photo #19 - Taken 4/19/00 by E. Seum. Shows miscellaneous items on the north side of the Eagle 1 claim.

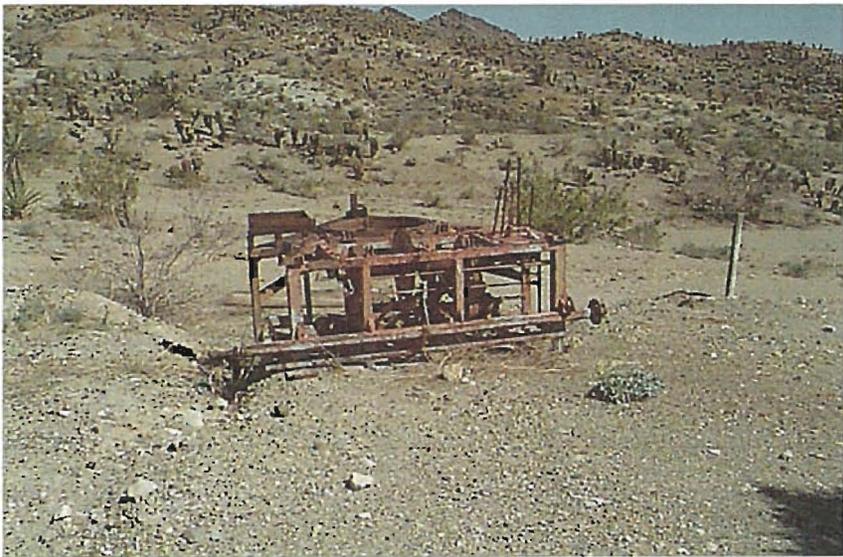
Photo #20 - Taken 4/19/00 by E. Seum. Scrap equipment located on the Eagle 1 claim.

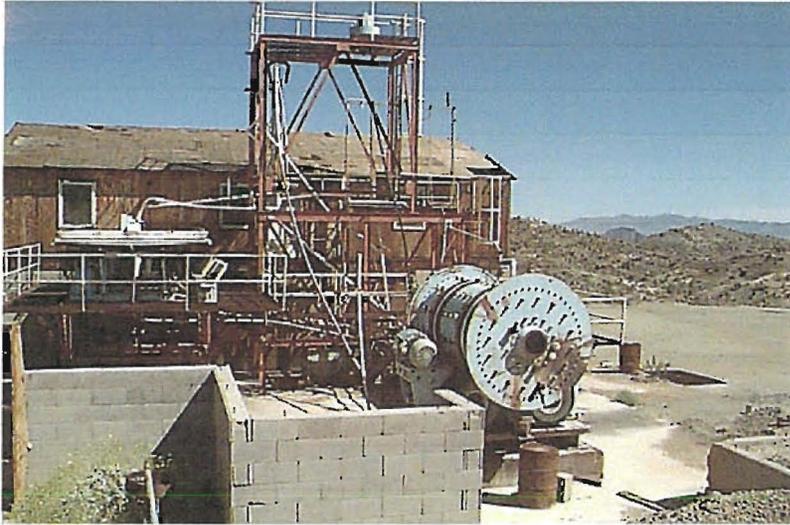
Photo #21 - Taken 4/19/00 by E. Seum. Looking north at non-working circuit and wooden building on the Eagle 1 claim.

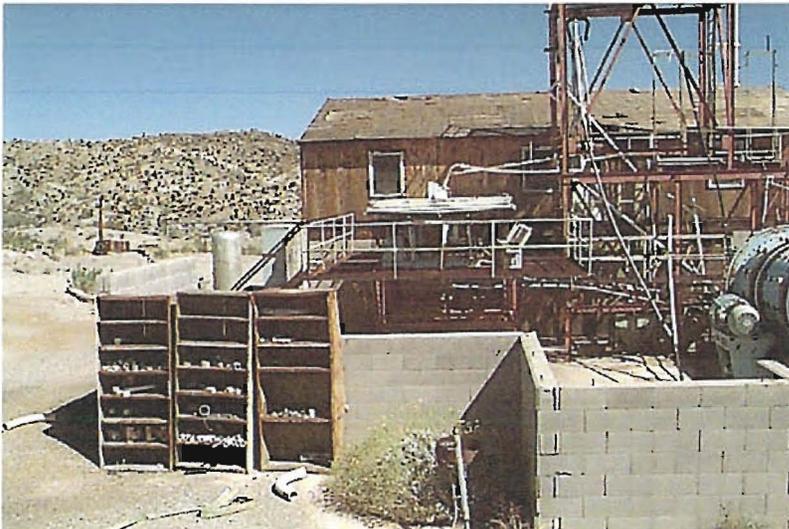
Photo #22 - Taken 4/19/00 by E. Seum. Another view slightly to the left of above picture.

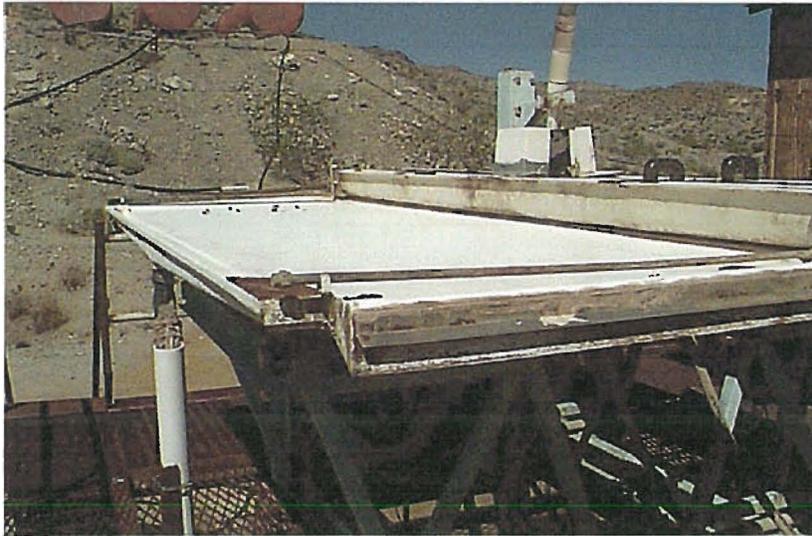
Photo #23 - Taken 4/19/00 by E. Seum. Closeup of separating table on the Eagle 1 claim.

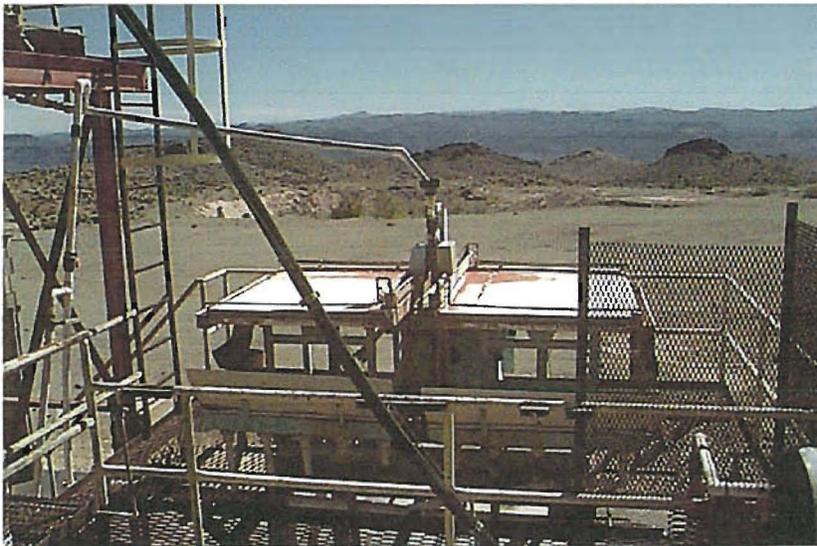
Photo #24 - Taken 4/19/00 by E. Seum. Closeup of separating tables on the Eagle 1 claim.

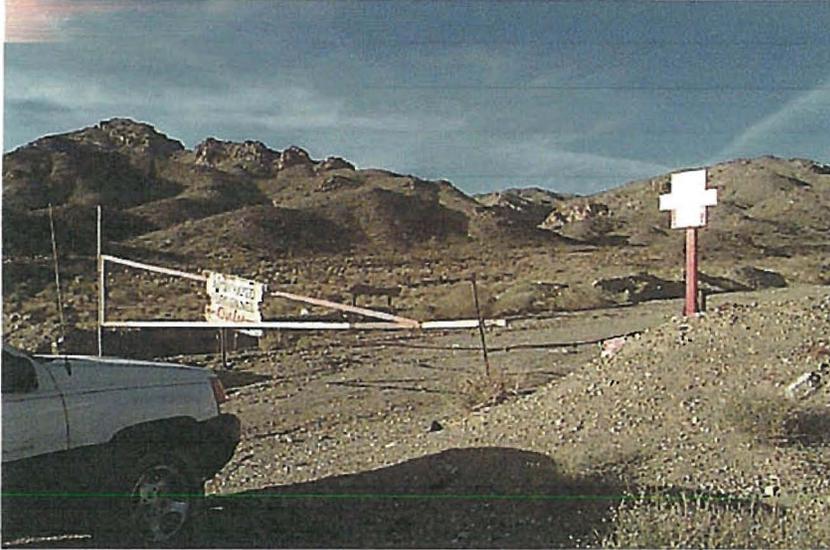
Photo #25 - Taken 1/5/01 by E. Seum. Shows gate blocking access to the Eagle 1 claim. Compare with photo 5.

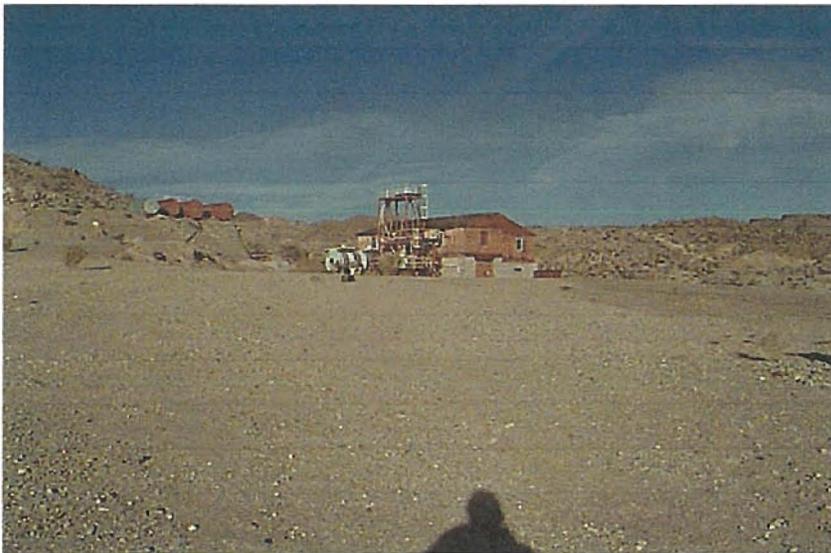
Photo #26 - Taken 1/5/01 by E. Seum. Looking west at the building and equipment on the Eagle 1 claim. Compare with photo 13.

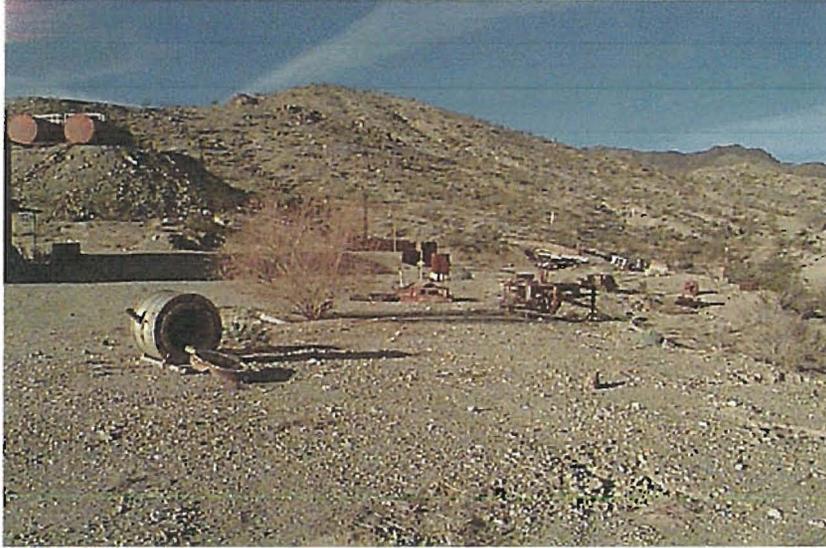
Photo #27 - Taken 1/5/01 by E. Seum. Shows items laying on the ground, north of the wooden building, located on the Eagle 1 claim. See also photos 18 & 19.

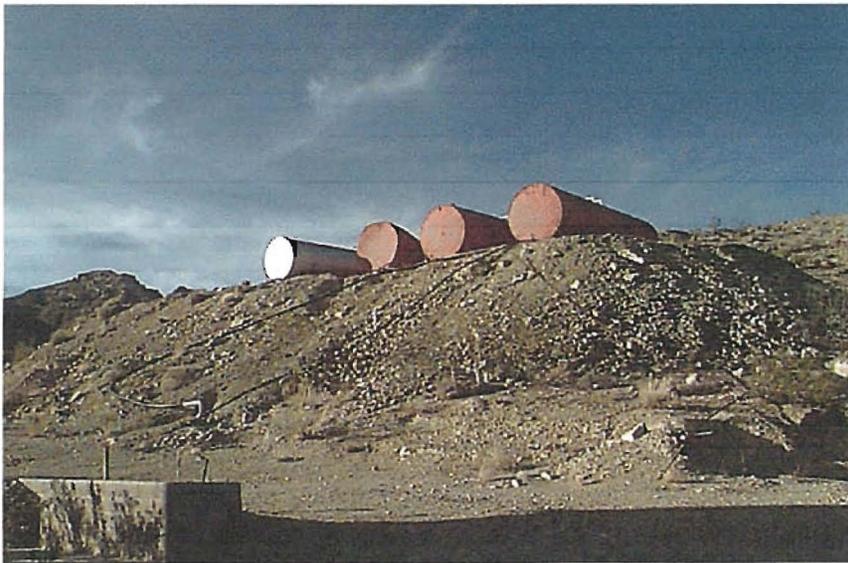
Photo #28 - Taken 1/5/01 by E. Seum. Shows empty water and fuel tanks on the west side of the Eagle 1 claim. See photos 2 & 17.

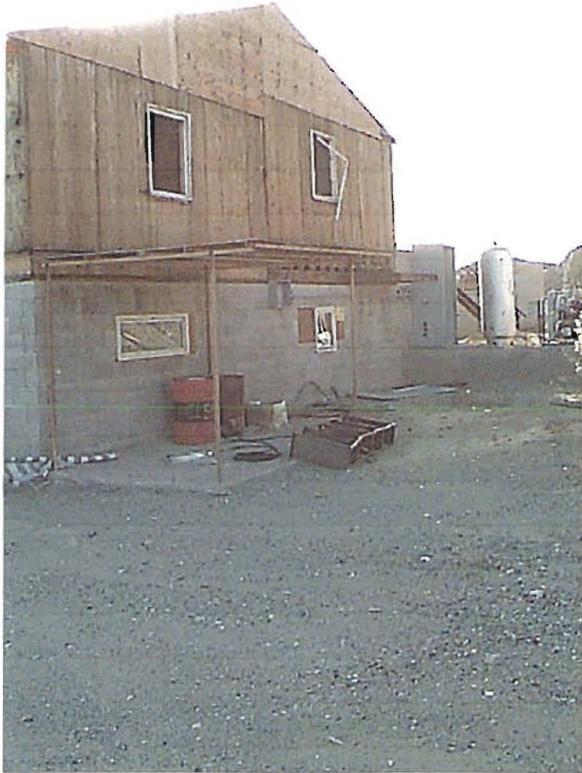
Photo #29 - Taken 1/5/01 by E. Seum. Shows west side of wooden building on the Eagle 1 claim. Upper windows are damaged.

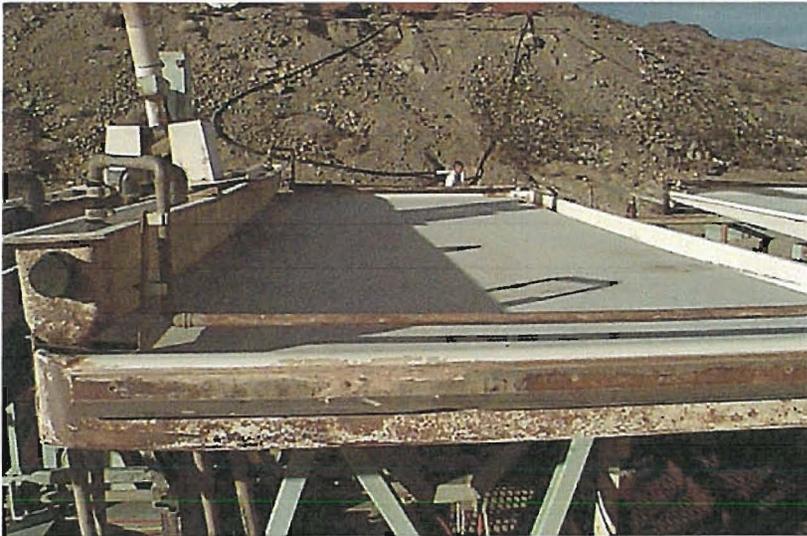
Photo #30 - Taken 1/5/01 by E. Seum. Shows one of the separating tables located on the south side of the wooden building, on the Eagle 1 claim.

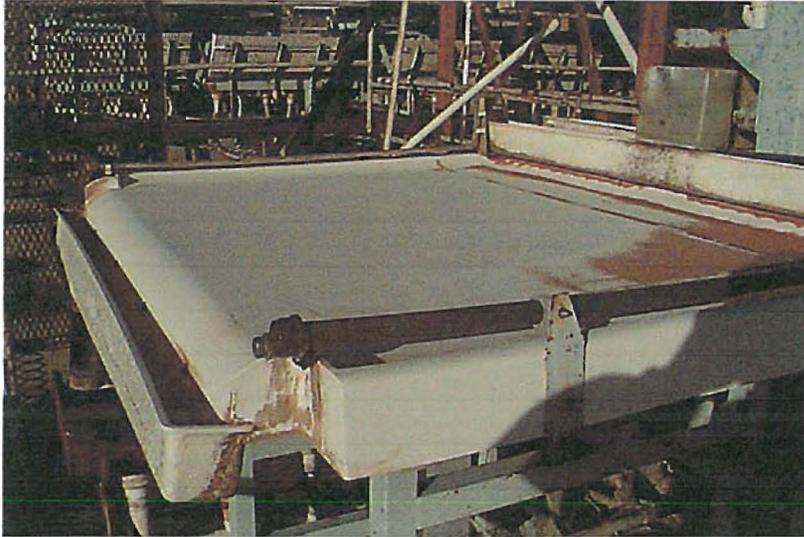
Photo #31 - Taken 1/5/01 by E. Seum. Shows another table next to the one shown above.

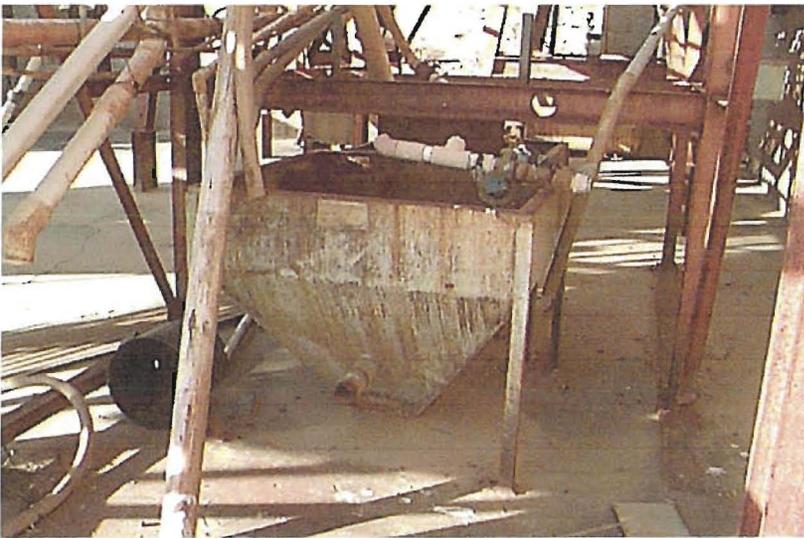
Photo # 32- Taken 1/5/01 by E. Seum. Shows hopper sitting at the base of the non-working circuit on the Eagle 1 claim.

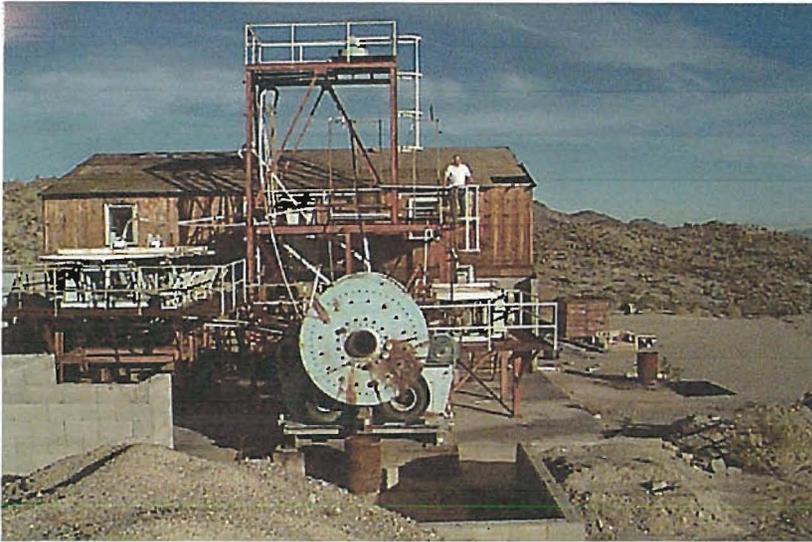
Photo #33 - Taken 1/5/01 by E. Seum. Looking north at ball mill and building on the Eagle 1 claim. Note the hole in the roof to right of Mark Chatterton. See also photo 21.

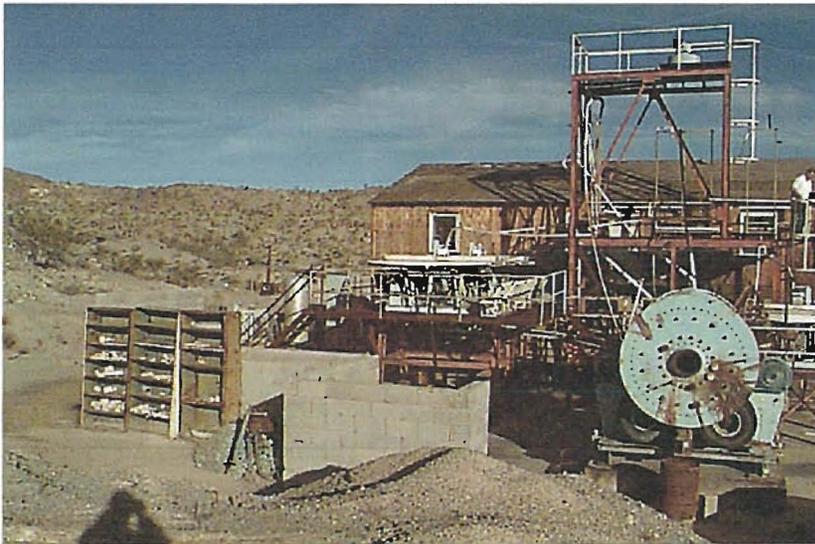
Photo #34 - Taken 1/5/01 by E. Seum. Another shot of the ball mill and non-working circuit on the Eagle 1 claim. See also photo 22.

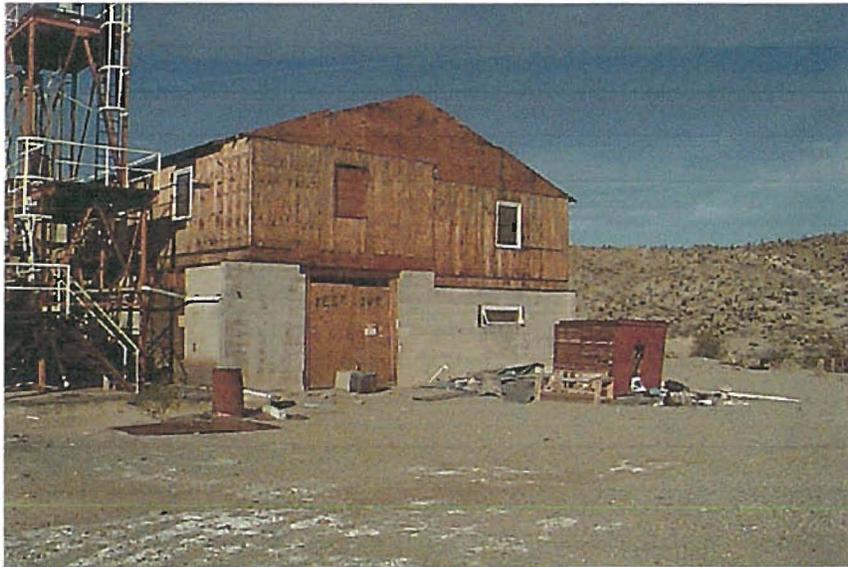
Photo #35 - Taken 1/5/01 by E. Seum. Shows east facing side of the wooden building on the Eagle 1 claim.
