# SAFETY OF DAMS

## CONDITION ASSESSMENT PROTOCOLS

### DAM DEFICIENCIES

By Dana Cork

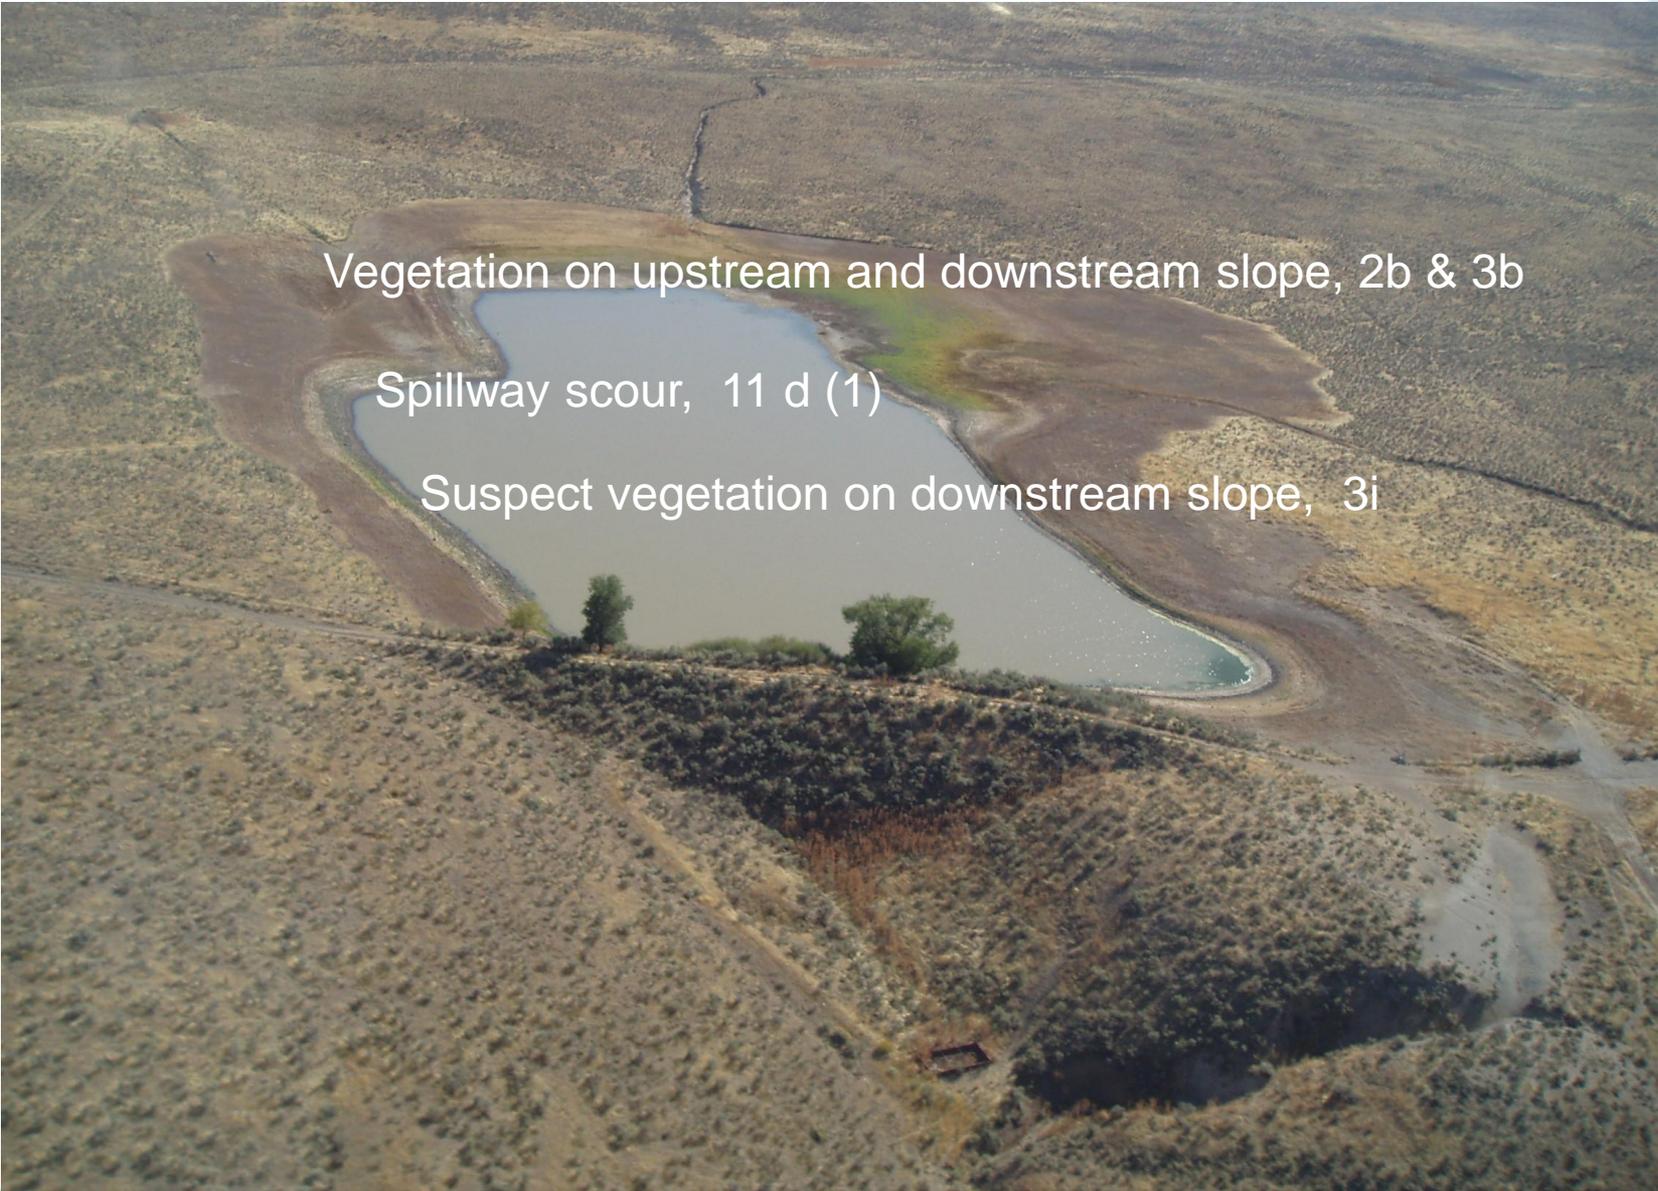
Vegetation on upstream and downstream slope, 2b & 3b

Spillway scour, 11 d (1)

Suspect vegetation on downstream slope, 3i

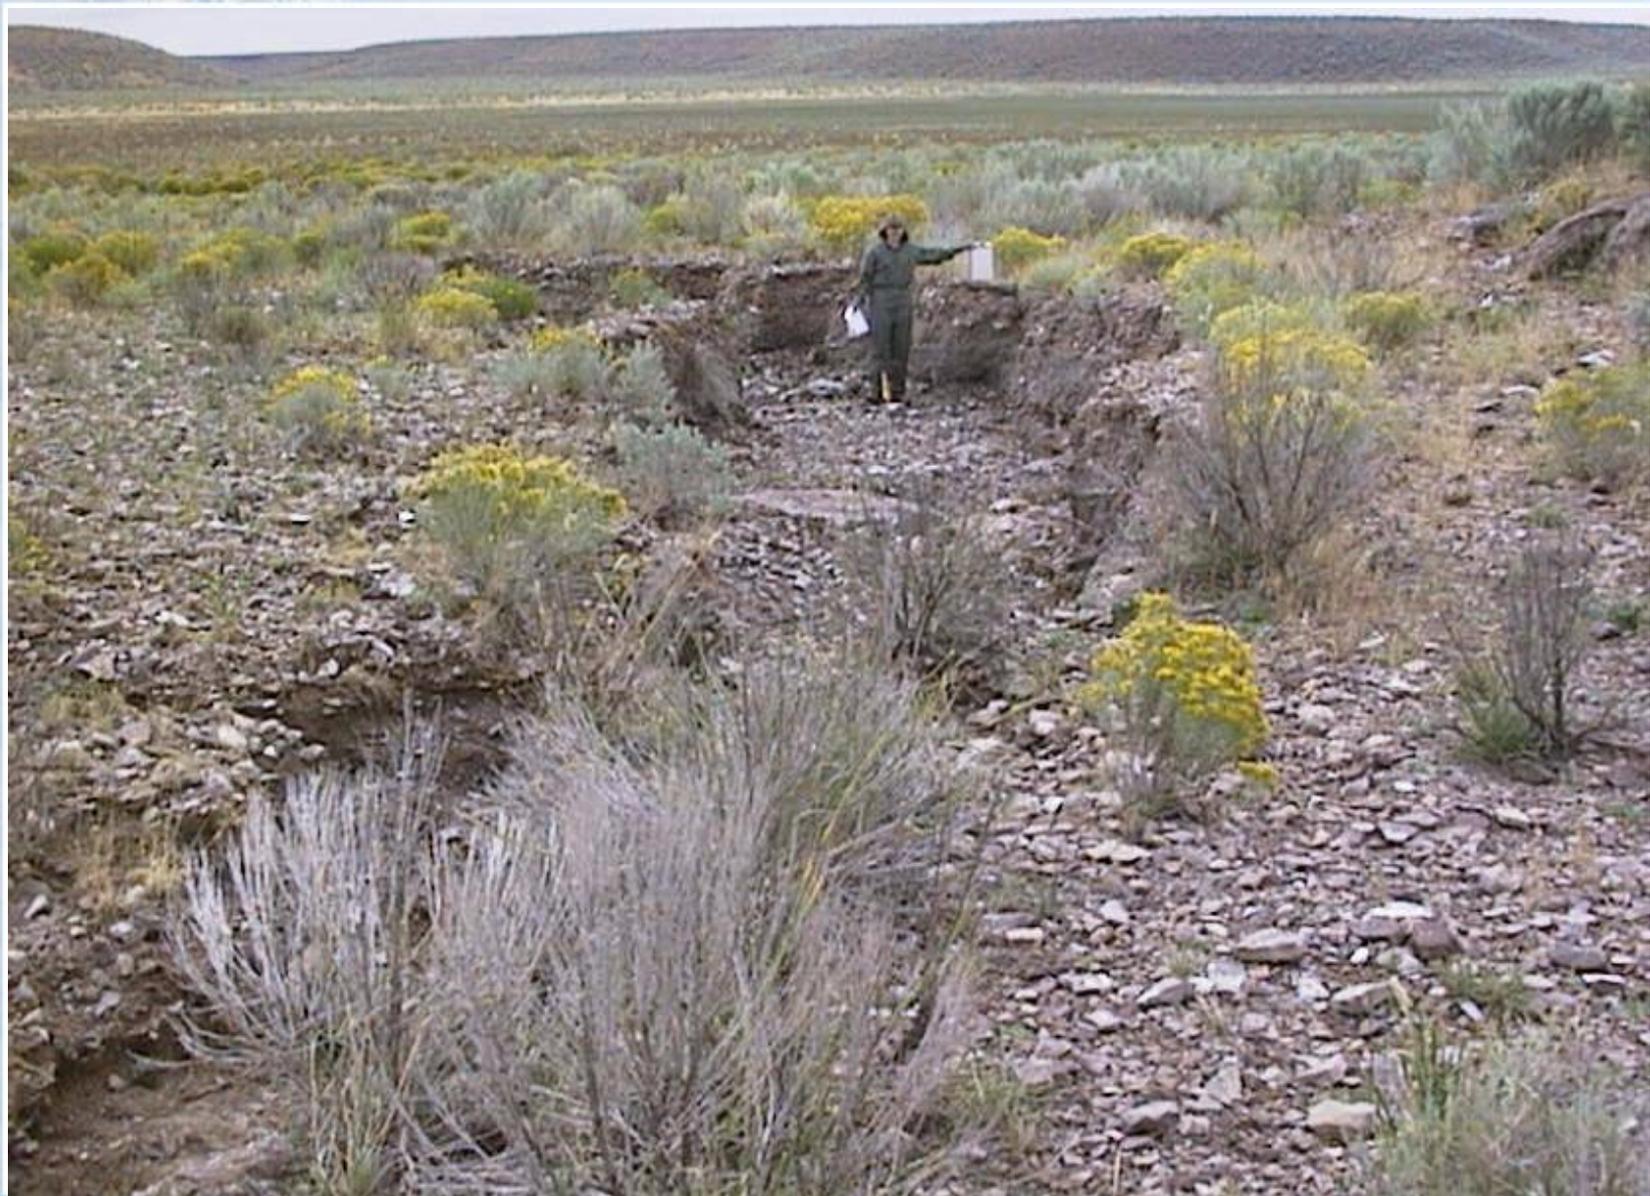
Undermining and erosion at the weir, 12 f (4)

Concrete failure, 12g

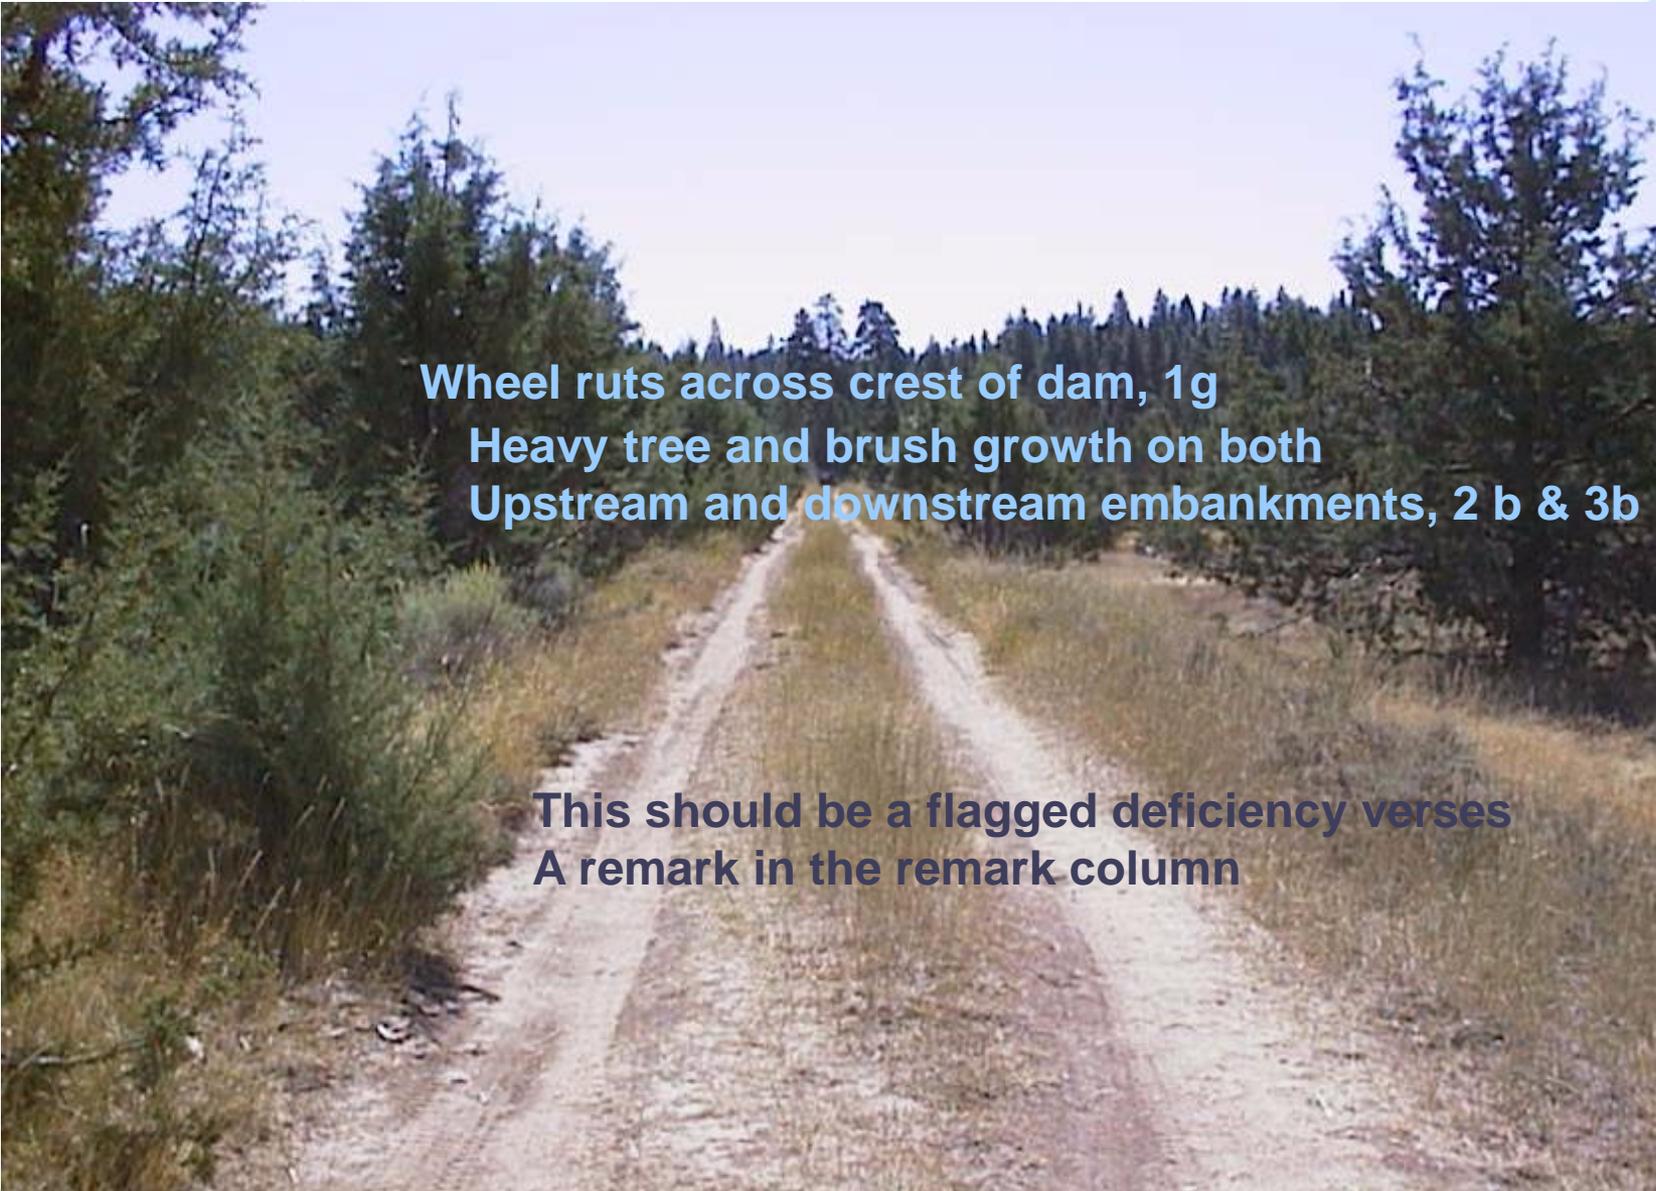
**Wheel ruts across crest of dam, 1g  
Heavy tree and brush growth on both  
Upstream and downstream embankments, 2 b & 3b**

**This should be a flagged deficiency verses  
A remark in the remark column**

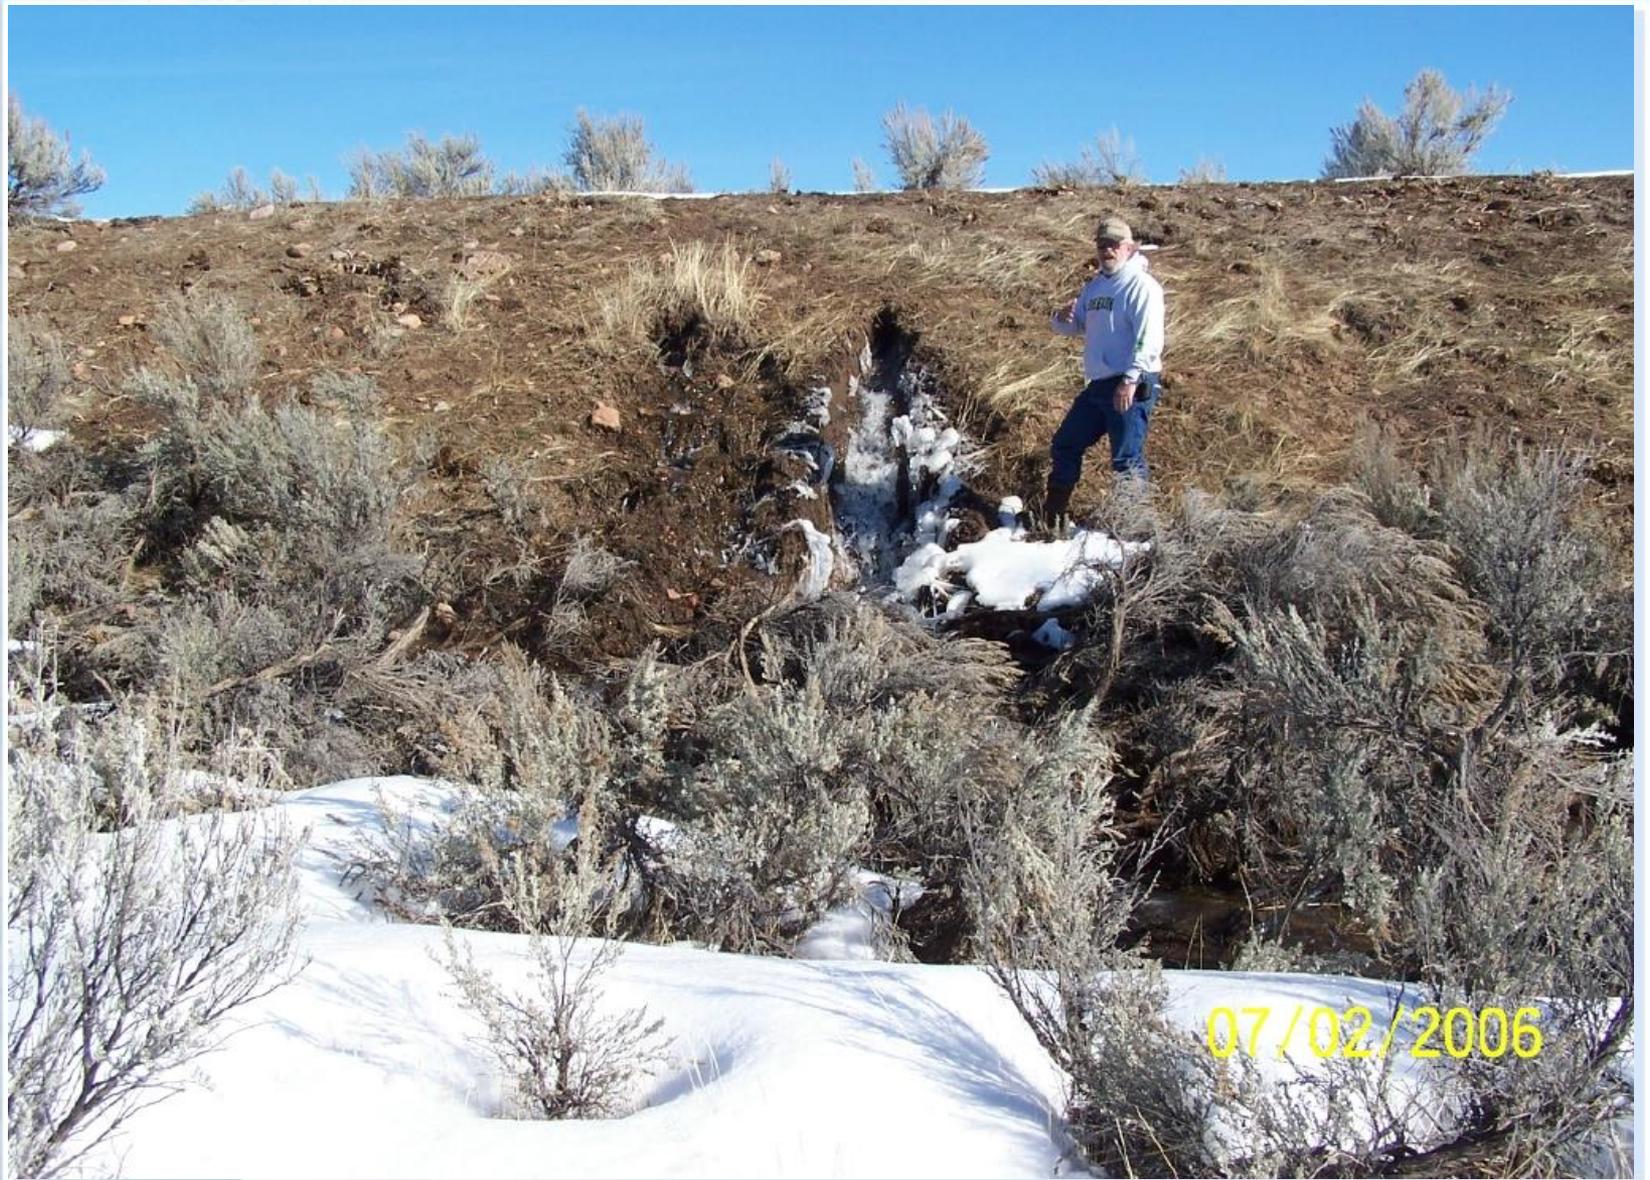
**Looks like rodent hole**

**But this minor depression/sink hole  
is actually a dispersive tunnel, 1 d**

**This deficiency needs to be flagged  
With notes on size, depth and  
Location.**

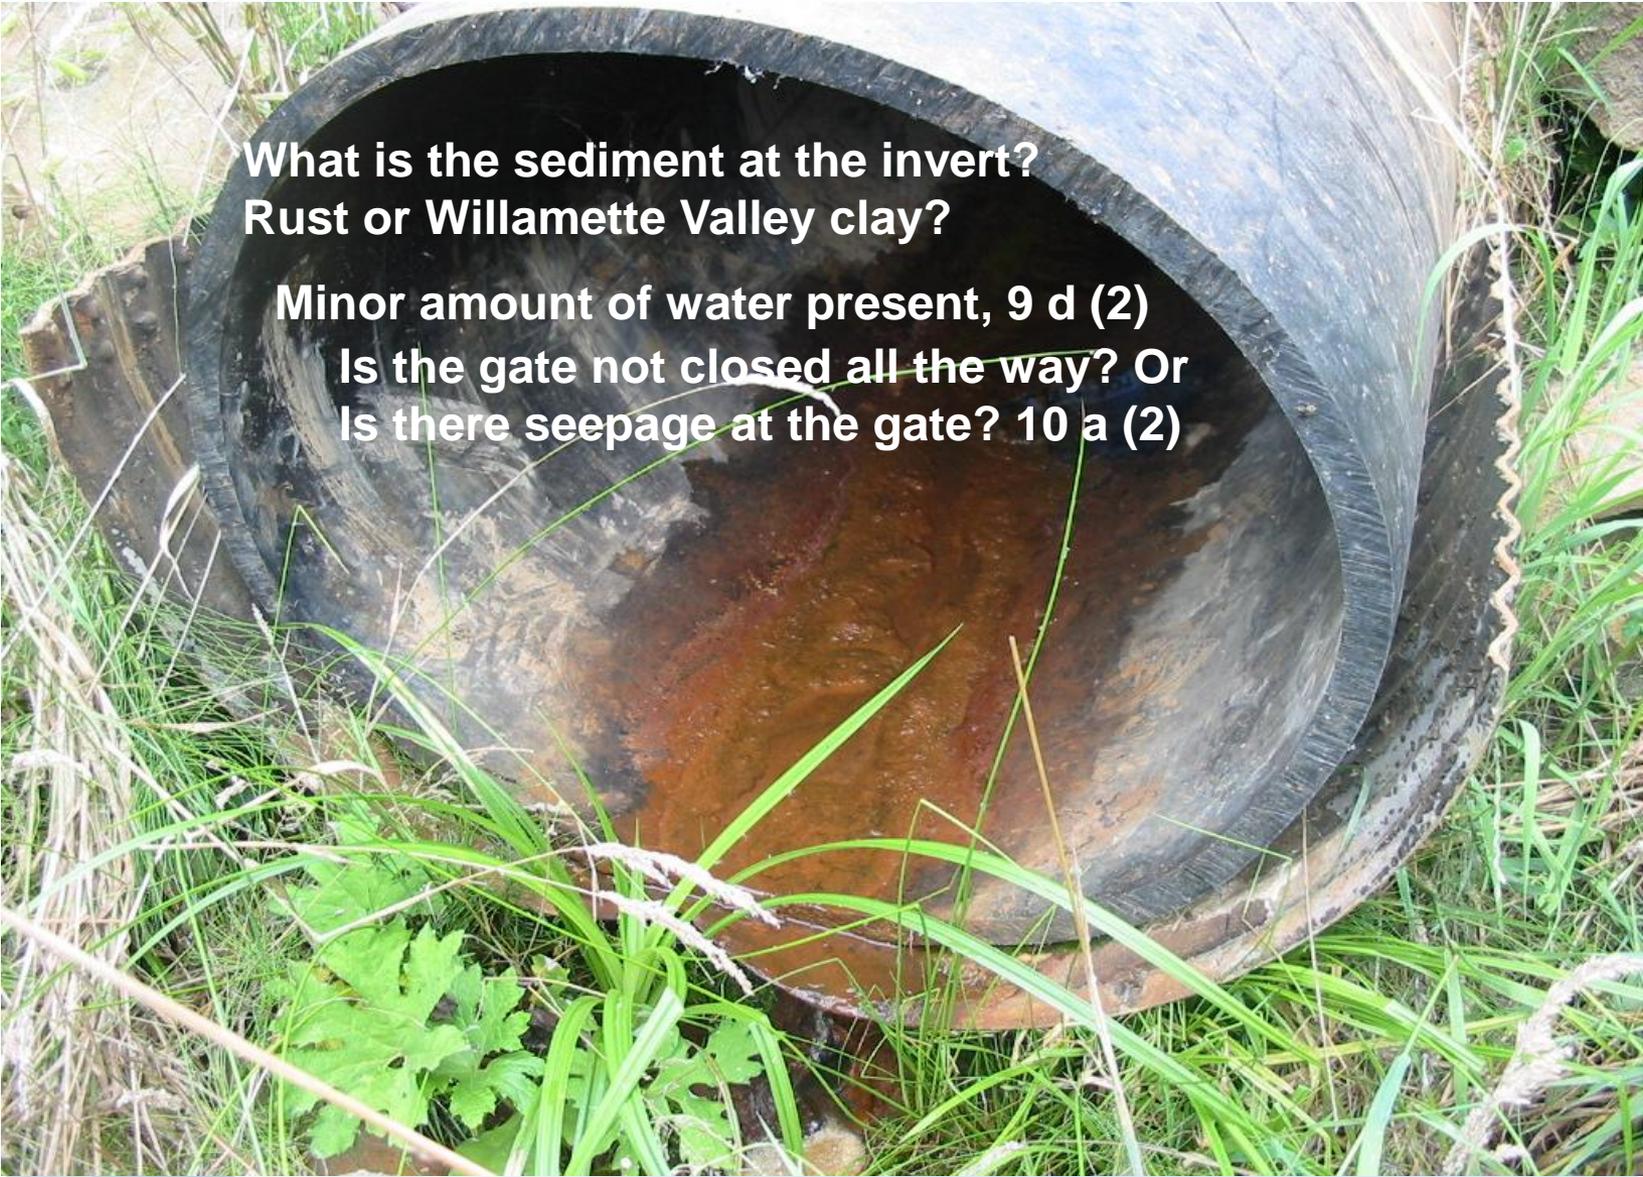
**What is the sediment at the invert?  
Rust or Willamette Valley clay?**

**Minor amount of water present, 9 d (2)  
Is the gate not closed all the way? Or  
Is there seepage at the gate? 10 a (2)**

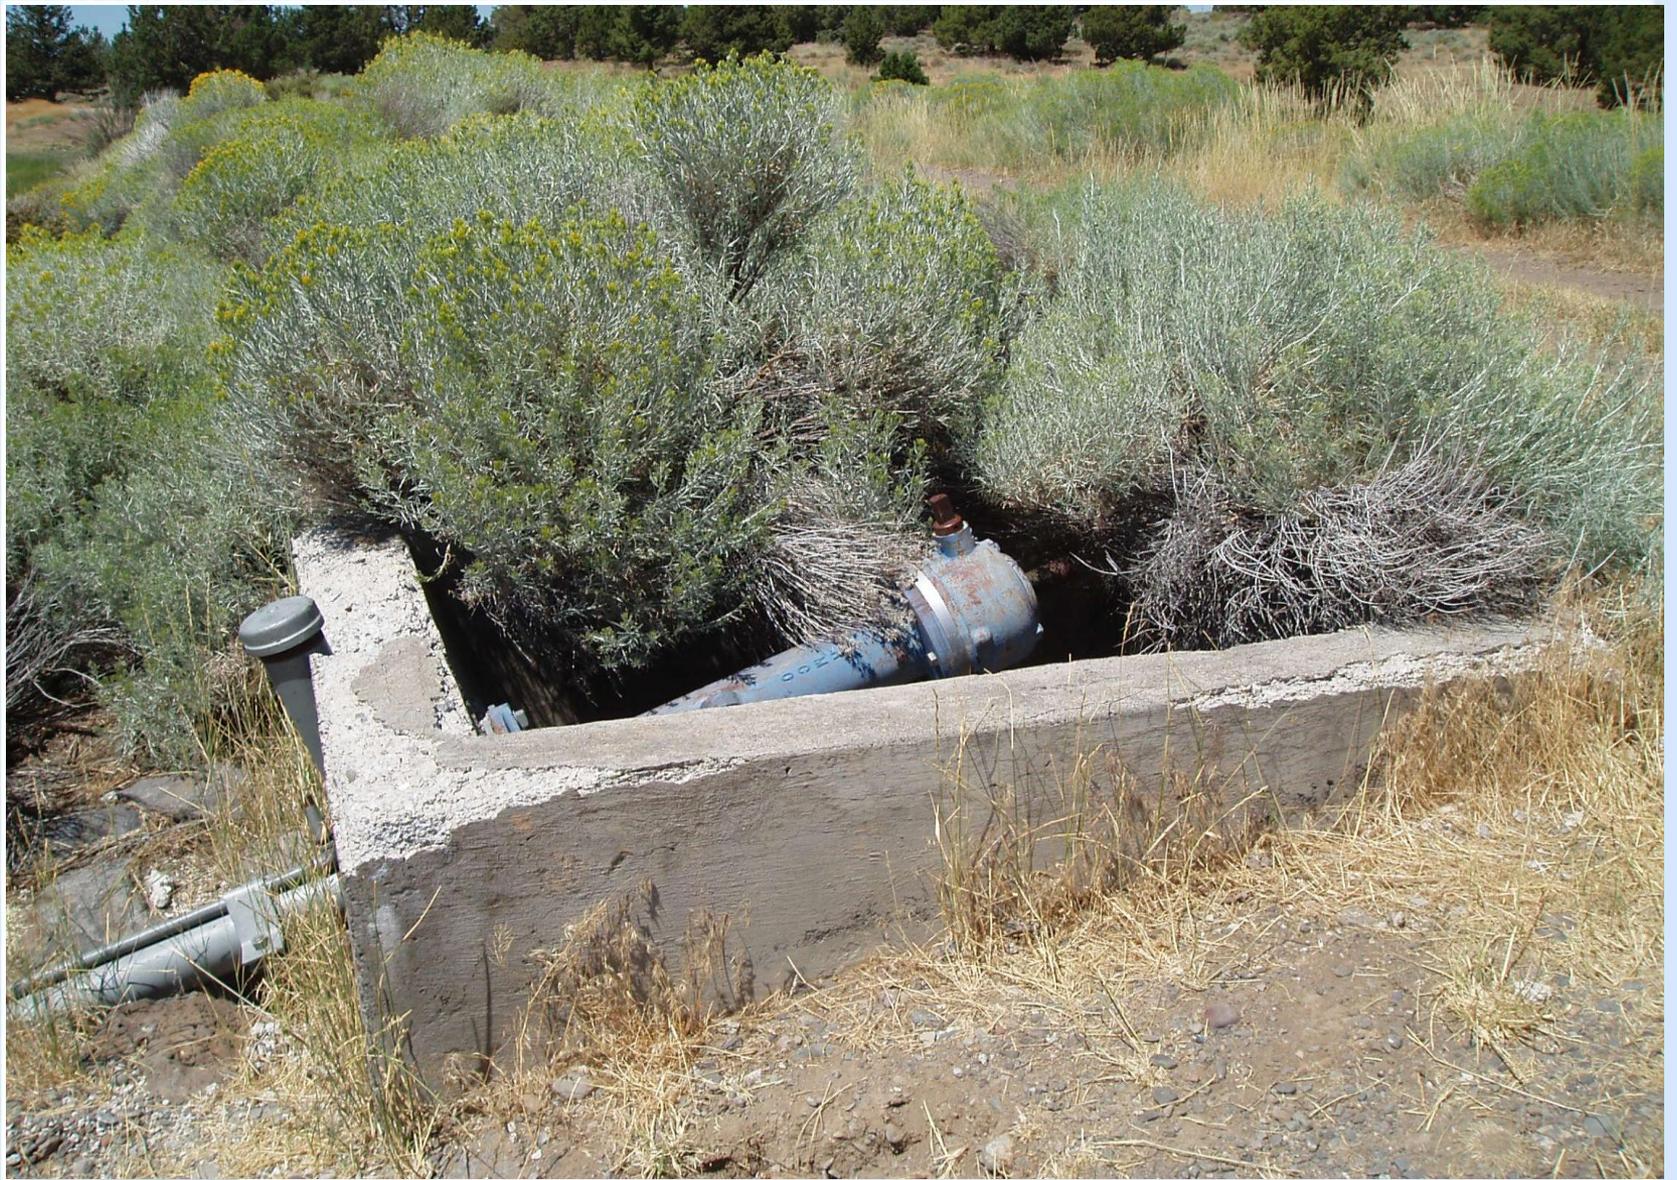
Corrosion on trash rack, 8 d (1)  
Minor debris around gate, 8 a  
Scaling, 8 b (4)

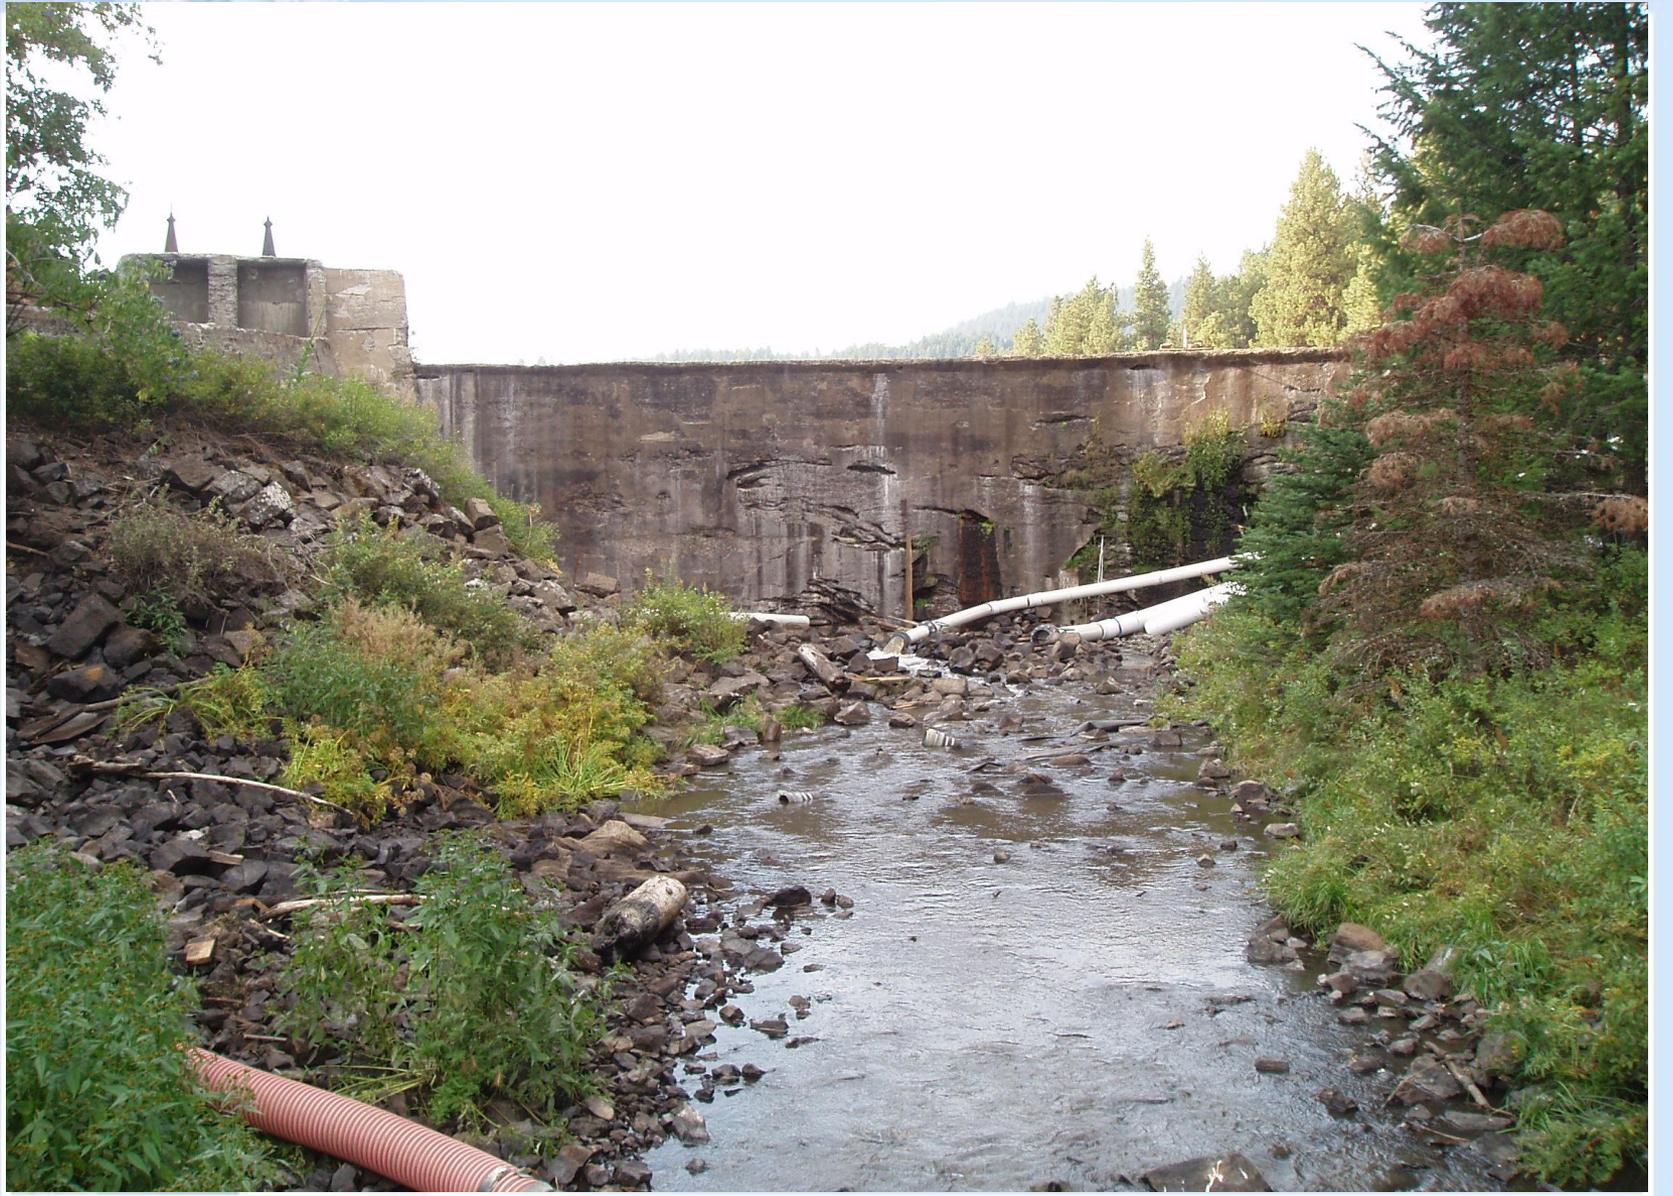
**Scaling, 12 a (4)**

**Spalling, 12 a (1)**

**Exposed rebar, 12 a (5)**

**Seepage, 3 i**

**Vegetation, 12 a (8)**

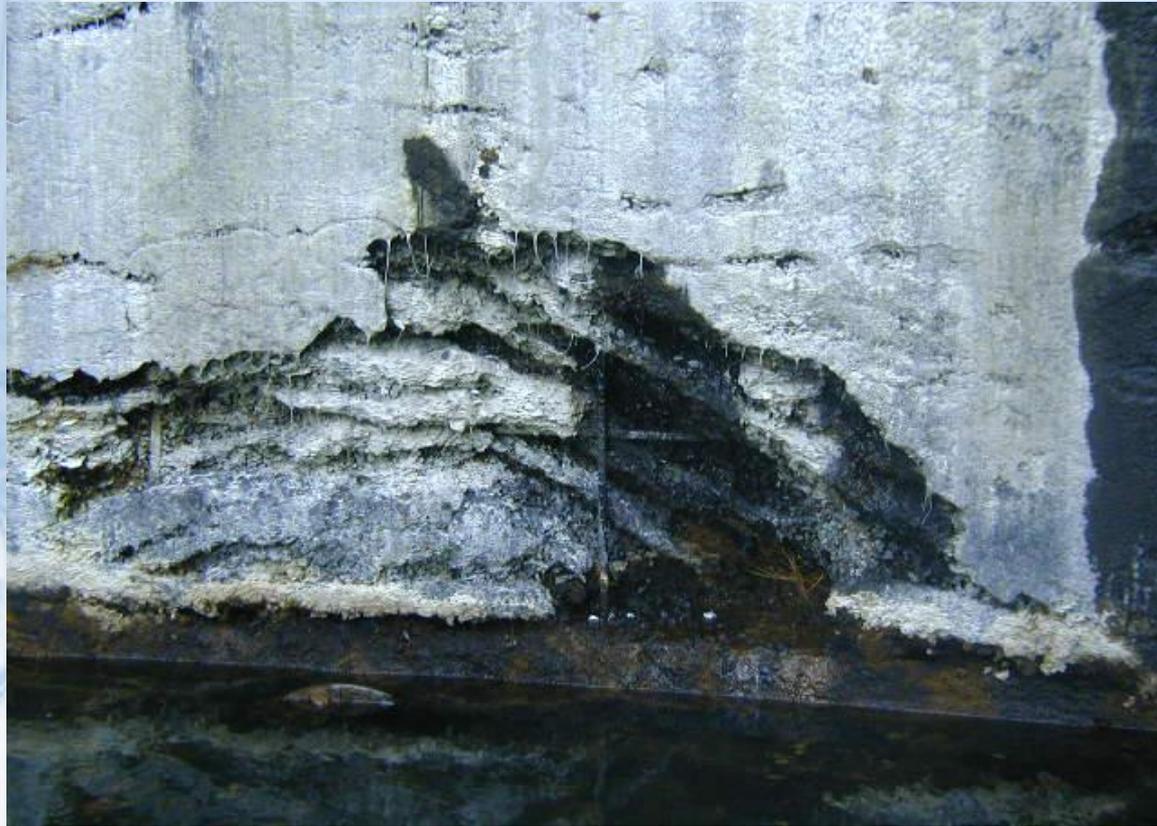
NAME OF DAM: Little Hyatt

1. N/C - Exposed vertical and horizontal rebar in downstream face of dam structure; mostly in left 1/3 of structure. NEW – Rebar is exposed at bottom of dam, 3/8 point from right abutment.
2. Observation of left 1/2 of dam structure shows seepage through concrete. Seepage appears at top and throughout the spalled area. Seepage rate is approx. 3 to 5 gallons per minute flow. NOTE: Did not measure flow rate this inspection (9/25/03). 95% of downstream face was exposed for inspection (e.g. without water flowing over face of dam)

PHOTOS: Looking at exposed rebar, downstream face 3/8 point from right abutment

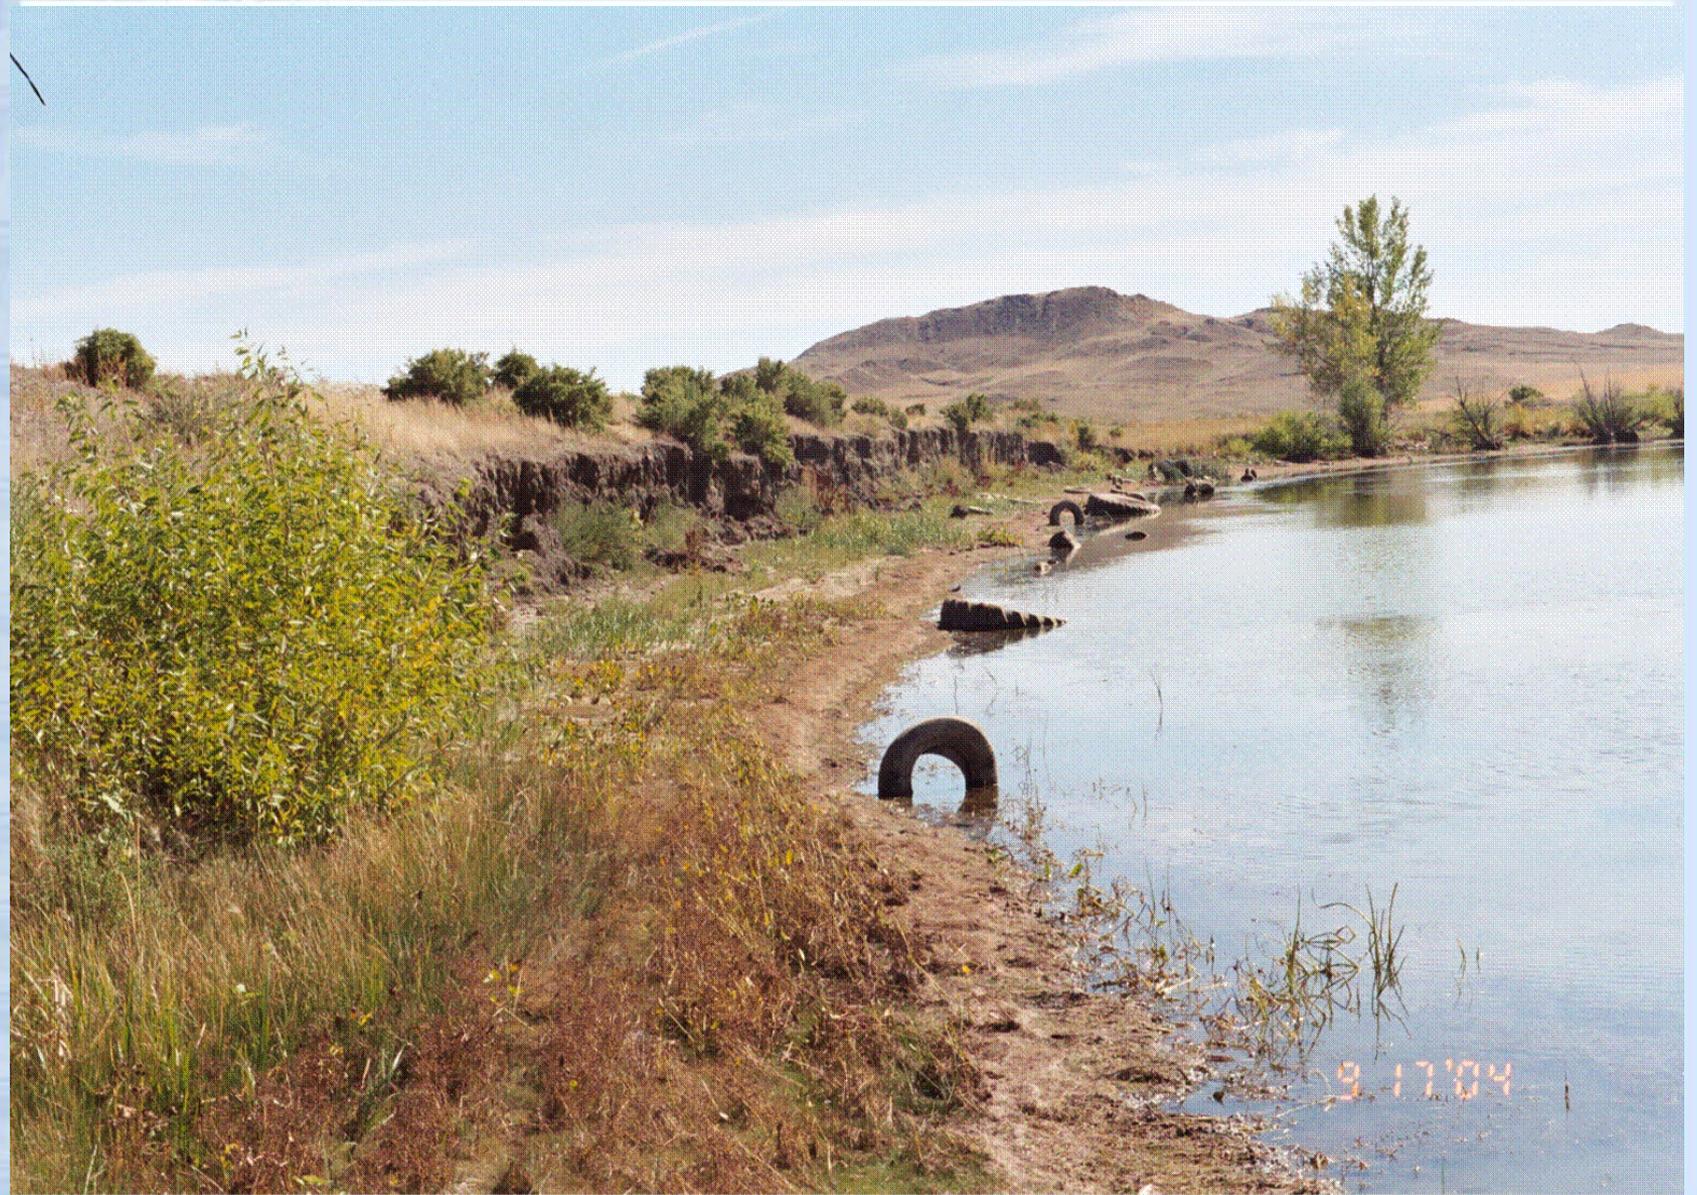
**Wave Action Erosion, 2a**

**Small  
depression, 2e**

**Beaching, 2a**
