Serial Number
NMC 293456
N54-93-001N
N-71982

MINERAL REPORT

Surface Use Determination
and
Validity Determination
For The Becki M
Mill Site Claim

Clark County, Nevada
T. 23 S., R. 63 E., MDM
Section 14, Lot 3
Consisting of 5 Acres

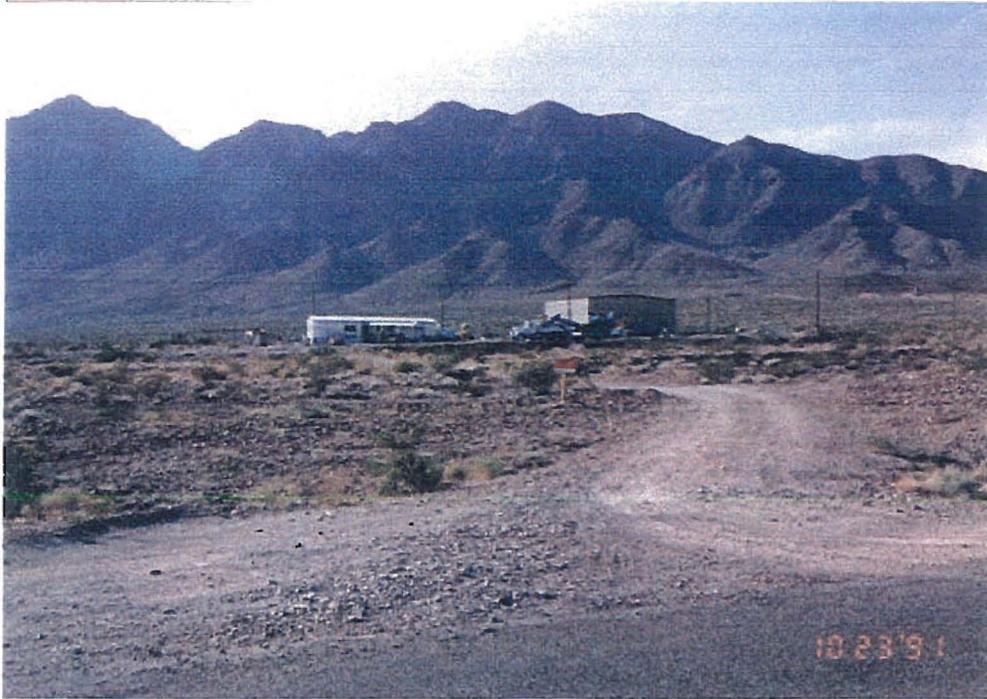
Photo #1 - Taken by G. Beckman 10/23/91. Looking west at the Becki M mill site from the access road.

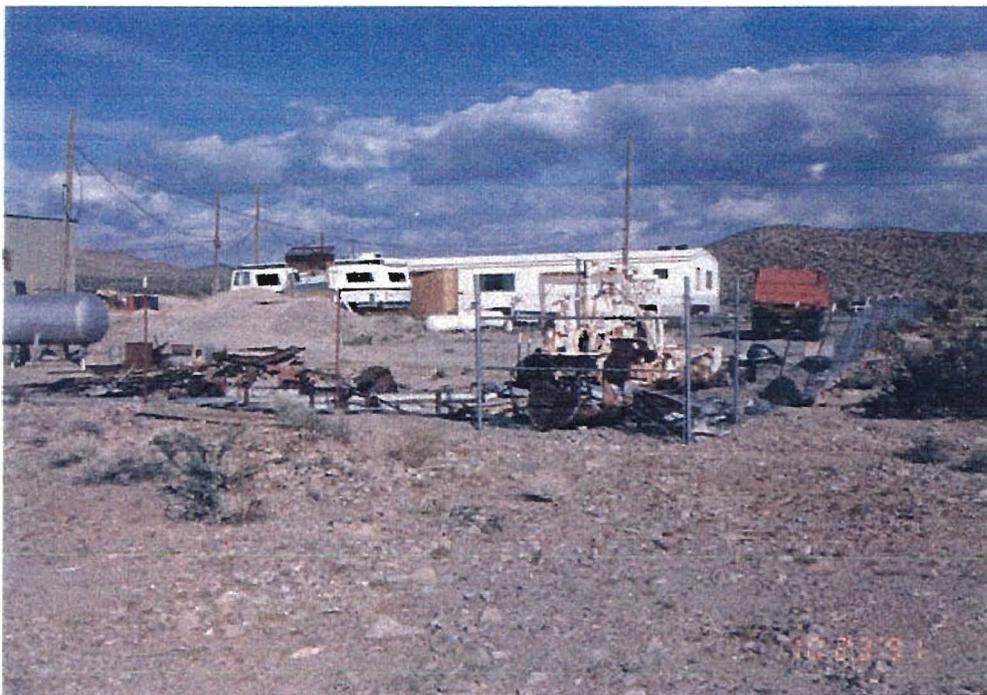
Photo #2 - Taken by G. Beckman 10/23/91. Looking east at the Becki M mill site from outside the fence. Shows area behind the mobile home.

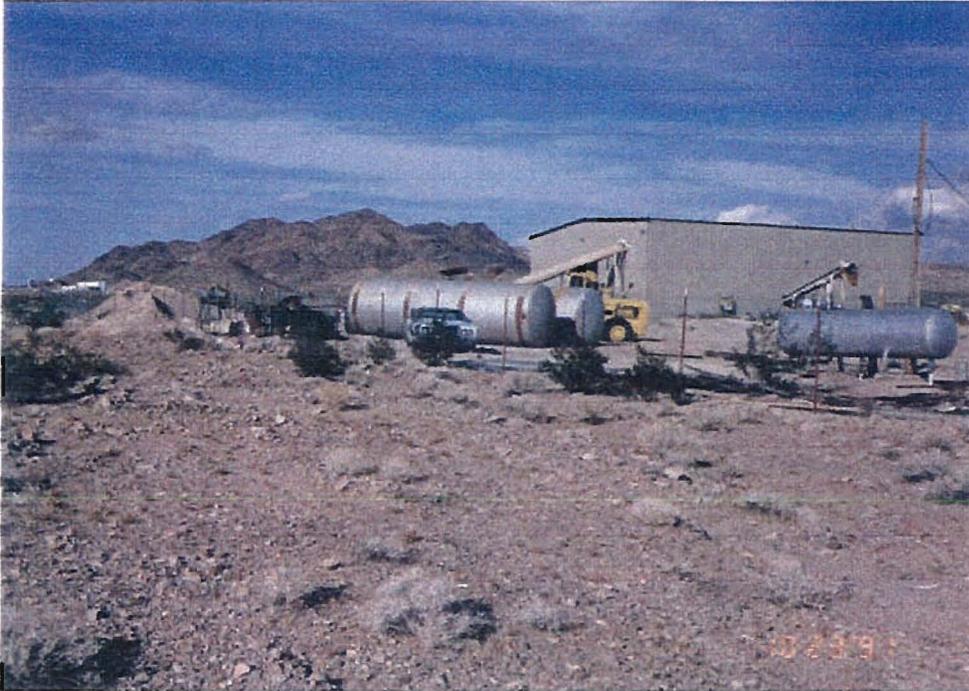
Photo #3 - Taken by G. Beckman 10/23/91. Looking north at the Becki M mill site from outside the fence. Shows mill building and tanks.

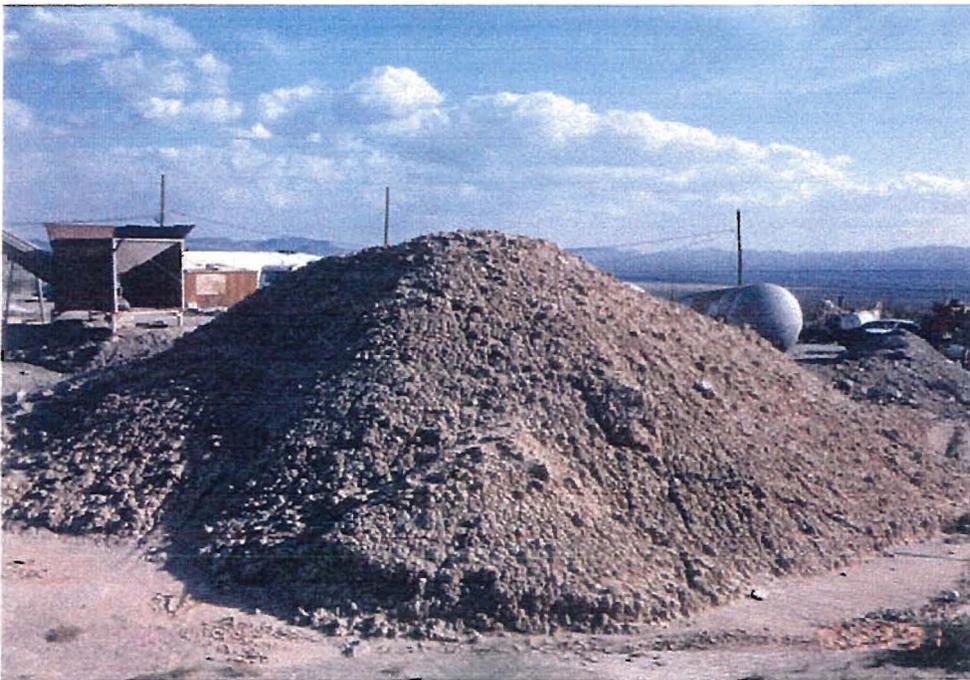
Photo #4 - Taken by G. Beckman 10/23/91. Shows stockpile of mineral material on the Becki M mill site.

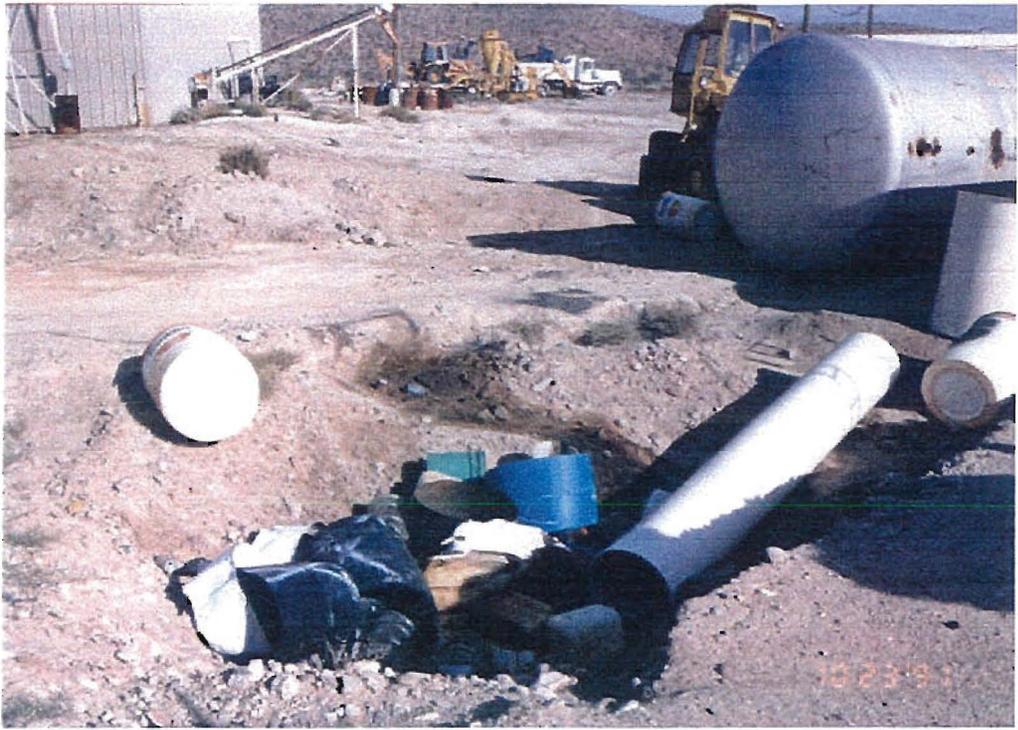
Photo #5 - Taken by G. Beckman 10/23/91. Shows small pit with trash on the Becki M mill site.

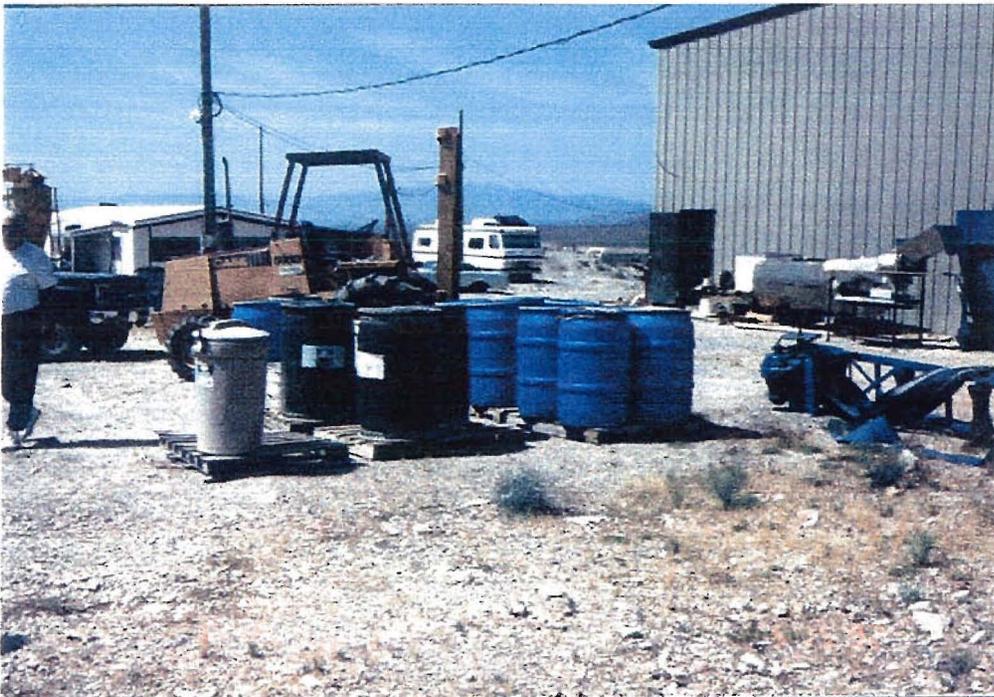
Photo #7 - Taken by J. Mur 5/15/92. Looking at chemicals stored on east side of the mill building on the Becki M mill site.

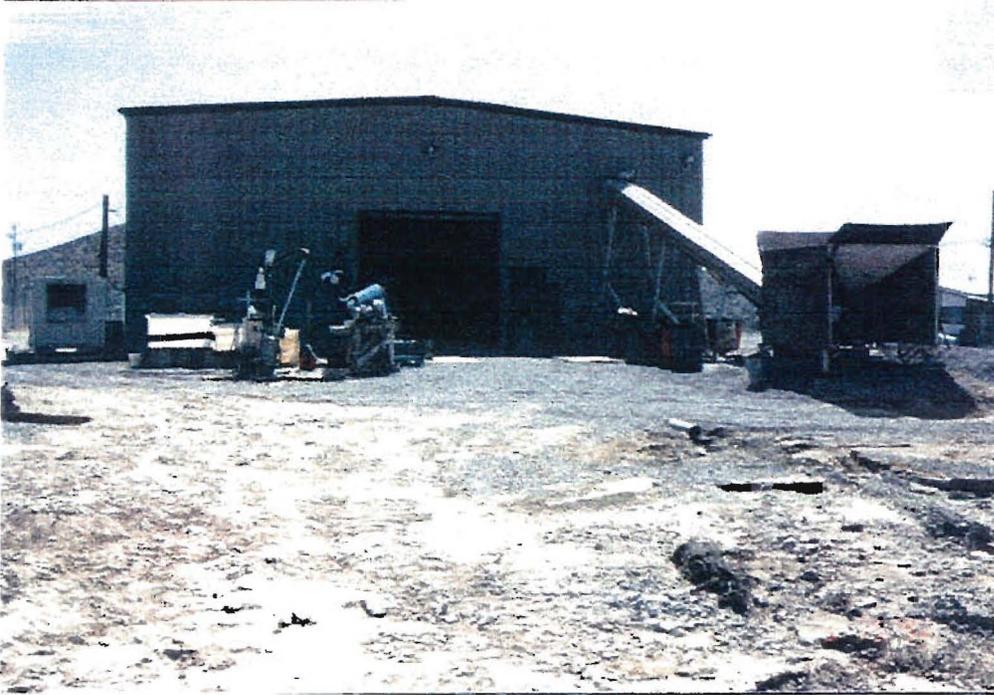
Photo #10 - Taken by J. Mur 5/15/92. Looking east at back of mill building on the Becki M mill site. Hopper/conveyor to right dumps into recovery circuit in building.

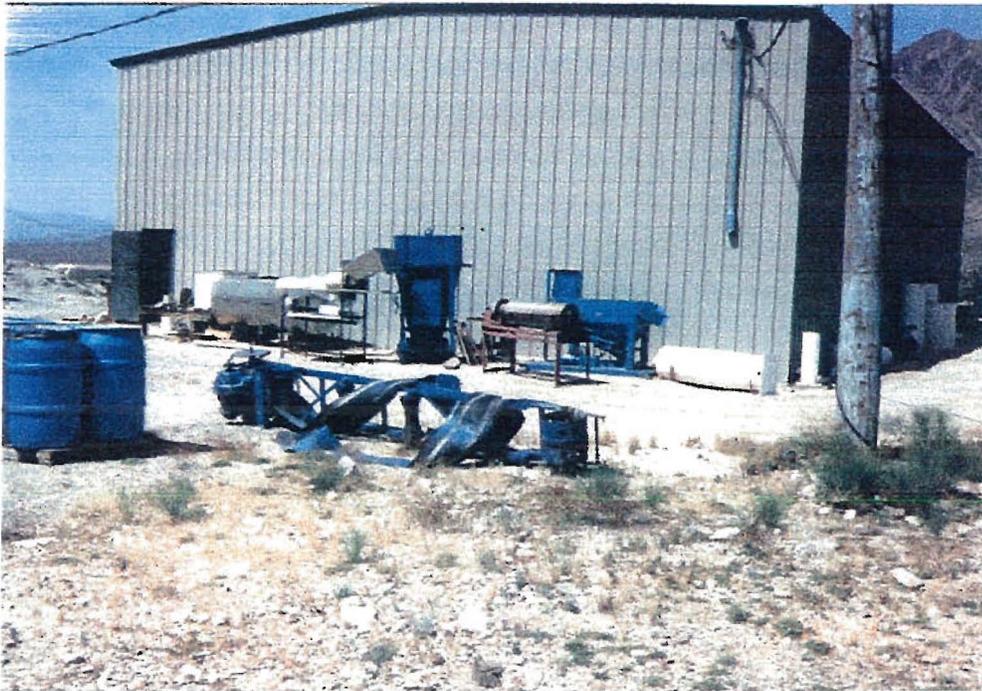
Photo #12 - Taken by J. Mur 5/15/92. Looking at south end of mill building on the Becki M mill site. Shows small circuit set up.

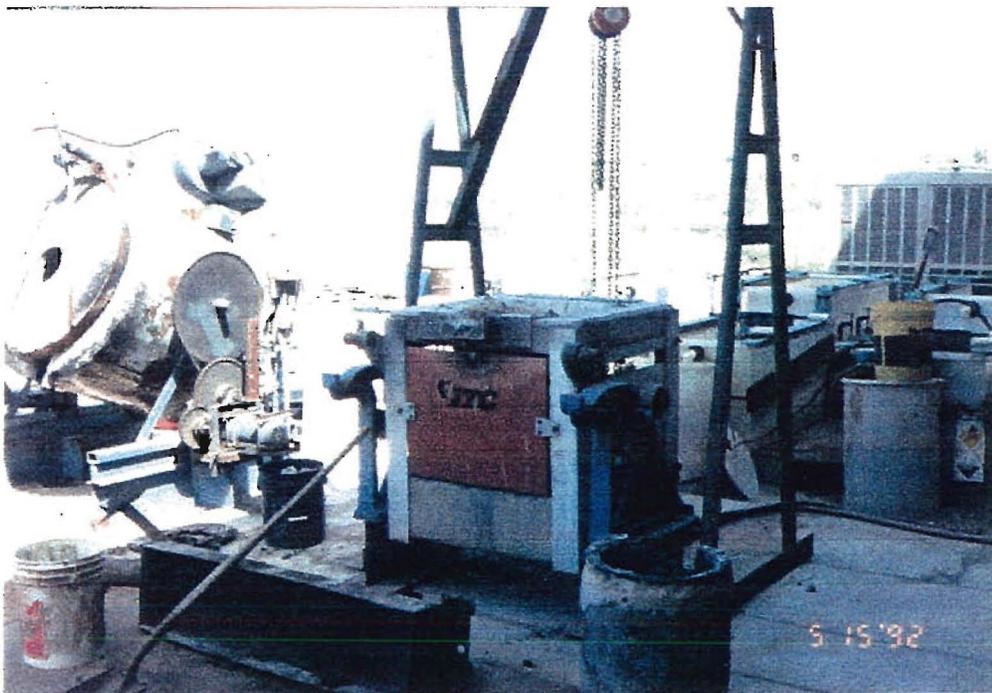
Photo #13 - Taken by J. Mur 5/15/92. Looking at furnaces on the Becki M mill site.

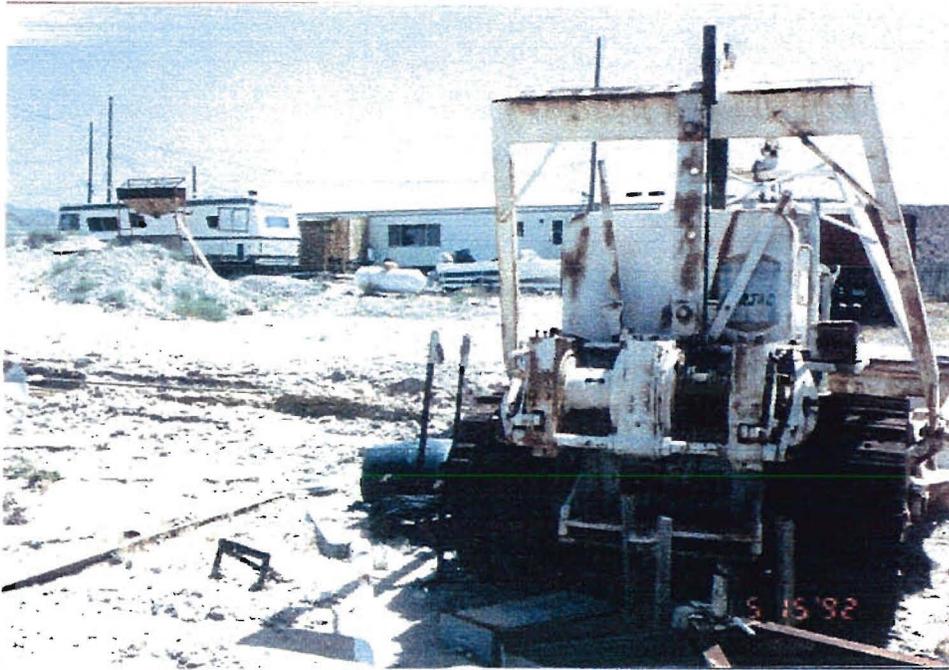
Photo #14 - Taken by J. Mur 5/15/92. Looking at old cable dozer in foreground and back of mobile home on the Becki M mill site.

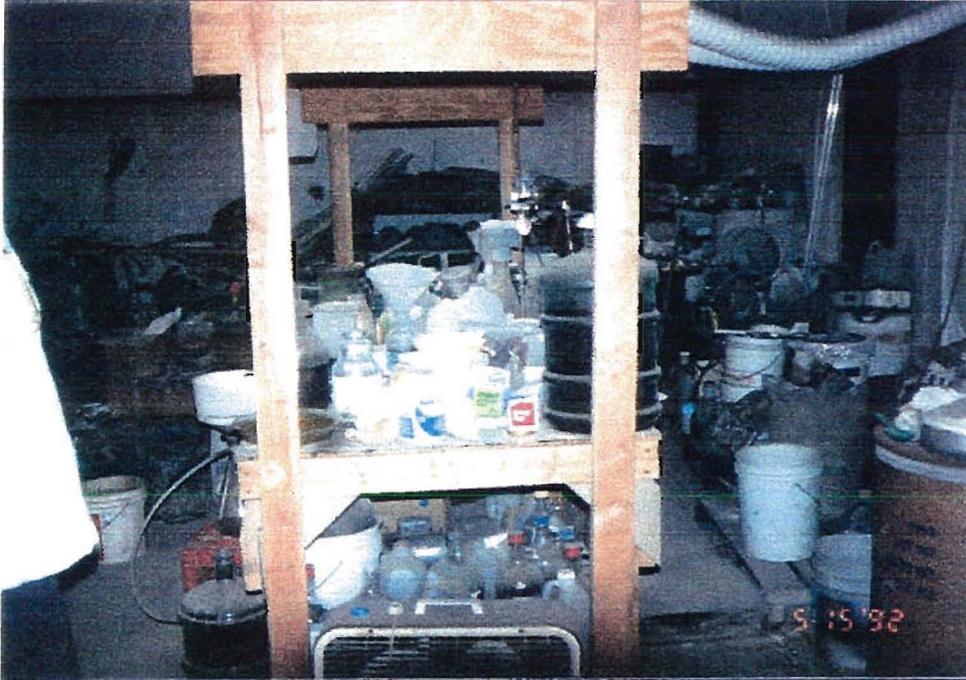
Photo #16 - Taken by J. Mur 5/15/92. Looking at chemicals inside the mill building on the Becki M mill site.

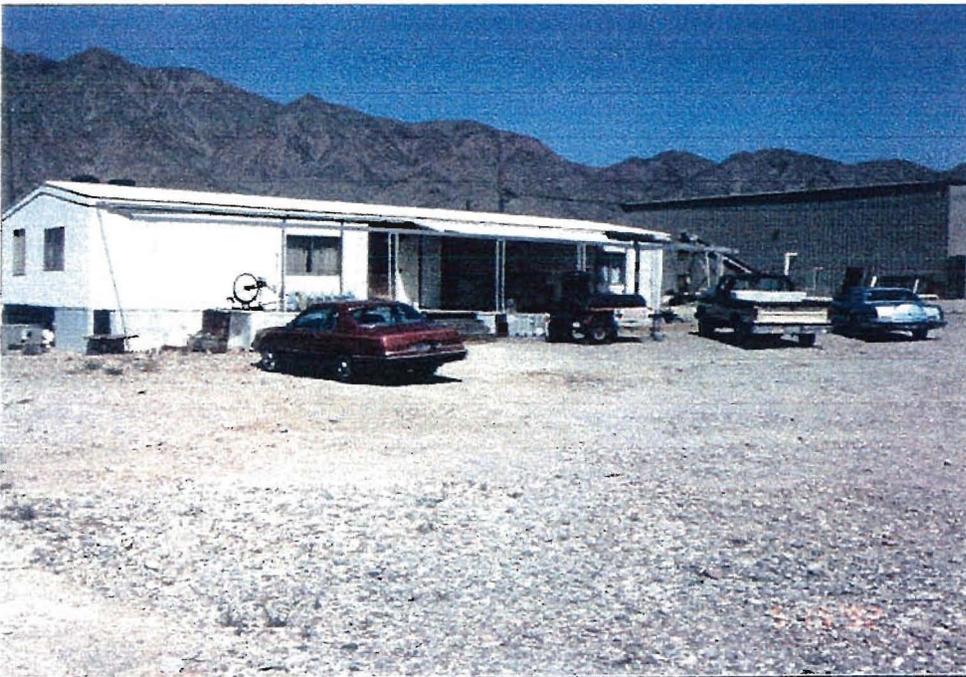
Photo #17 - Taken by J. Mur 5/15/92. Looking at mobile home used as watchman's residence on the Becki M mill site.

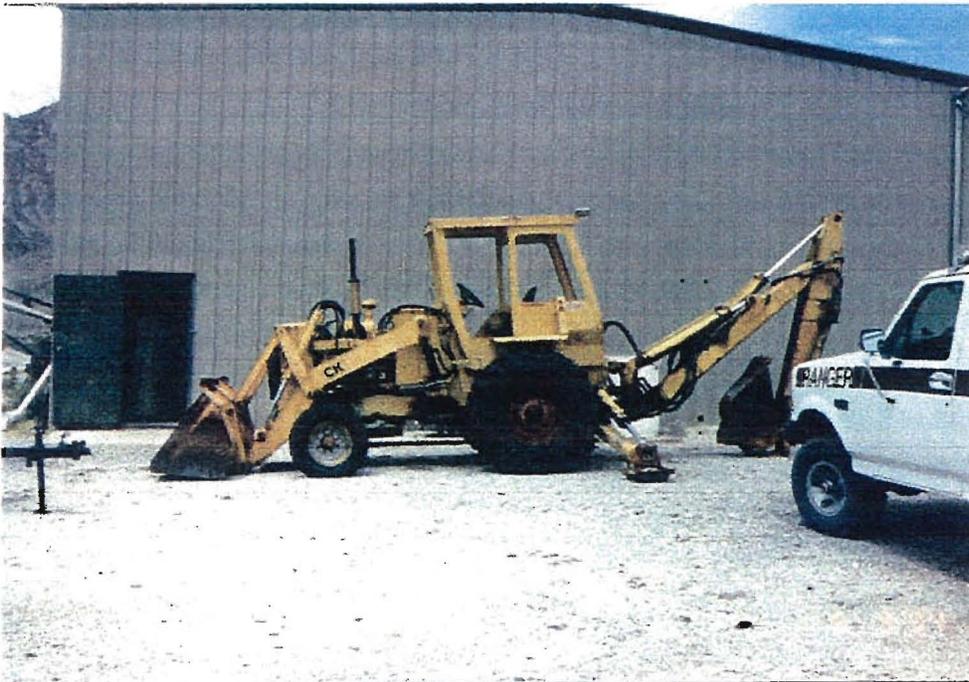
An inspection on May 9, 1994 found a backhoe to be parked in the same place as during the previous inspection. The report notes that the trailer met Clark County codes. The report also states that no milling has taken place for 2 years. A subsequent inspection on July 4, 1994 found that the backhoe was still in the same place and was not operable. Some hydrocarbon spills were also noted. No milling was observed.

Photo #19 - Taken by G. Miller 5/9/94. Backhoe/loader parked on east side of mill building on the Becki M mill site.

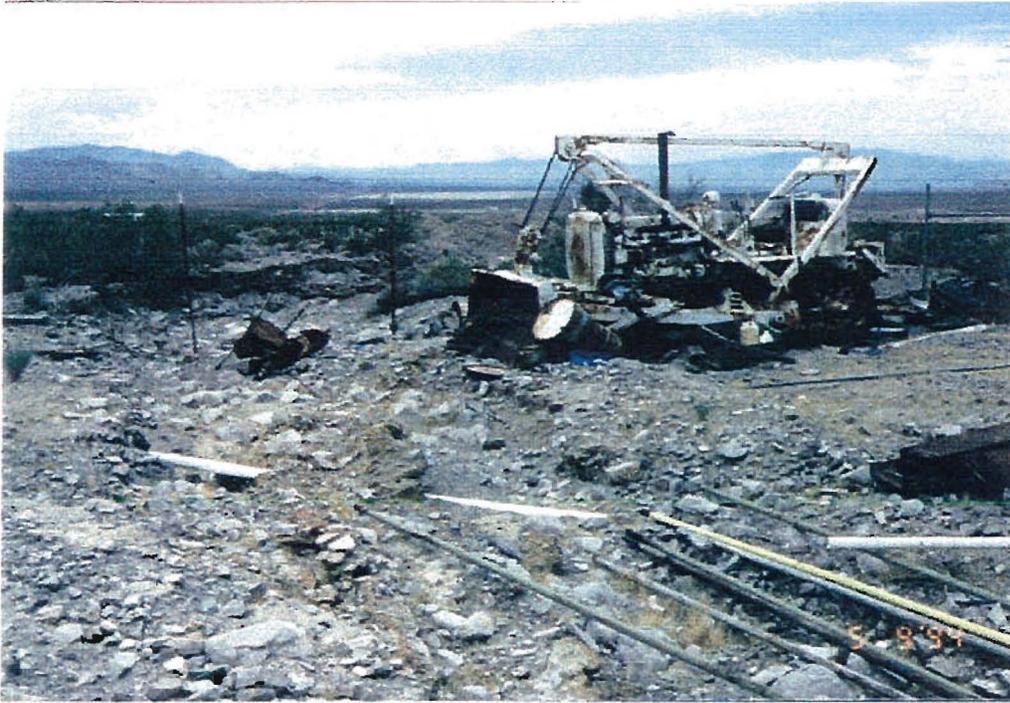
Photo #20 - Taken by G. Miller 5/9/94. Old cable dozer on southwest corner of the Becki M mill site.

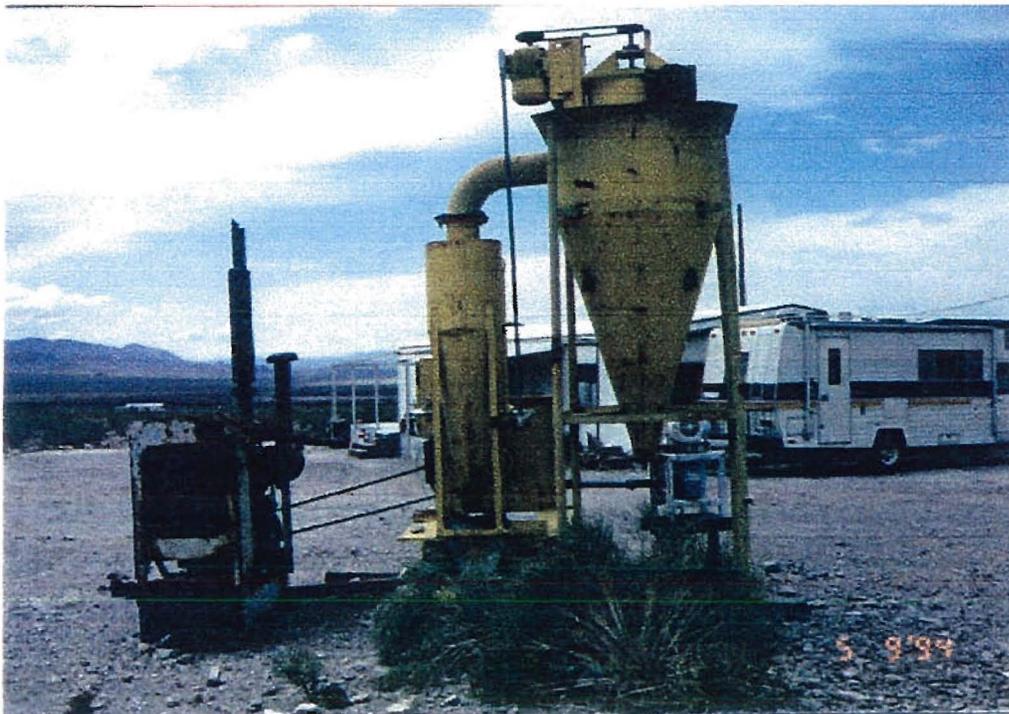
Photo #21 - Taken by G. Miller 5/9/94. Separator hooked up to a generator on the Becki M mill site.

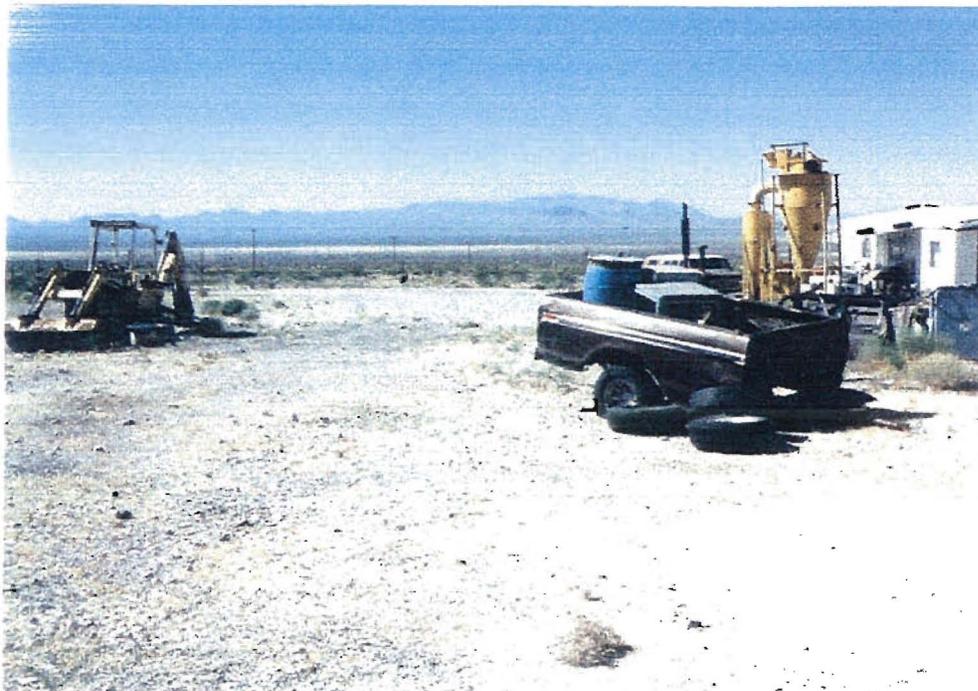
Photo #26 - Taken by G. Miller 6/20/95. Shows part of car body, separator and loader/backhoe on the Becki M mill site.

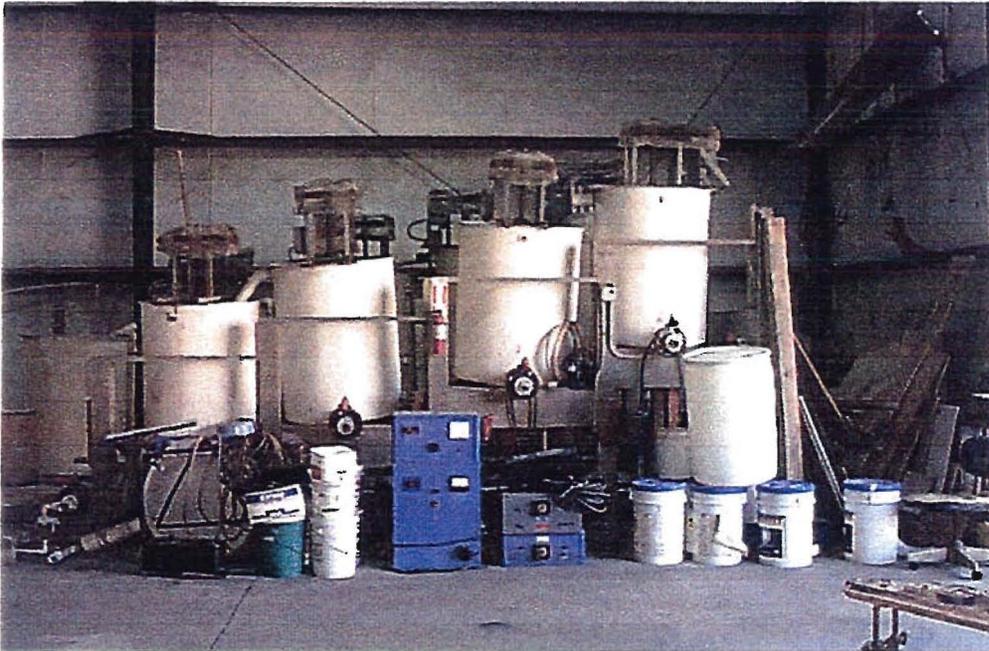
Photo #32 - Taken by J. Mur 6/25/98. Mixing tanks located inside mill building on the Becki M mill site.

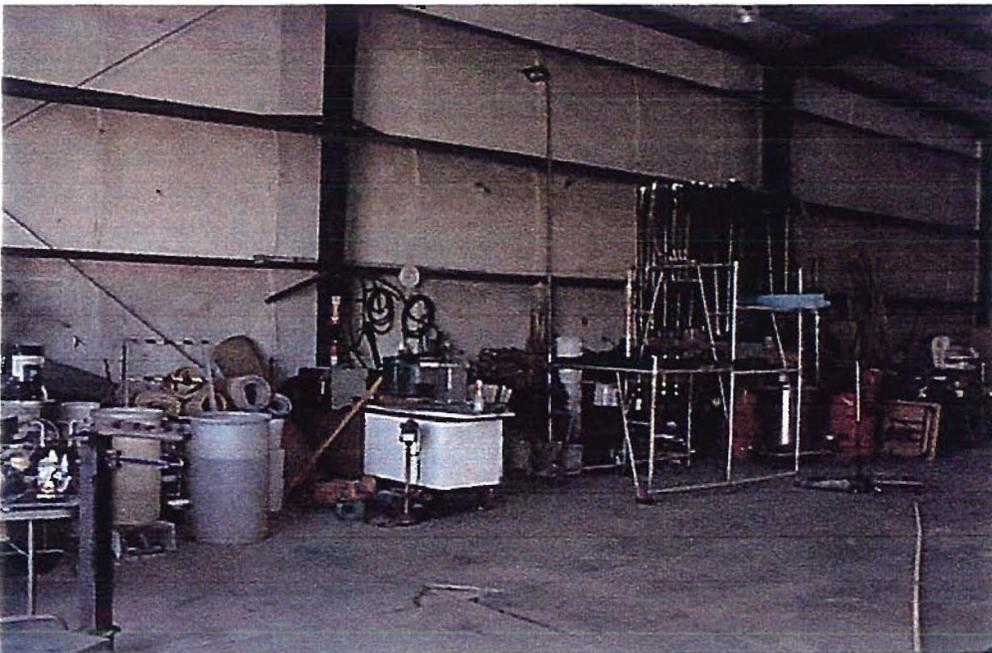
Photo #34 - Taken by J. Mur 6/25/98. Items inside the mill building on the Becki M mill site. Separating column on the right.

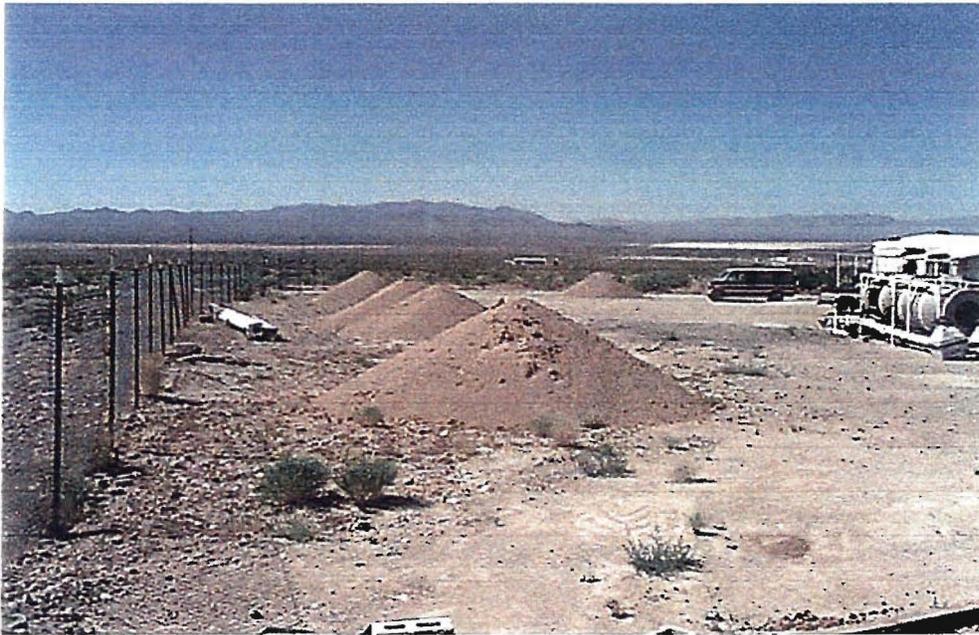
Photo #42 - Taken by J. Mur 6/25/98. Looking south. Shows mineral material stockpiles on the Becki M mill site.

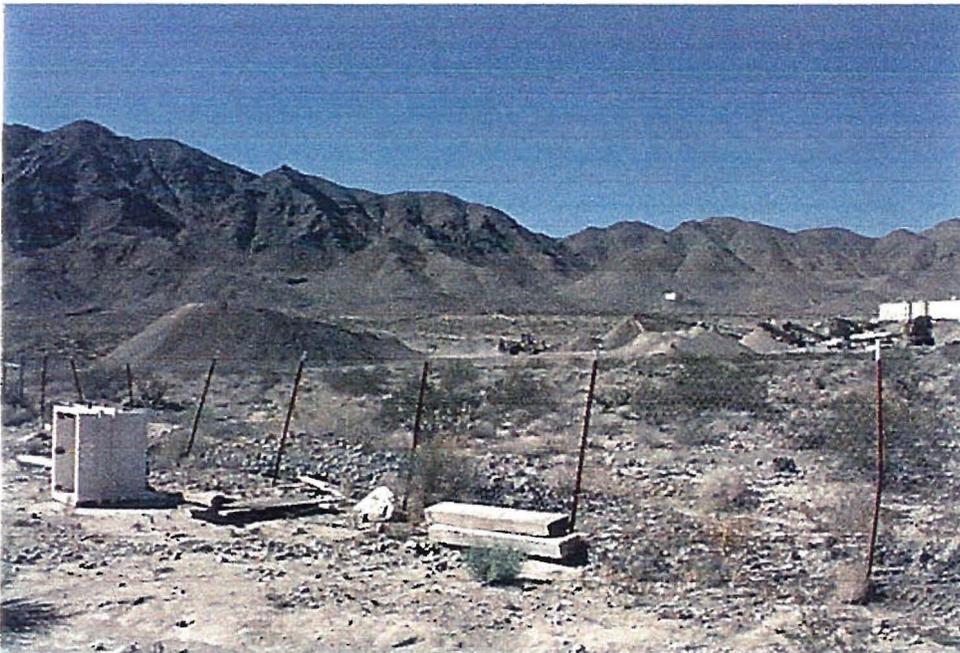
Photo #46 - Taken by J. Mur 10/01/98. Looking west. Shows mining on the Mijo #16 placer claim adjacent to the Becki M mill site.

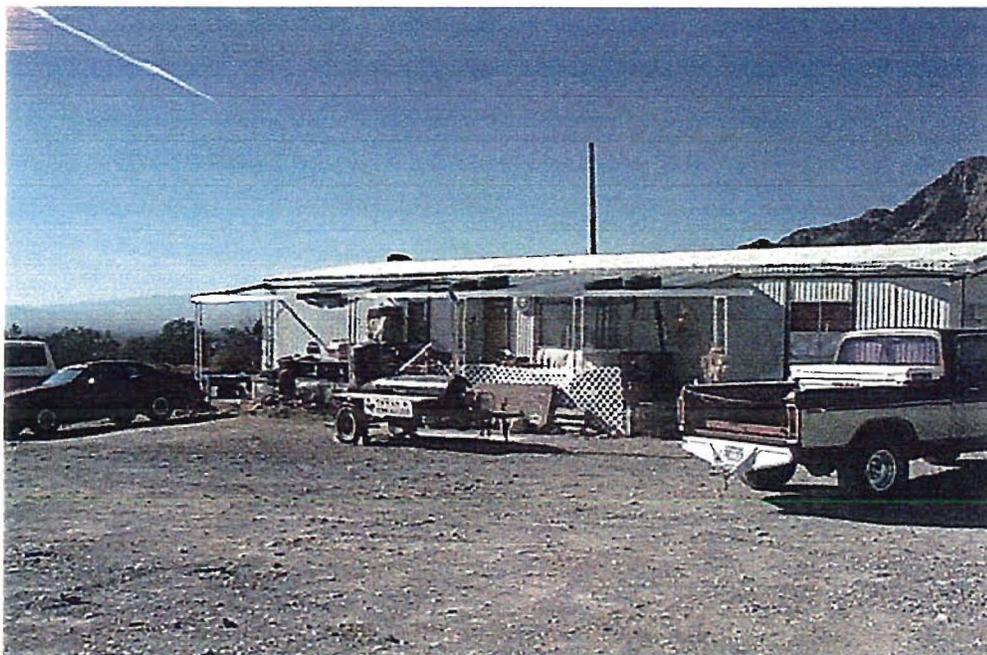
Photo #49 - Taken by E. Seum 1/10/2000. Looking east at the watchman's mobile home on the Becki M mill site. Compare to photos 17, 29.

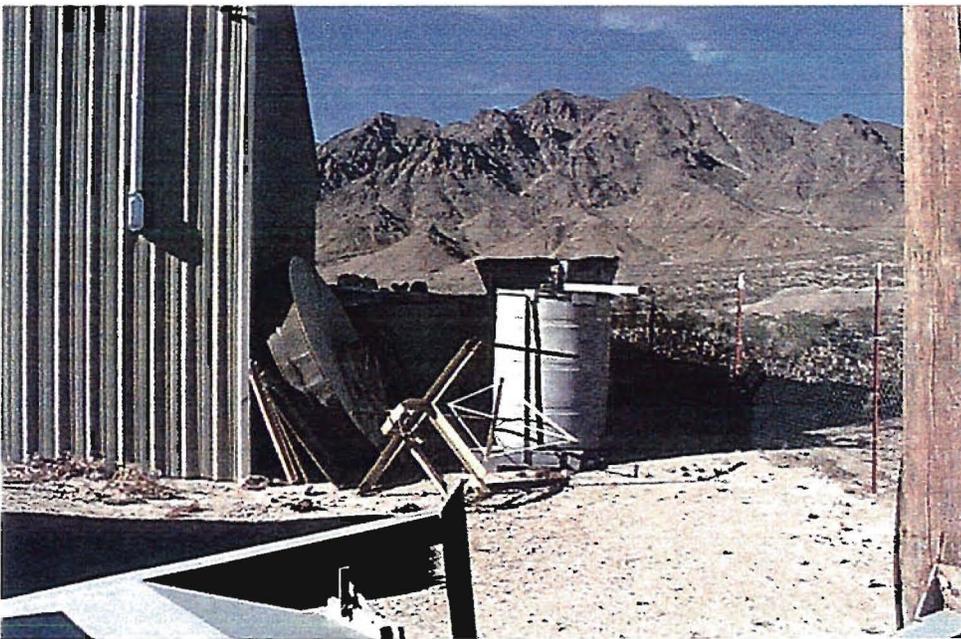
Photo #54 - Taken by E. Seum 1/10/2000. Looking along the north end of the mill building. Shows items accumulating, compare to photos 8, 30.

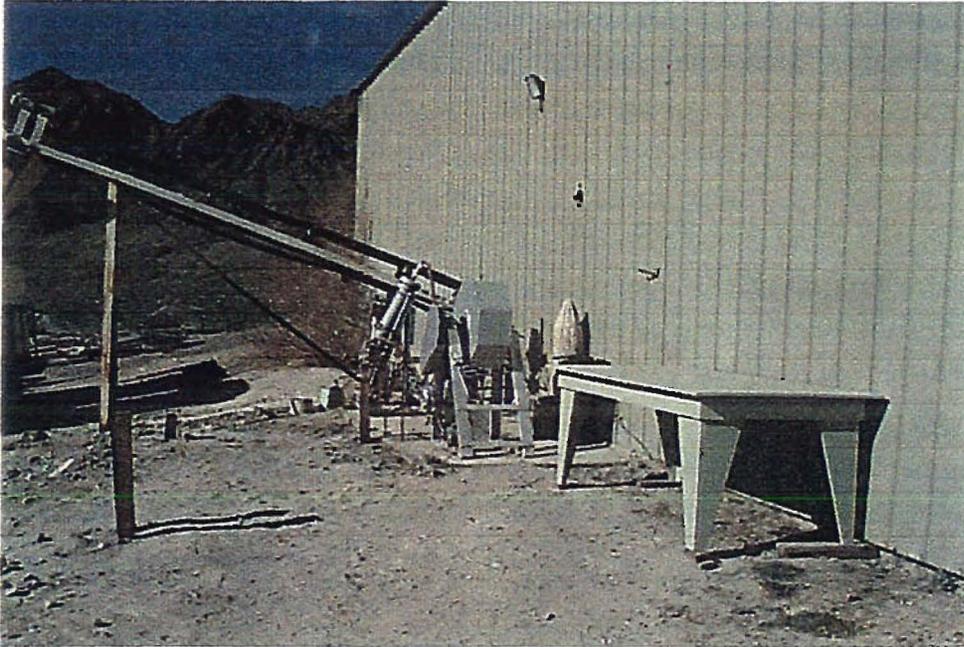
Photo #55 - Taken by E. Seum 1/10/2000. Looking along the south side of the mill building. Shows small ball mill, not in operation during the exam.

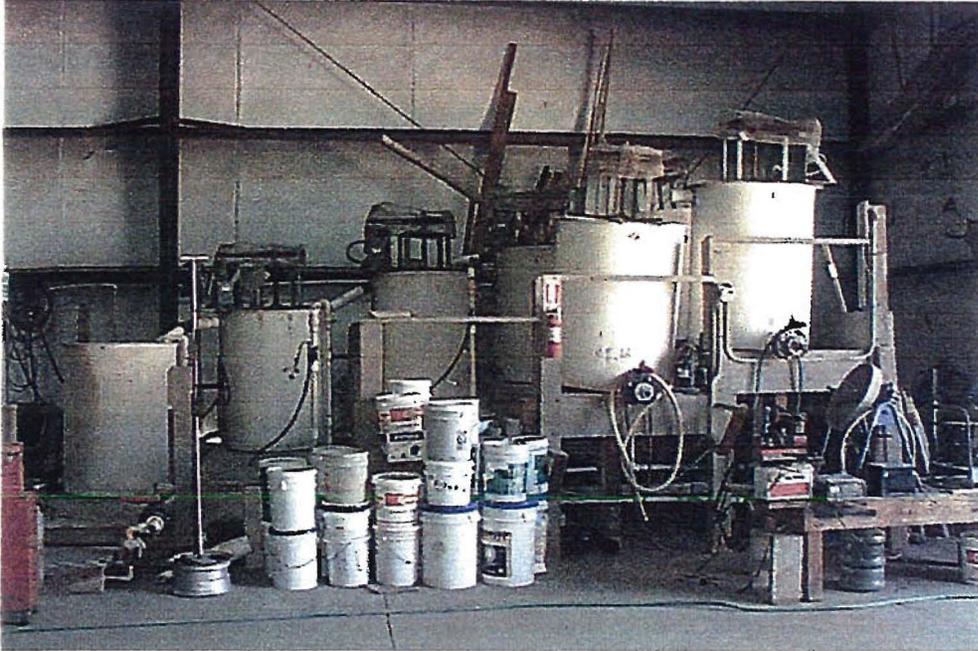
Photo #57 - Taken by E. Seum 1/10/2000. Mixing tanks inside mill building fed by hopper in above picture. Not currently used for processing.

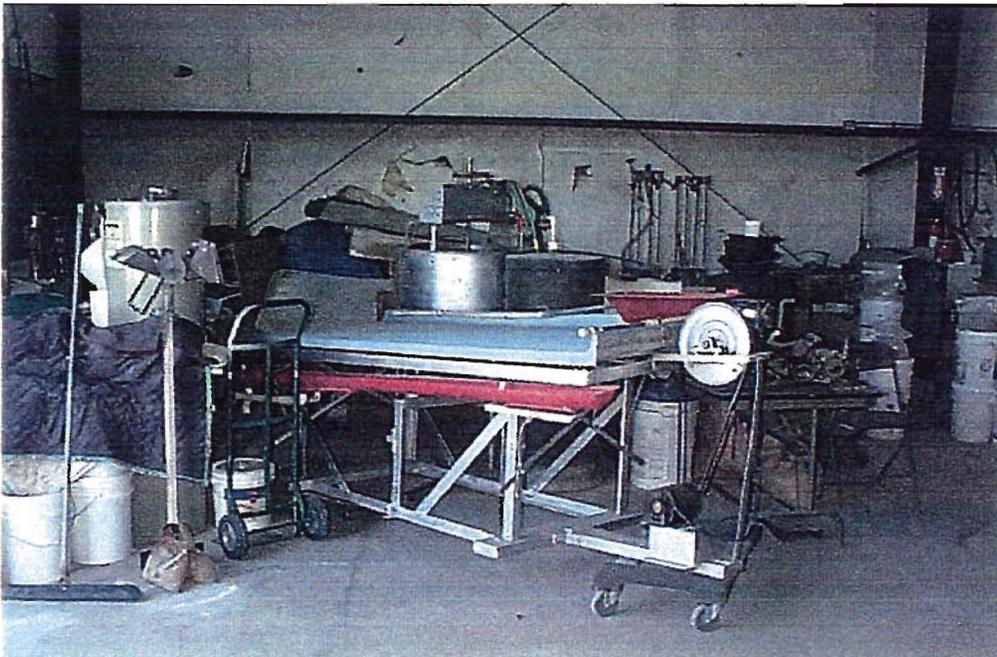
Photo #58 - Taken by E. Seum 1/10/2000. Jig table stored inside mill building.

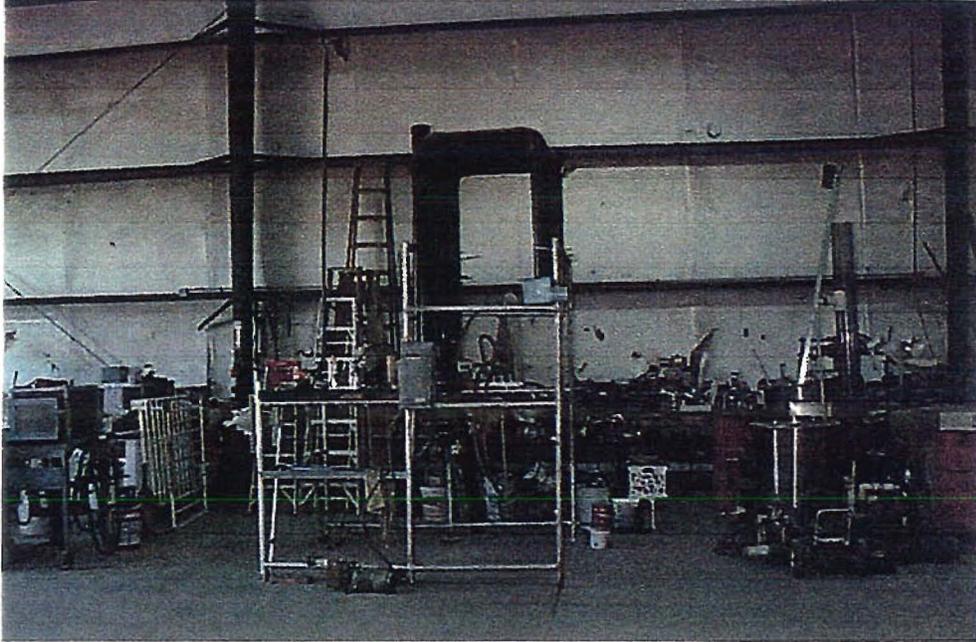
During an inspection on December 9, 1997, Joel Mur found that a small barrel, roll mill in the mill building was being operated. Some processed samples were viewed in the lab. A tower concentrator, that was not in use, was viewed in the mill building. Vehicles not related to mining were still under repair on the site.

Photo #59 - Taken by E. Seum 1/10/2000. Tower concentrator stored in mill building. Not set up to run.

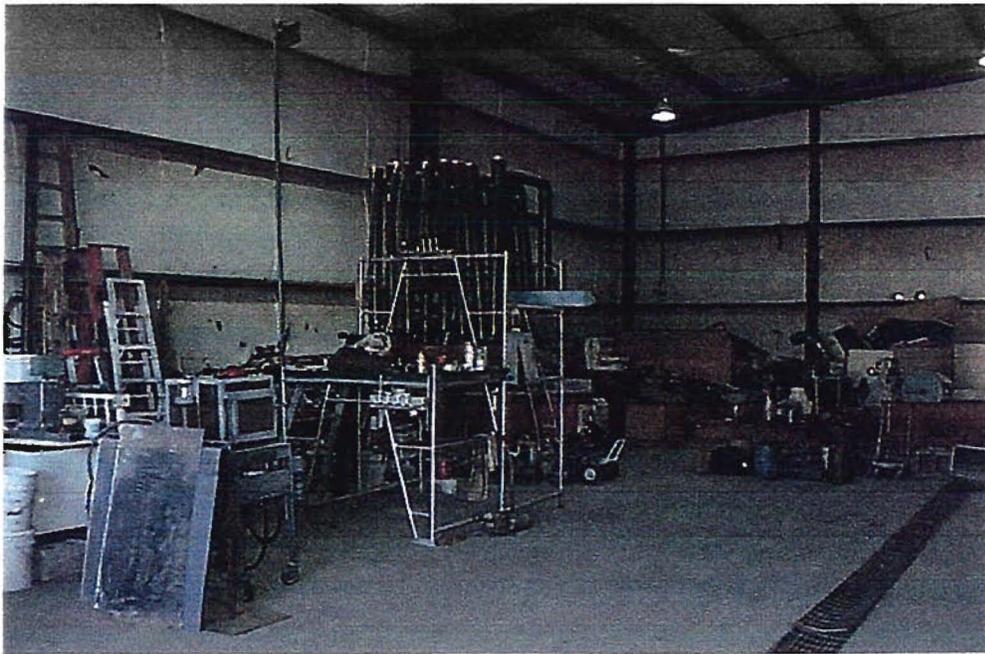
Photo #60 - Taken by E. Seum 1/10/2000. Tower concentrator in above picture from different angle.

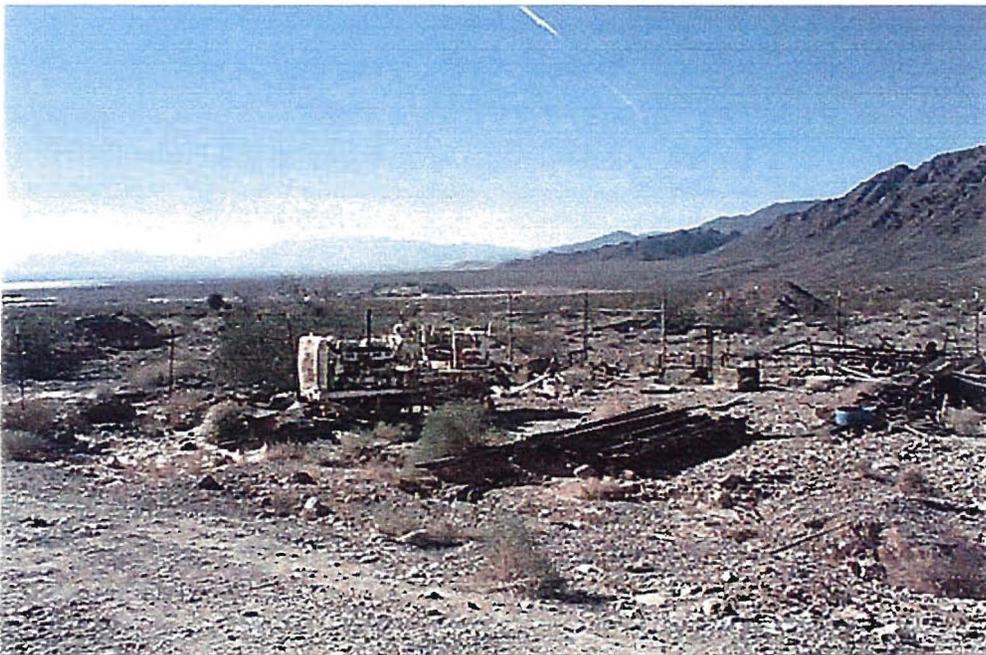
Photo #64 - Taken by E. Seum 1/10/2000. Broken down dozer on southwest corner of the Becki M mill site. Compare with photos 14, 20, 27, 39.

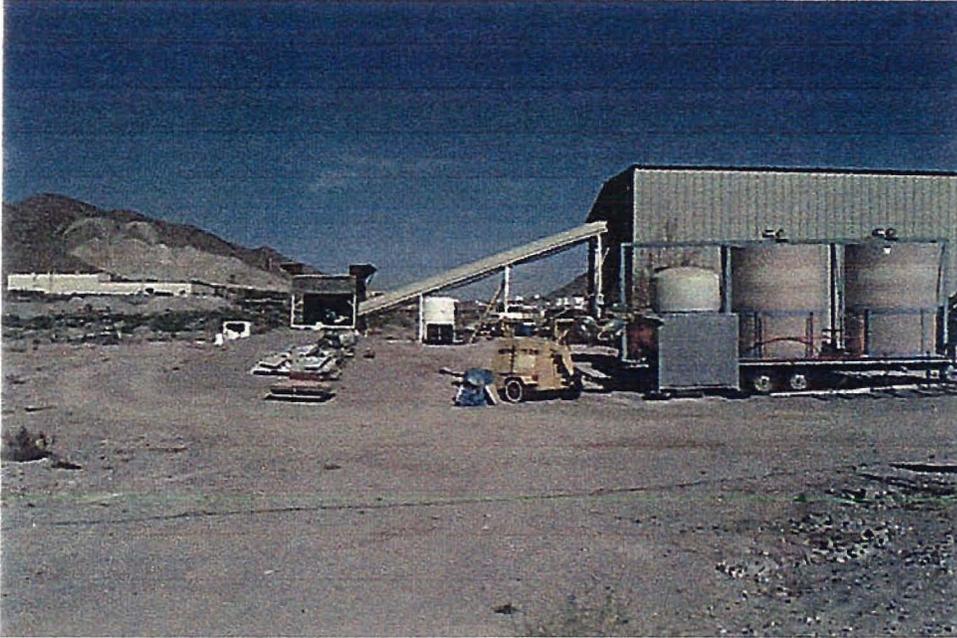
Photo #65 - Taken by E. Seum 1/10/2000. Looking north at rear of mill building. Tanks on right empty.

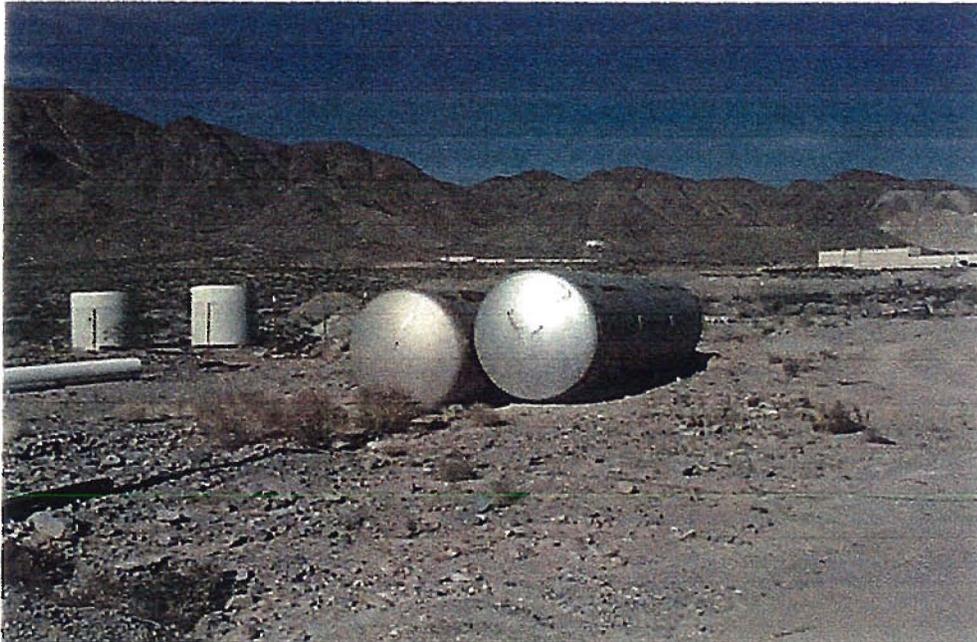
Photo #67 - Taken by E. Seum 1/10/2000. Tanks stored on west side of Becki M mill site. Not in use and on site since at least 1991. See photo 3.

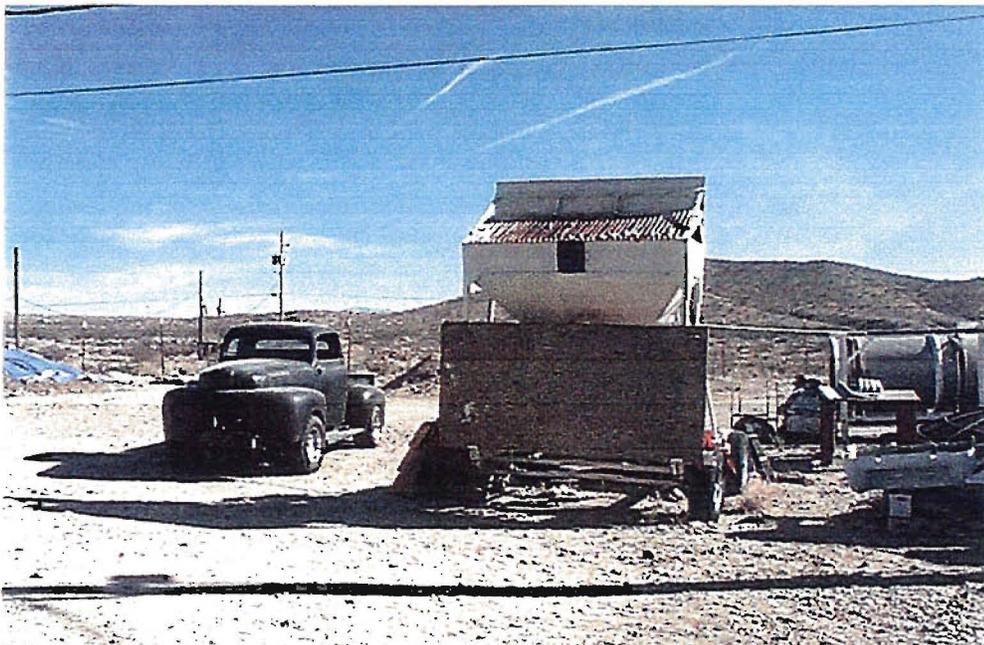
Photo #68 - Taken by E. Seum 1/10/2000. Portable screen used on Mijo #16 project and stored on the Becki M mill site. Truck on left belongs to Gene Phebus.

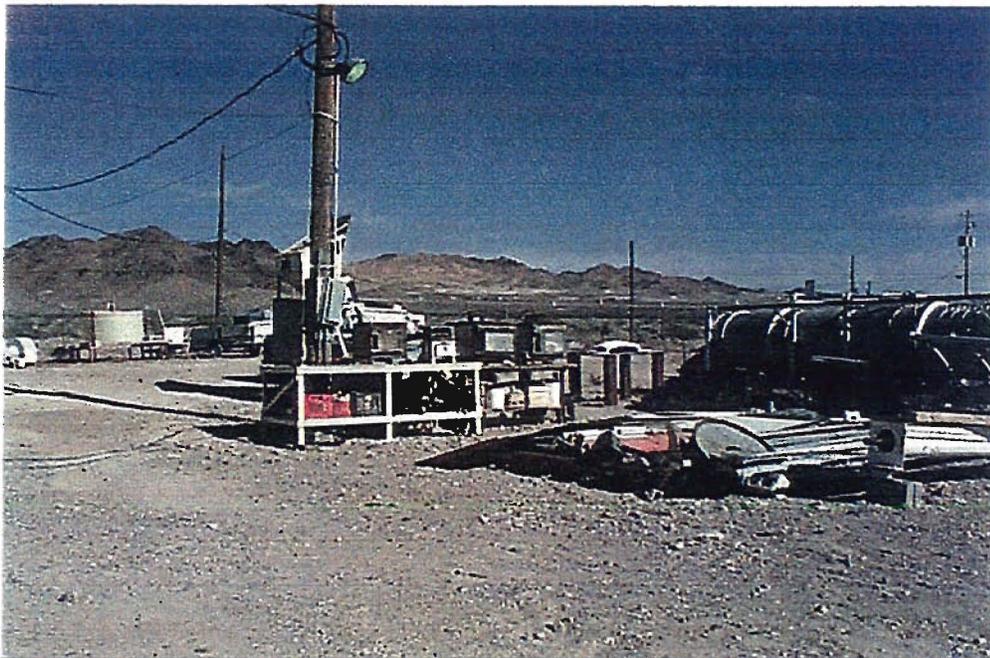
Photo #69 - Taken by E. Seum 1/10/2000. Row of furnaces on northeast side of the Becki M mill site. Not currently hooked up to power.

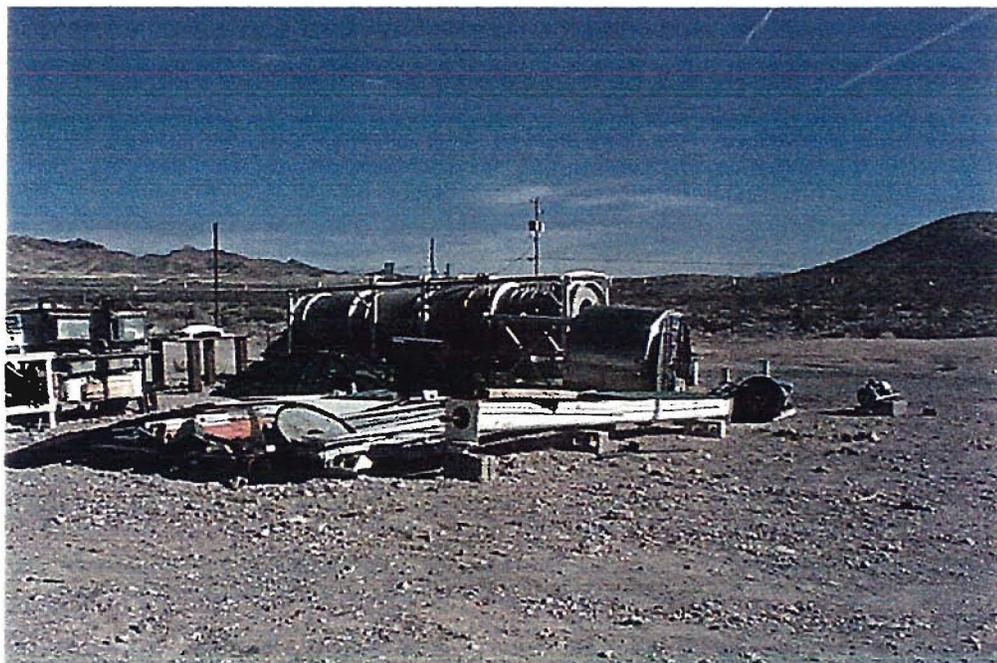
Photo #70 - Taken by E. Seum 1/10/2000. Trommel sitting on northeast side of the Becki M mill site.
