Serial Number
NMC 293456
N54-93-001N
N-71982

MINERAL REPORT

Surface Use Determination
and
Validity Determination
For The Becki M
Mill Site Claim

Clark County, Nevada
T. 23 S., R. 63 E., MDM
Section 14, Lot 3
Consisting of 5 Acres

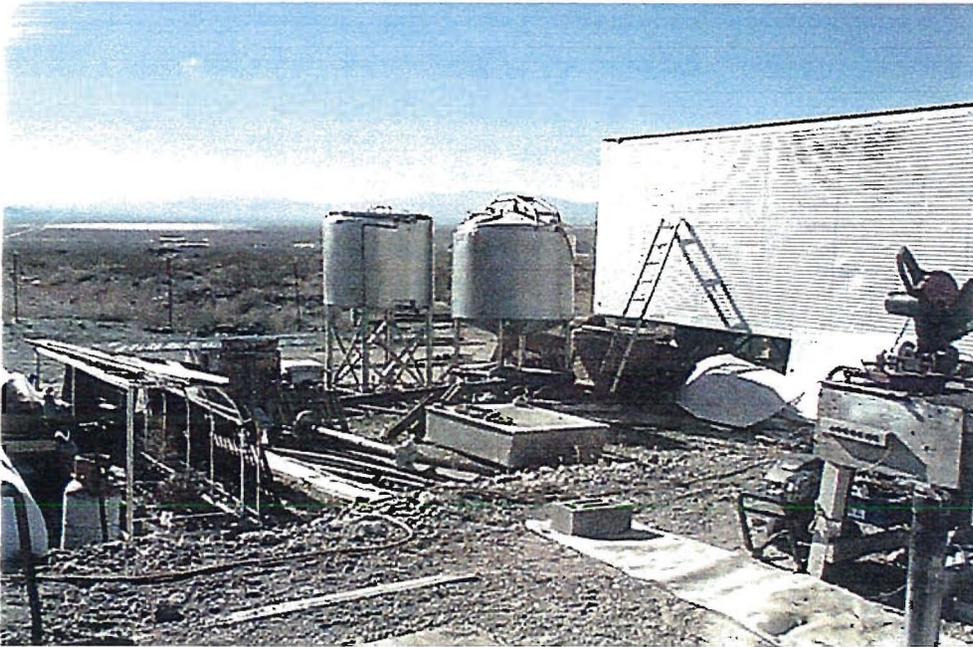
Photo #73 - Taken by E. Seum 1/10/2000. Looking south at stainless steel tanks, concrete forms and other items on the Becki M mill site.

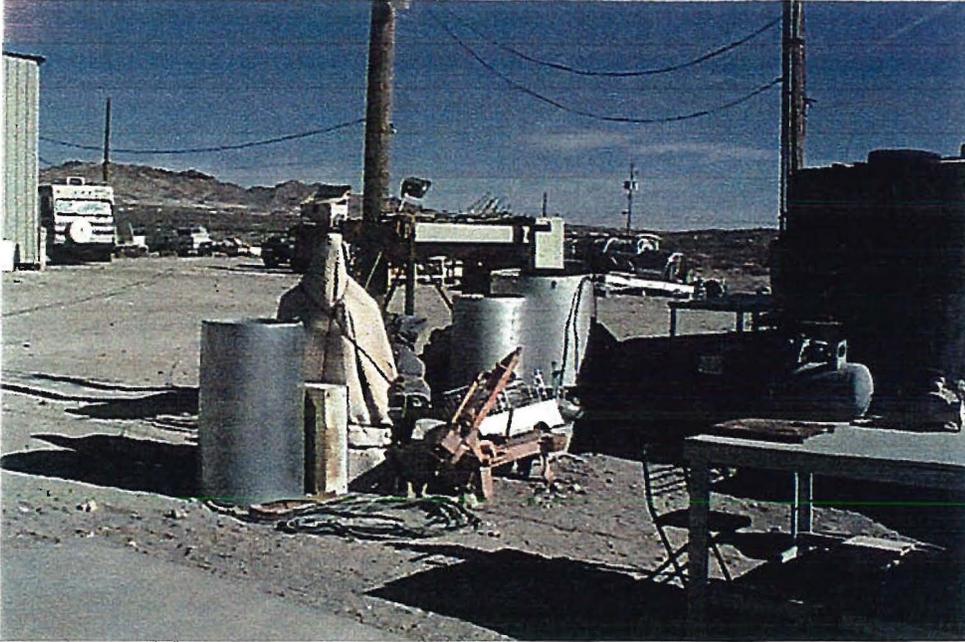
Photo #75 - Taken by E. Seum 1/10/2000. Shows bag house in center of photo. Also goes with trommel in photo 68.

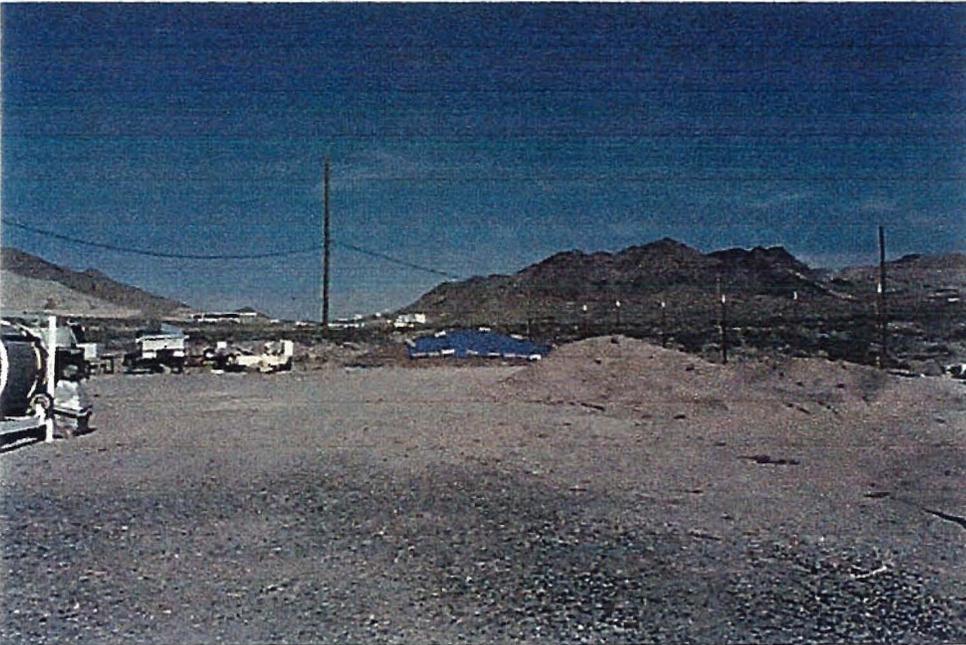
Photo #76 - Taken by E. Seum 1/10/2000. Shows stockpiles of mineral materials from the Mijo #16. Sits on the northeast corner of the Becki M mill site.
