MINERAL REPORT

Validity Determination

Iron Mill #1, Iron Mill #2, Iron Mill #3, Iron Mill #4

Mill Site Claims

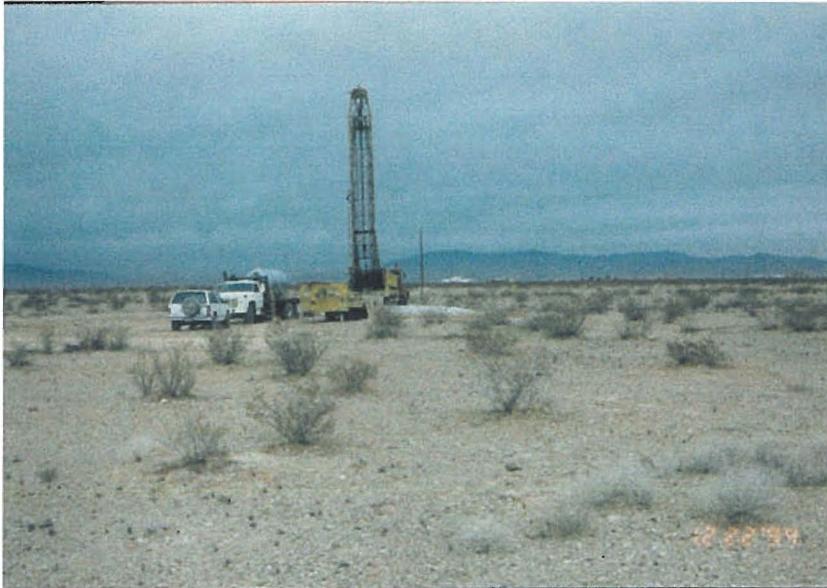
Photo #1 - Taken by G. Miller on 12/22/94. Looking northwest at drilling rig on the Iron Mill #1 mill site claim.

The first inspection was completed on this site in December of 1994. The claimant/operator was having a well drilled on the Iron Mill #1 claim. No Notice or Plan had been submitted as required by 43 CFR 3809. As a result of the inspection a Notice of Noncompliance requiring the submittal of a Notice or Plan was sent to the claimant/operator.

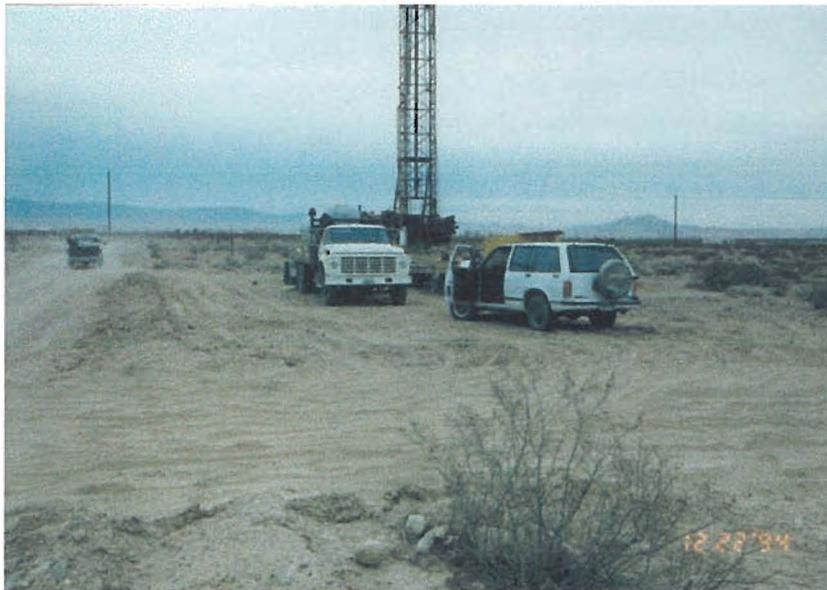
Photo #2 - Taken by G. Miller on 12/22/94. Shows closeup of drilling rig located on the southwest corner of the Iron Mill #1 mill site claim.

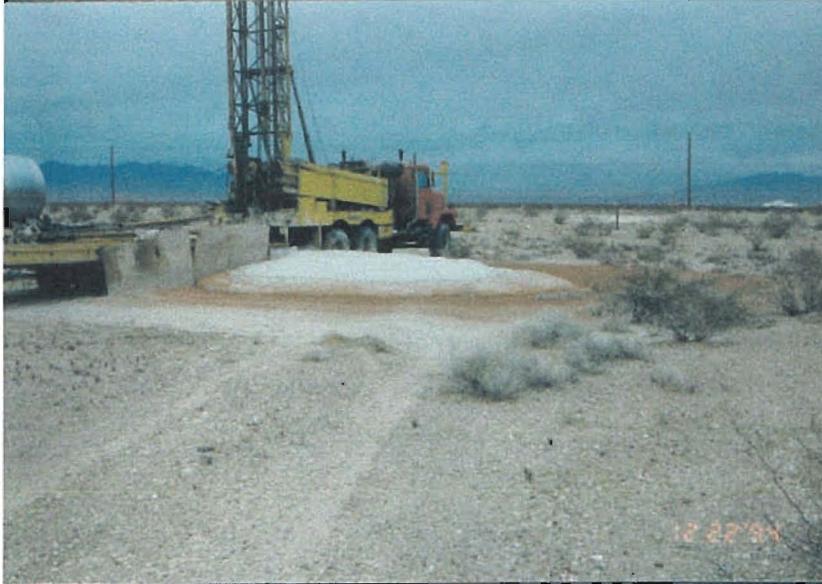
Photo #3 - Taken by G. Miller on 12/22/94. Closeup of drilling operation on the Iron Mill #1 mill site claim. Shows drilling fluids to right of truck.

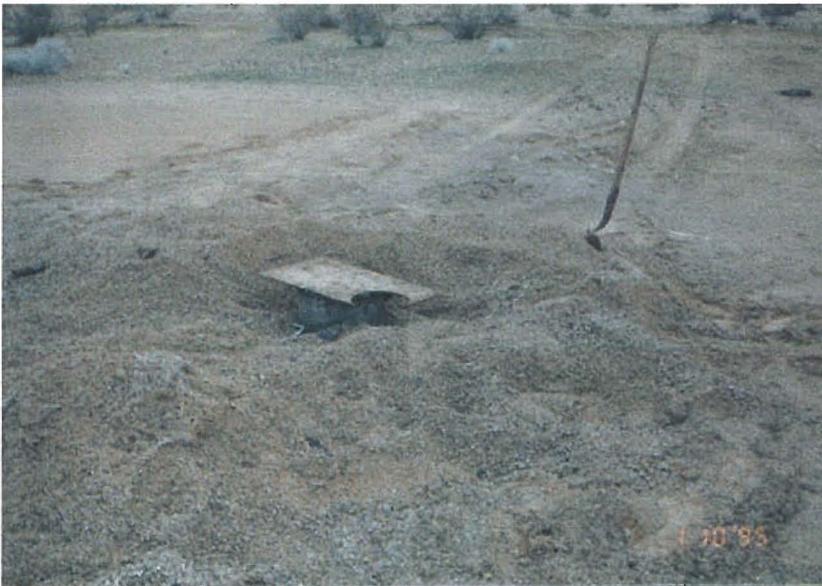
Photo #4 - Taken by G. Miller on 1/10/95. Shows steel plate on well head. Well is located on the Iron Mill #1 mill site claim.

The inspection of January 10, 1995 noted the well and nothing else. The February 14, 1995 inspection noted that no copies of County permits had been received but did not note any new activity on the claims. The February 17th inspection found that the well was being worked on again. Dimick Drilling was using an eight inch bit to size the well.

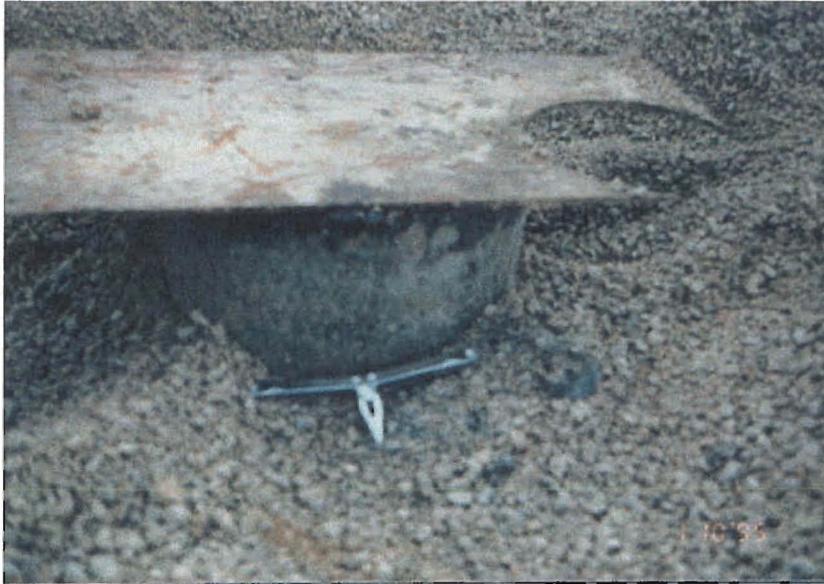
Photo #5 - Taken by G. Miller on 1/10/95. Closeup of well head shown in above picture. Located on the Iron Mill #1 mill site claim.

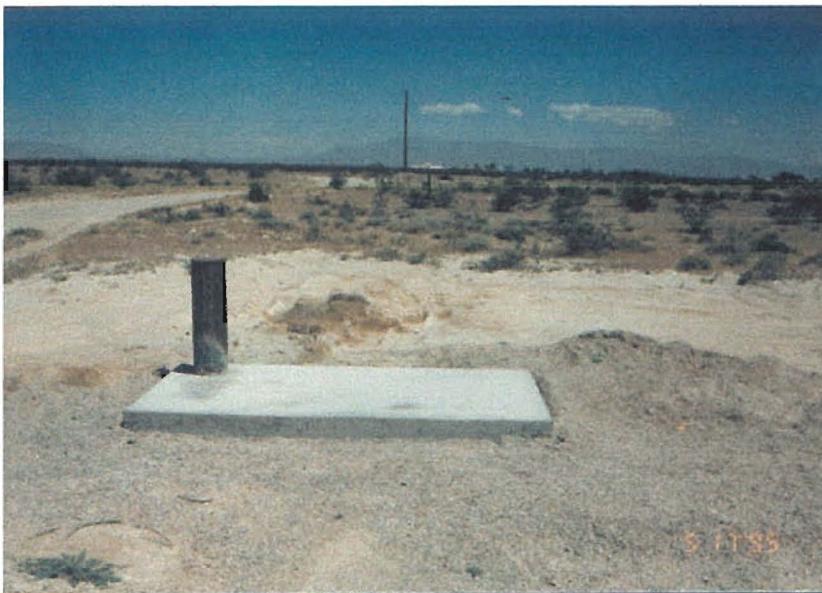
Photo #6 - Taken by G. Miller on 5/17/95. Shows well head with cement apron around it. Same well as shown in photos 4 & 6. Located on the Iron Mill #1 mill site claim.

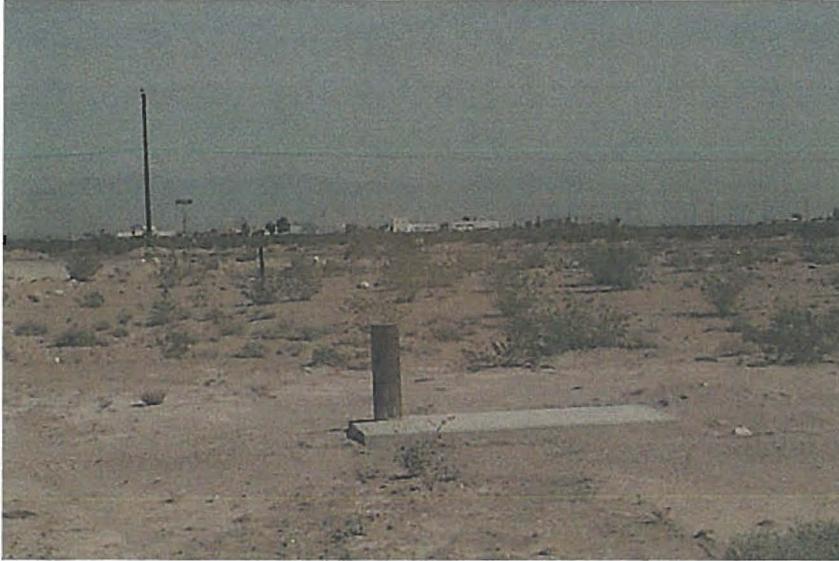
Operations on the site should not degrade either surface or ground waters of the State. No hazardous materials or substances were found during the exam. The well on the Iron Mill #1 claim is sealed and appears to be properly cased.

Photo #8 - Taken by E. Seum on 04/13/00. Looking north at water well on the Iron Mill #1 mill site claim.

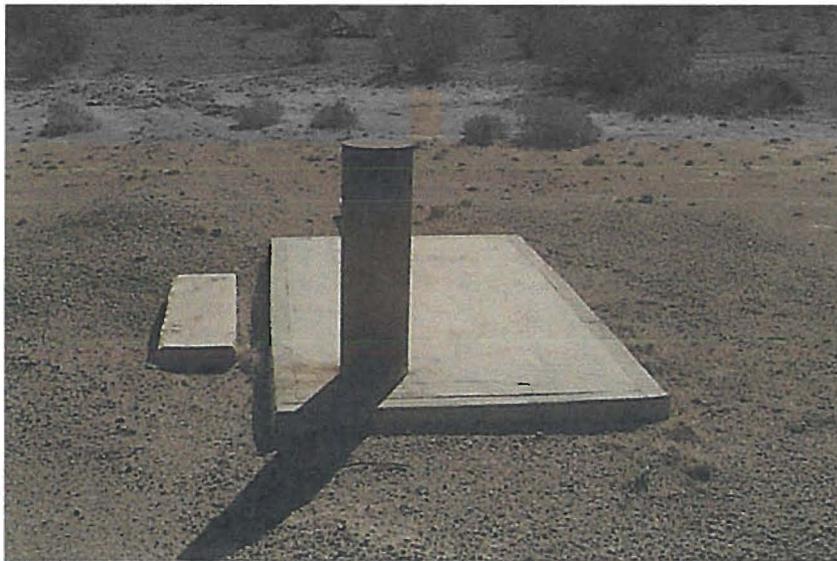
Photo #9 - Taken by E. Seum on 04/13/00. Close-up of water well on the Iron Mill #1 mill site claim.

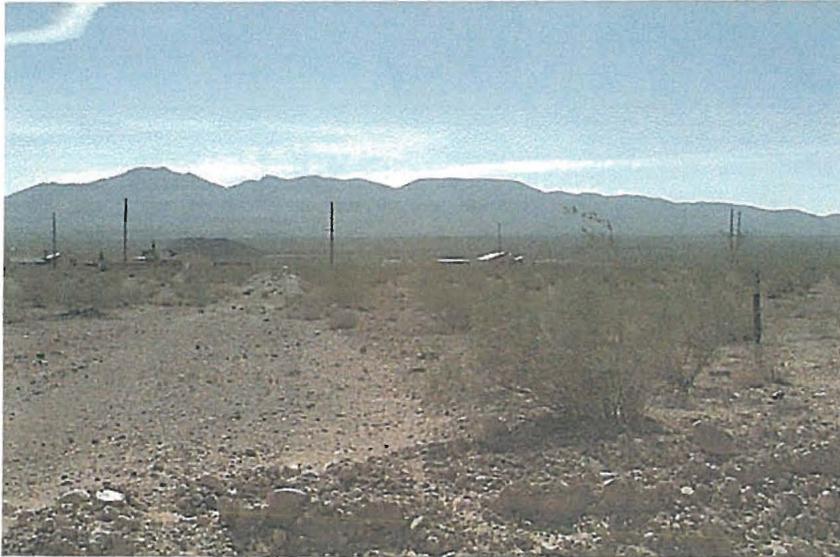
Photo #10 - Taken by E. Seum on 04/13/00. Looking east along an unused road on the north end of the Iron Mill #1 mill site claim.

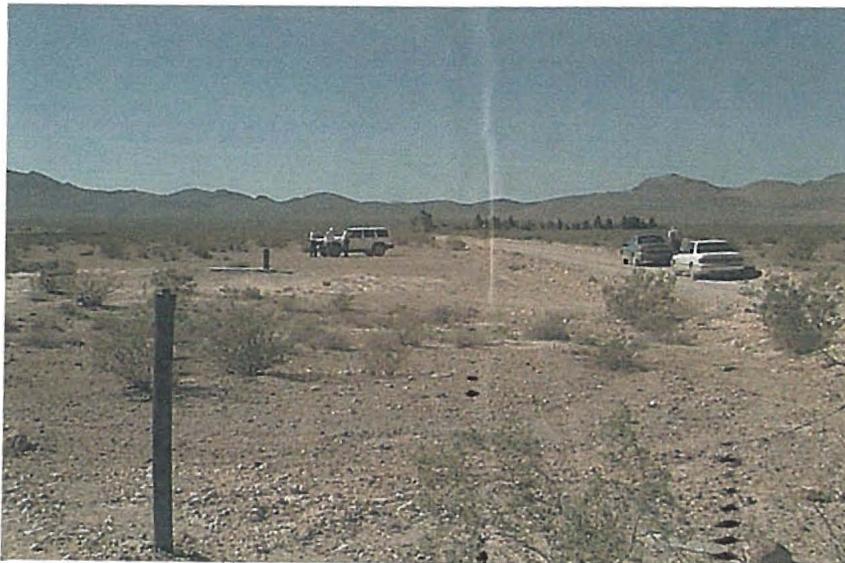
Photo #11- Taken by E. Seum on 04/13/00. Looking south along the western edge of the Iron Mill #1 mill site claim.

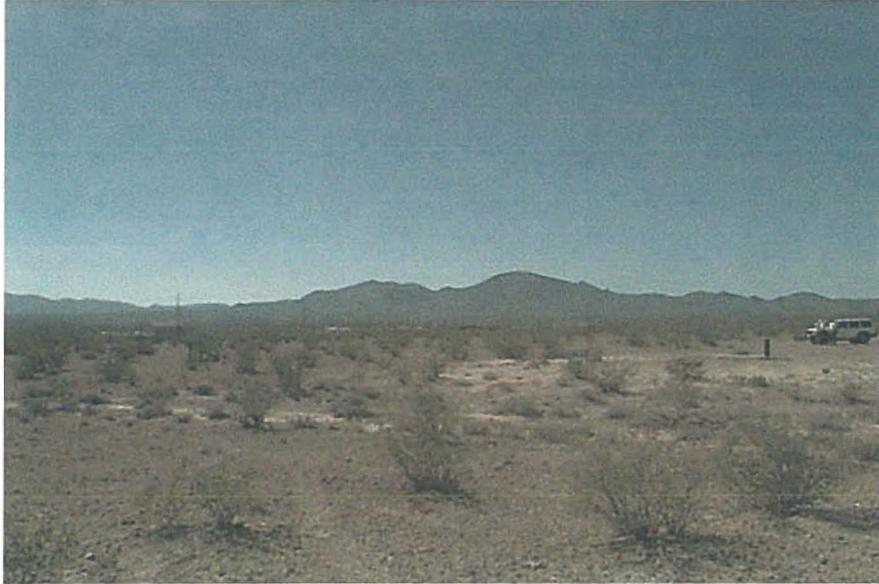
Photo #12 - Taken by E. Seum on 04/13/00.
Looking southeast across the Iron Mill #1 mill site claim.

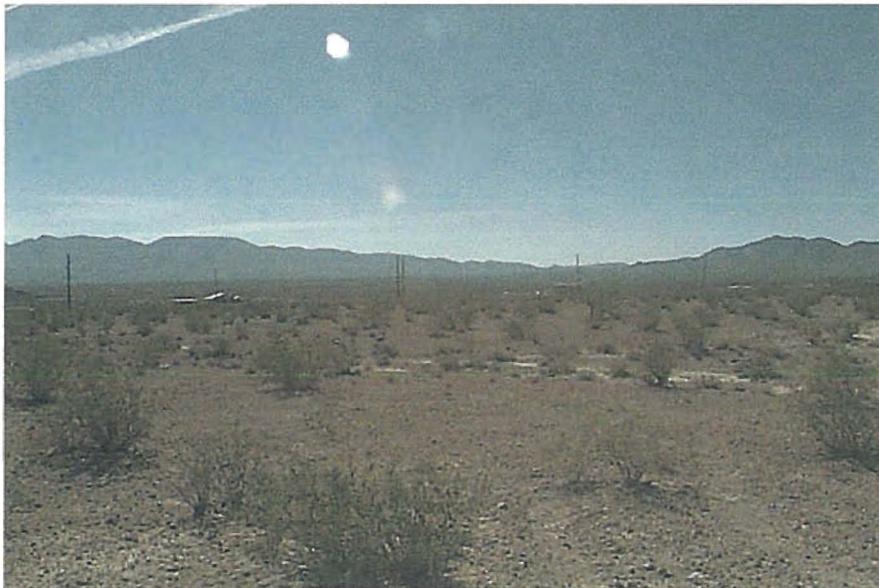
Photo #13 - Taken by E. Seum on 04/13/00.
Looking east across the Iron Mill #1 mill site claim.

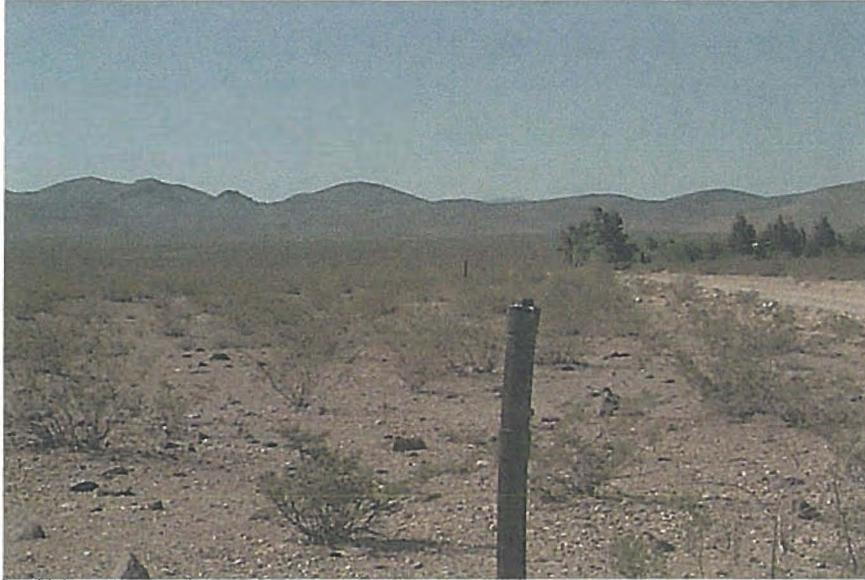
Photo #14 - Taken by E. Seum on 04/13/00. Looking south along the western edge of the Iron Mill #2 mill site claim.

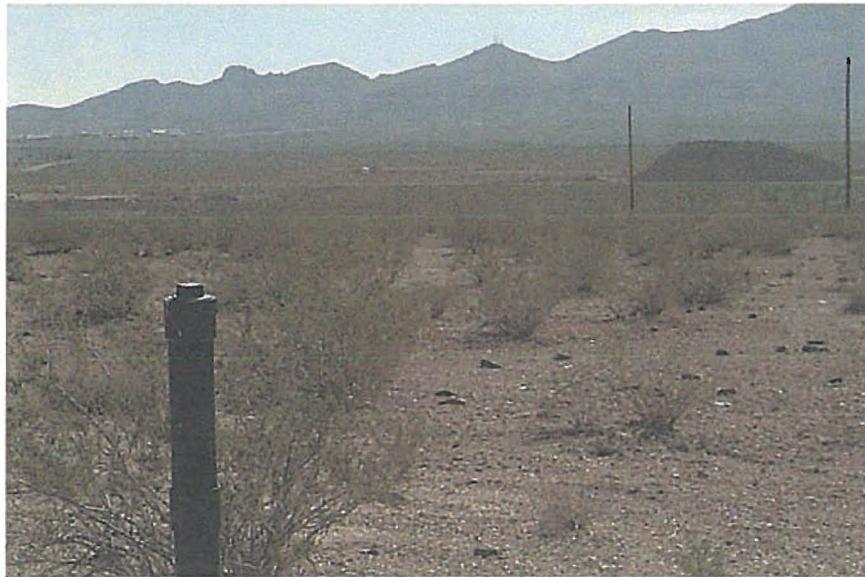
Photo #15 - Taken by E. Seum on 04/13/00. Looking east across the Iron Mill #2 mill site claim. Stockpiled material in right rear background on NDOT material site right-of-way.

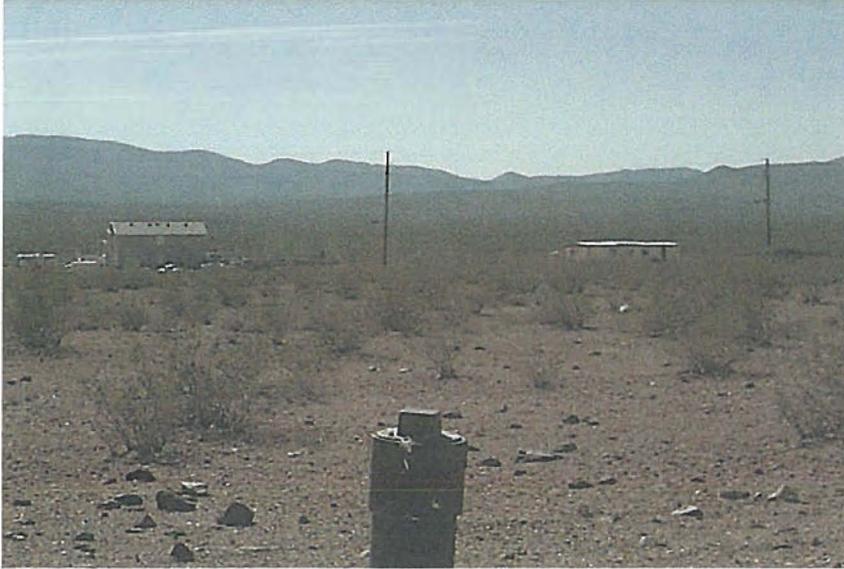
Photo #16 - Taken by E. Seum on 04/13/00. Looking southeast across the Iron Mill #2 mill site claim.

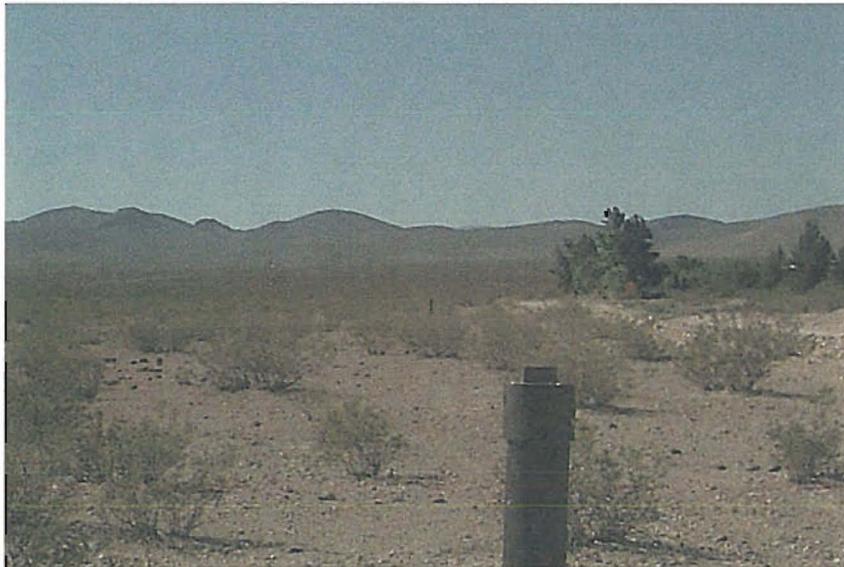
Photo #17 - Taken by E. Seum on 04/13/00. Looking south along the western edge of the Iron Mill #3 mill site claim. Iron Mill #4 claim post in center midground of photo.

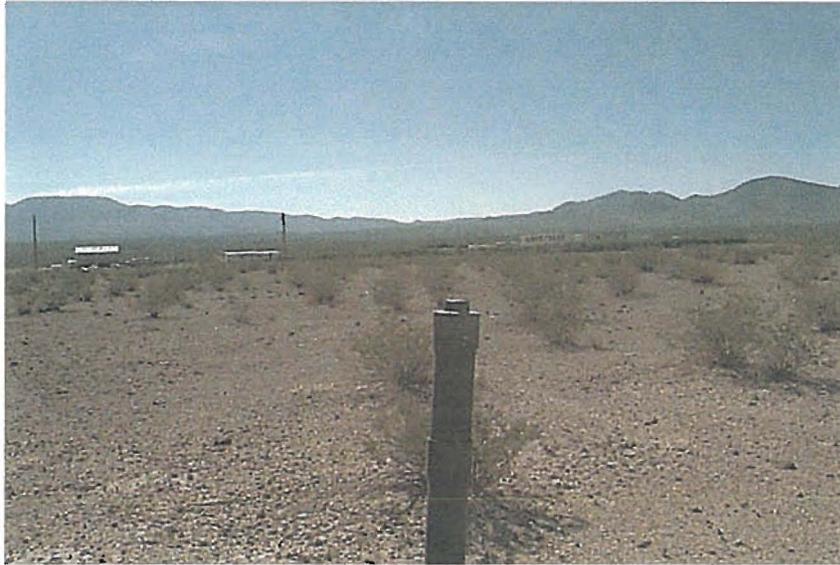
Photo #18 - Taken by E. Seum on 04/13/00. Looking southeast across the Iron Mill #3 & #4 mill site claims.

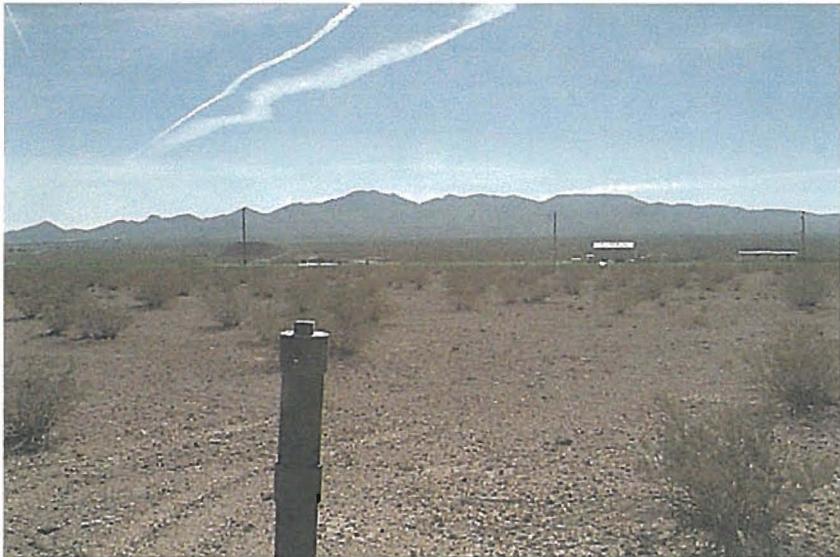
Photo #19 - Taken by E. Seum on 04/13/00. Looking east across the Iron Mill #3 mill site claim.

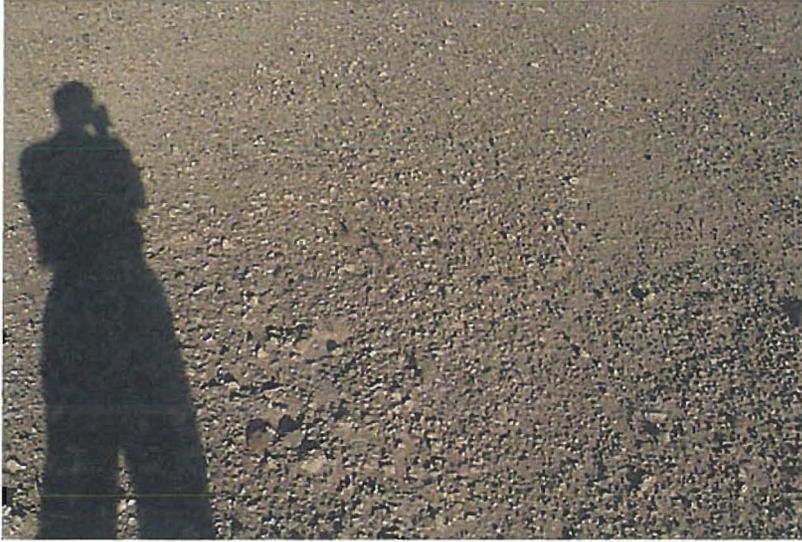
According to the *SAND and GRAVEL in the LAS VEGAS BASIN PRELIMINARY REPORT* (Castor, Carr and Breit 1991), the site is composed of sand and gravel containing mainly limestone detritus of Quaternary age. The report shows the site to be in an area of high potential for sand and gravel production. Photographs 20 and 21 show the surface materials which occur on the Iron Mill claim group. The surface materials are mainly fine grained with a few pebbles and cobbles mixed in. The pebbles and cobbles appear to be either limestone or dolomite in composition. There are no washes or cuts on the Iron Mill claim group which expose subsurface materials.

Photo #20 - Taken by E. Seum on 06/14/00. Looking at surface materials on the Iron Mill #1 mill site claim.

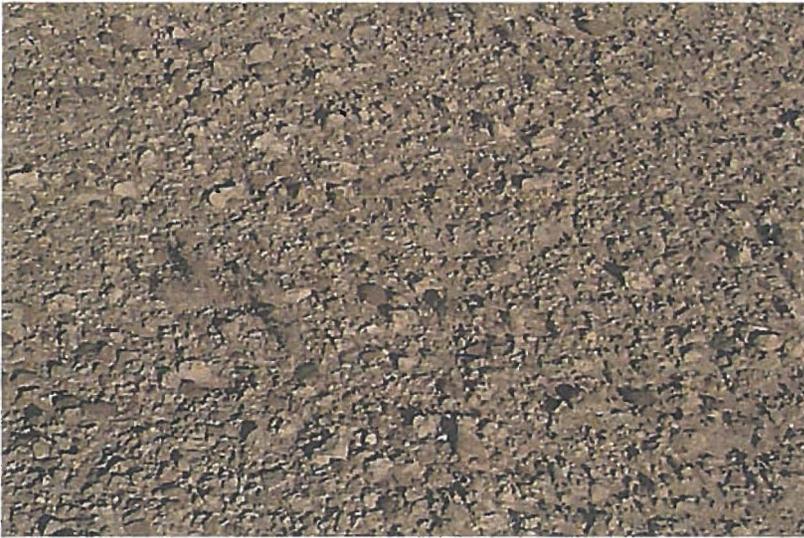
Photo #21 - Taken by E. Seum on 06/14/00. Close-up of the materials shown in photo #20.

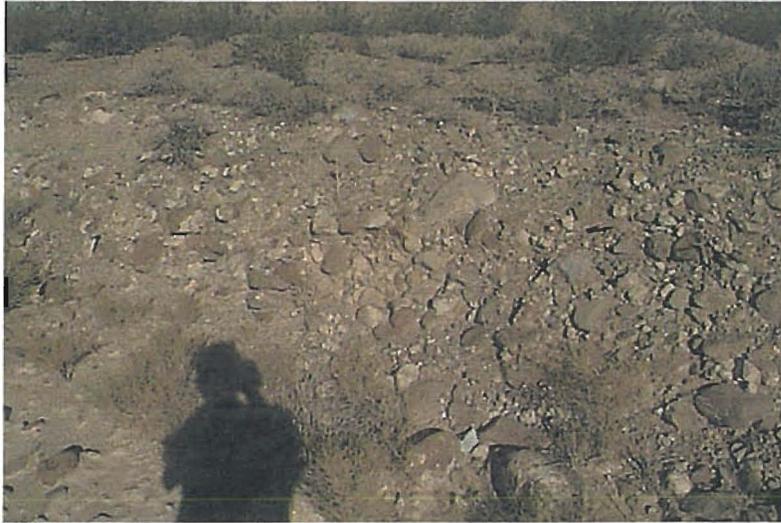
A wash located down gradient (approximately 20 feet lower in elevation) and a quarter mile to the east of the Iron Mill claim group was examined on June 14, 2000. A bank of the wash, which was approximately three feet high, showed a large percentage of pebbles and cobbles to finer grained materials (photos 22 and 23). The wash bottom showed materials of a similar nature (photo 24).

Photo #22 - Taken by E. Seum on 06/14/00. Shows channel bank of dry wash located east of the Iron Mill mill site group.

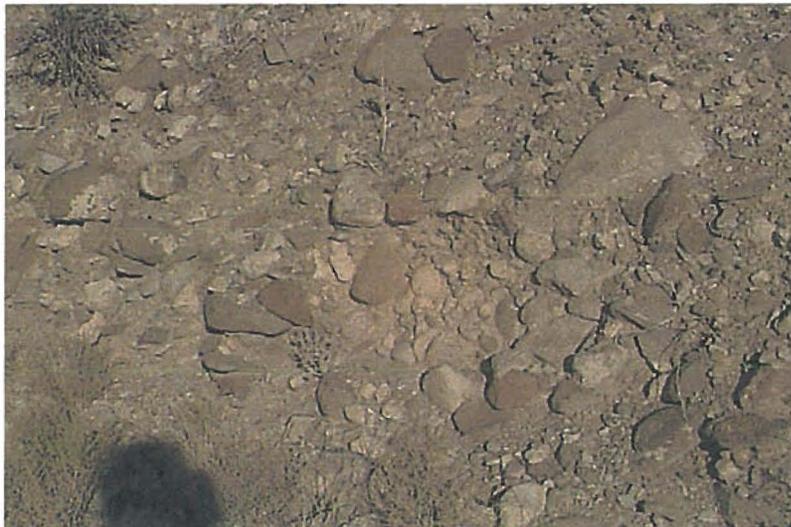
Photo #23 - Taken by E. Seum on 06/14/00. Close-up of the materials shown in photo #22.

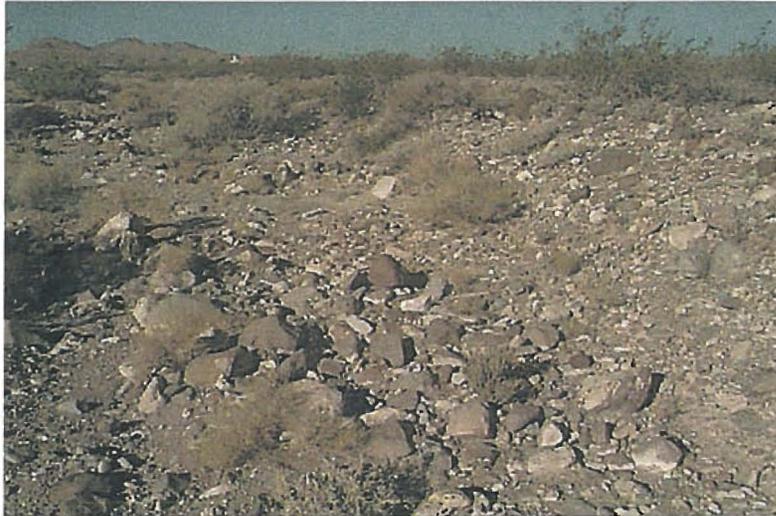
Photo #24 - Taken by E. Seum on 06/14/00. Taken looking south along the dry wash located east of the Iron Mill mill site group.

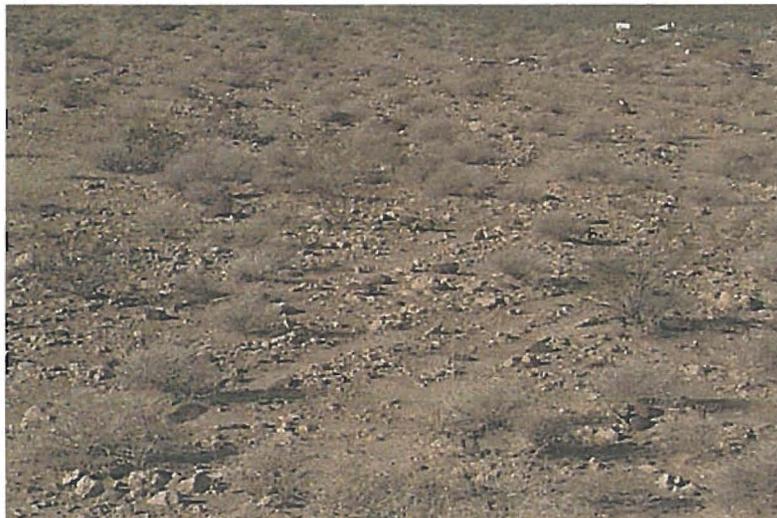
An active material site right-of-way, N-056780, is located on public lands approximately one half mile to the east of the subject lands. Surface materials at the site are of the same nature as those on the Iron Mill claim group (photo 25). Photograph 26 shows the large stockpile of mineral materials which have been mined on a portion of the right-of-way. Based on geologic inference and the 1991 report, the authors believe that the lands covered by the claim group would be an area of high potential for sand and gravel. Maps showing mineral material potential and geology for the area are attached to this report.

Photo #25 - Taken by E. Seum on 06/14/00. Shows surface materials located within the NDOT material site right-of-way, east of the Iron Mill mill site claim group.

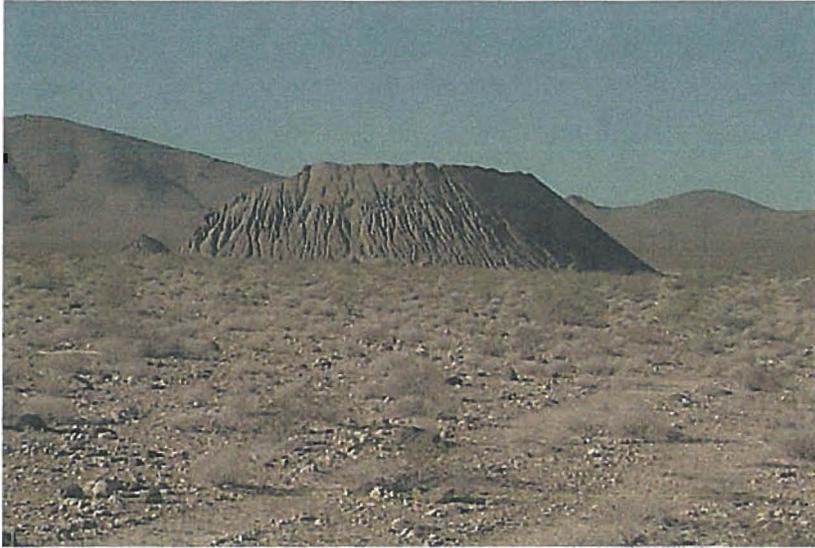
Photo #26 - Taken by E. Seum on 06/14/00. Close-up of material stockpiled within the NDOT material site right-of-way, east of the Iron Mill mill site group.
