Serial Number
NMC 590342
NMC 590343
N54-90-021N

MINERAL REPORT
Surface Use Determination
and
Validity Determination
For
The Tron #3 and Tron #4
Mill Site Claims

LANDS INVOLVED
Clark County, Nevada
T. 15 S., R. 67 E., MDM
Section 17, N½NE¼NE¼NE¼, N½NW¼NE¼NE¼
Consisting of 10 Acres

Prepared by: Edward Seum
(Signature)
Minerals Specialist
(Title)
January 31, 2000
(Date)

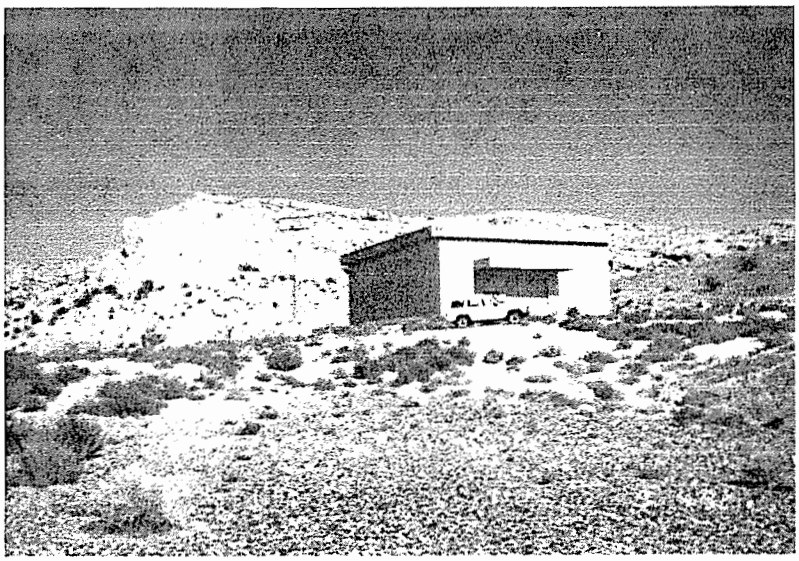
The following items are located on the Tron #4 mill site. A large two story mill building (photos 1, 2, 5, 6) is on the site. The mill building has electricity and water service photos 5, 7, 9). Sewage is handled by septic tanks but it was not possible to verify this during the inspection. According to Mr. Pence the septic system is not being put to use at this time. Water is obtained from a water district pipeline running along the south side of the mill site. The interior of the mill building contained a number of wooden posts (photo 11) for marking mining claims, and water testing equipment (photo 13). The upstairs does not house anything at this time. The building also houses an engineering room, offices and a bathroom.

Photo #1 - Taken by D. Kuntz 9/4/92. Looking at the mill building on the Tron #4 mill site.

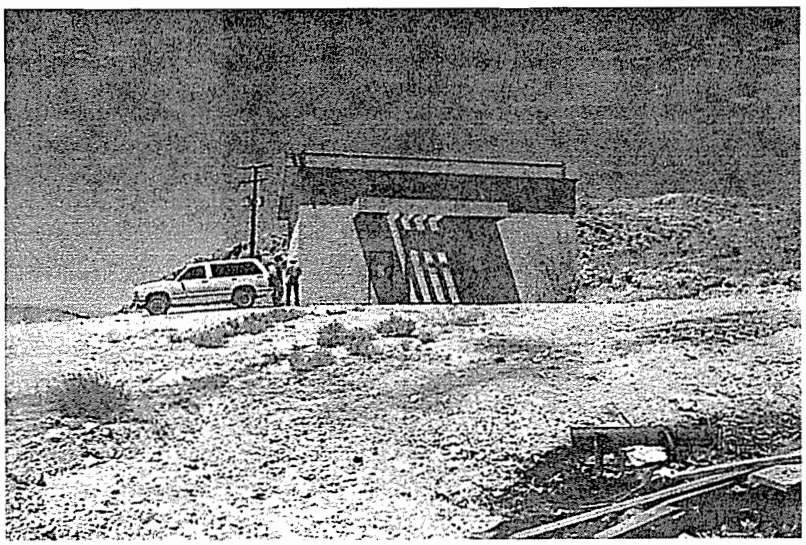
Photo #2 - Taken by E. Seum 8/16/99. Looking at the mill building on the Tron #4 mill site.

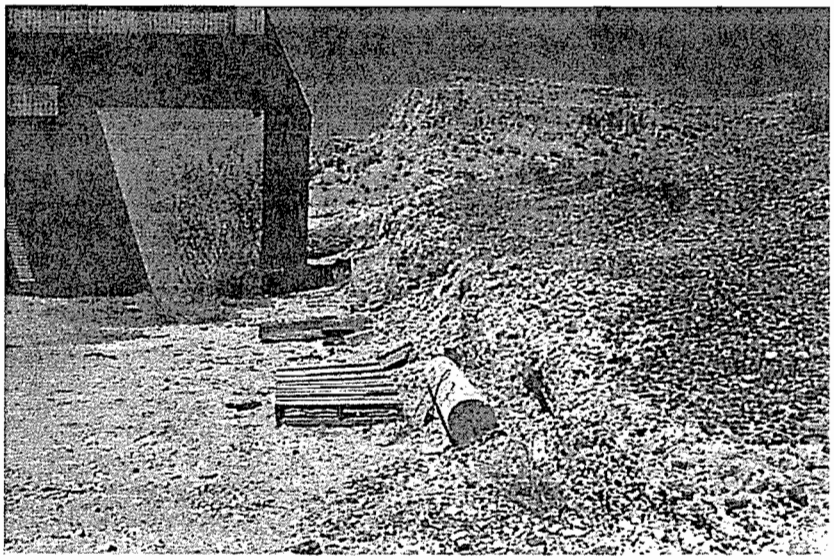
Photo #3 - Taken by E. Seum 8/16/99. Looking at the mill building on the Tron #4 mill site.

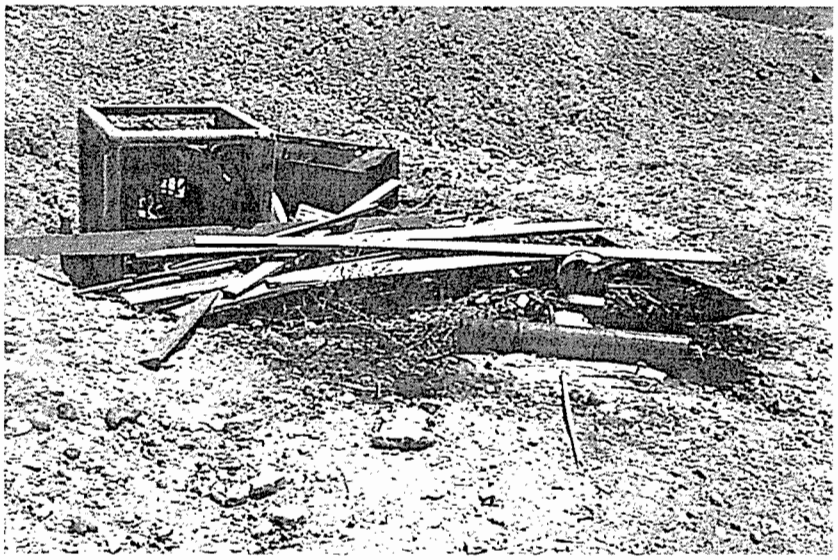
A mobile camper trailer sits on the west side of the mill building (photos 5, 8). The trailer is used by the watch person as living quarters. Minor amounts of trash and a burn pit are located just south of the mill building (photos 4, 10).

Photo #4 - Taken by E. Seum 8/16/99. Looking trash in burn pit east of the mill building on the Tron #4 mill site.

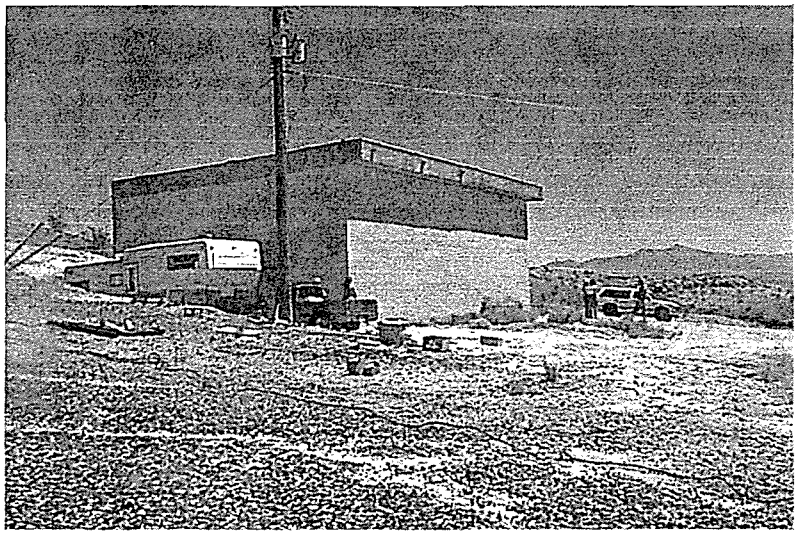
Photo #5 - Taken by E. Seum 8/16/99. Looking at the watchman's trailer on west side of mill building on the Tron #4 mill site.

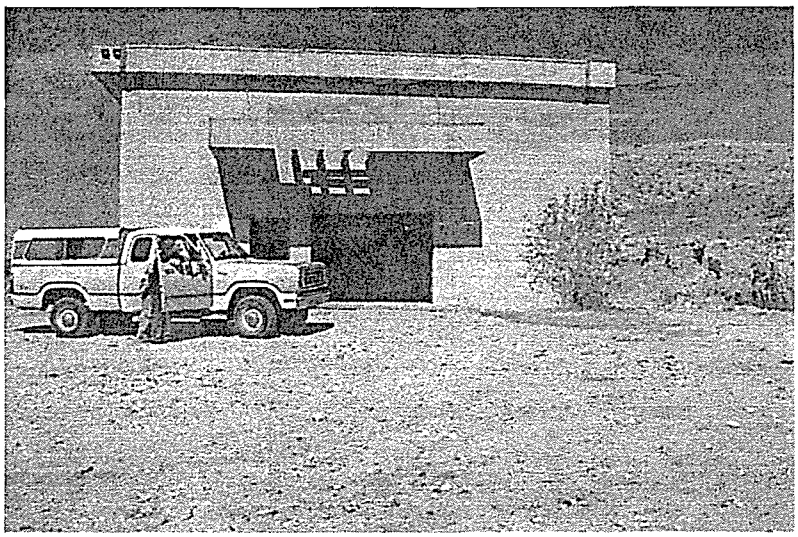
Photo #6 - Taken by E. Seum 9/9/99. Looking at the mill building on the Tron #4 mill site.

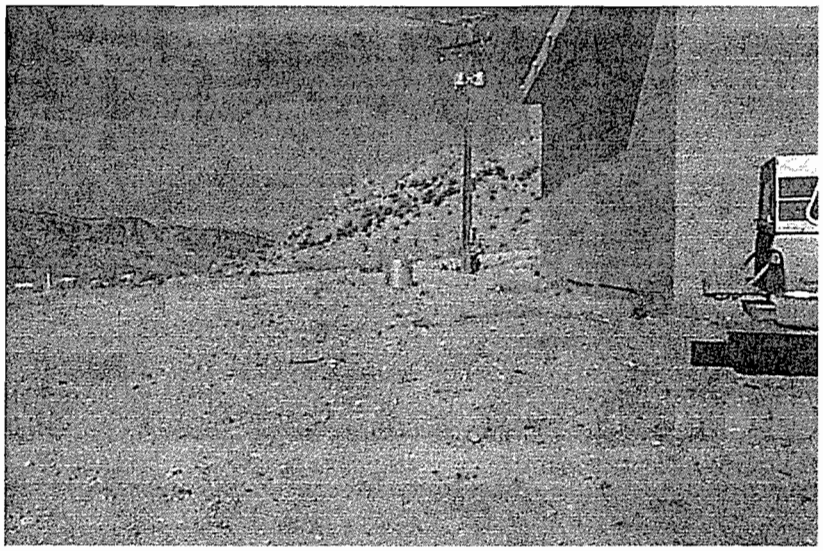
Photo #7 - Taken by E. Seum 9/9/99. Shows area on south side of mill building on the Tron #4 mill site.

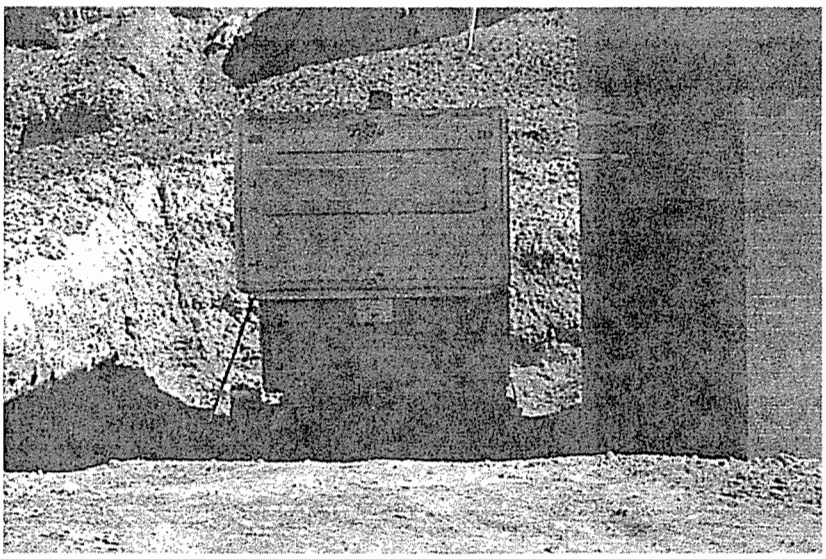
Photo #8 - Taken by E. Seum 9/9/99. Shows watchman's trailer on north side of mill building on the Tron #4 mill site.

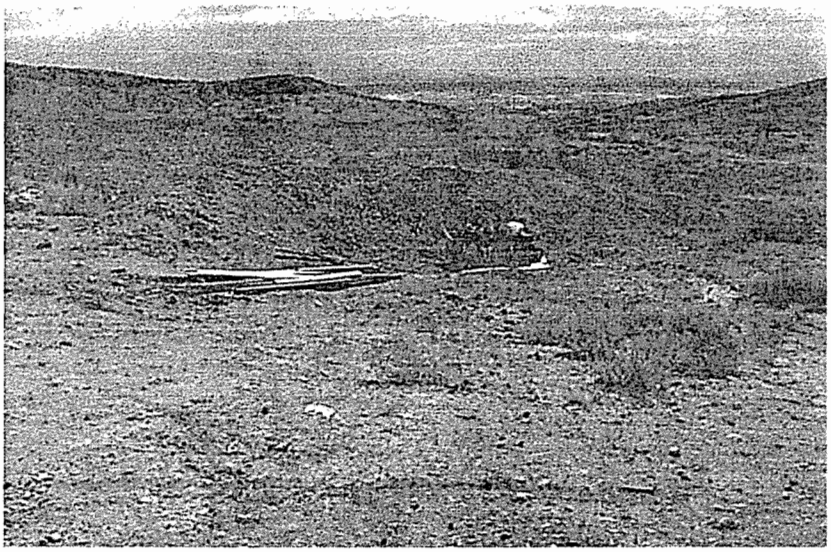
Photo #10 - Taken by E. Seum 9/9/99. Shows trash and burn pit east of mill building on the Tron #4 mill site.

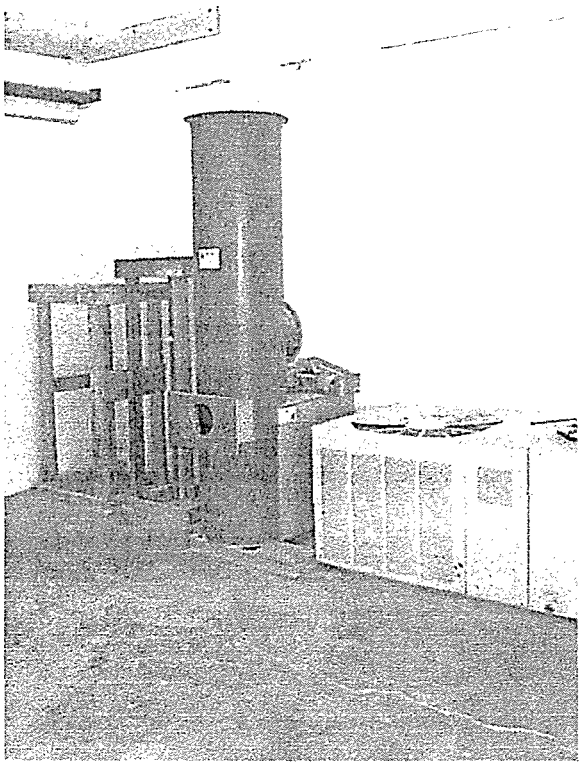
Photo #12 - Taken by E. Seum 9/9/99. Shows cooling unit and equipment inside the mill building on the Tron #4 mill site.

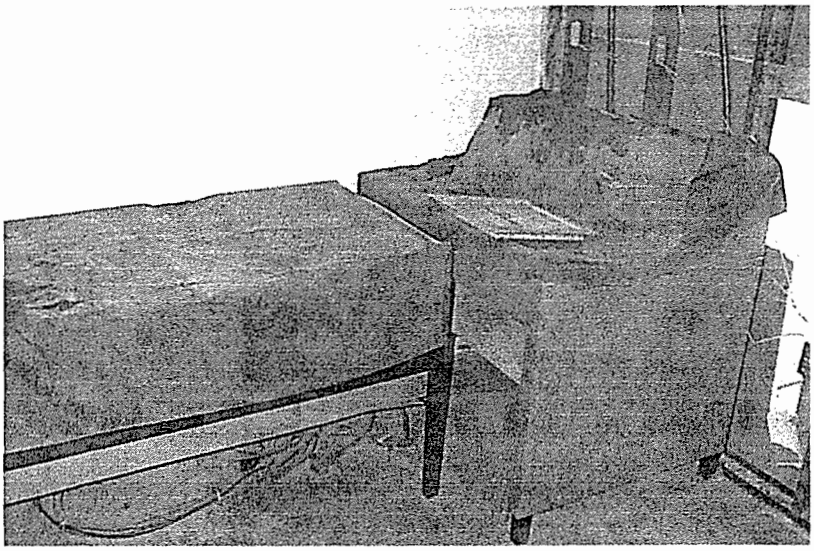
Photo #13 - Taken by E. Seum 9/9/99. Shows water testing equipment under covers in mill building on the Tron #4 mill site.

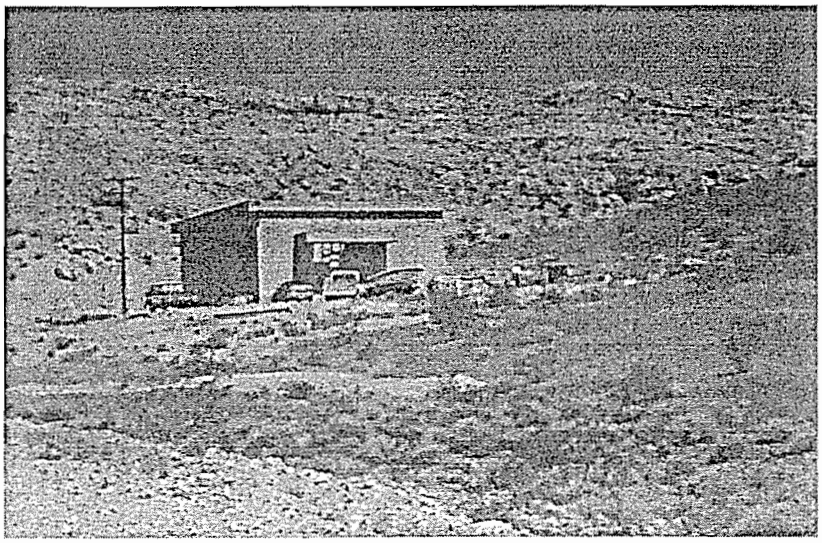
View of the mill site from the southwest looking north.

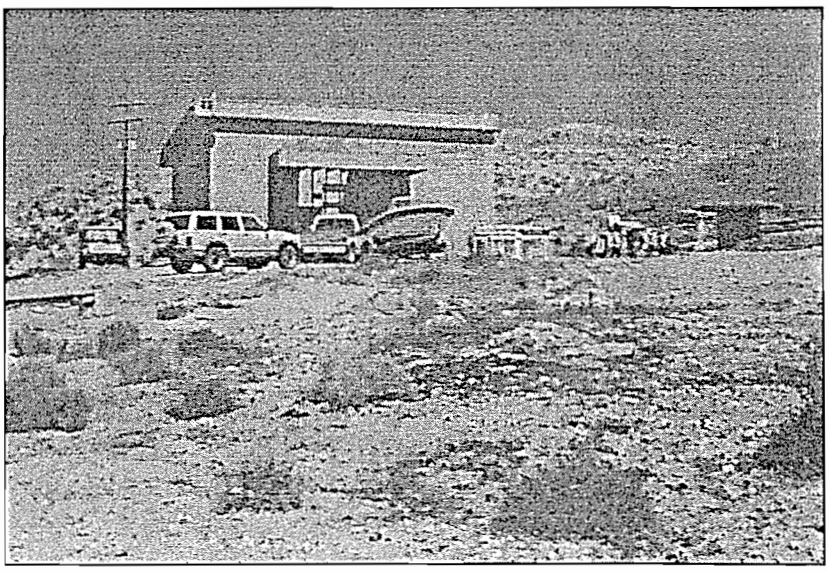
View of the mill site from the southwest looking north.

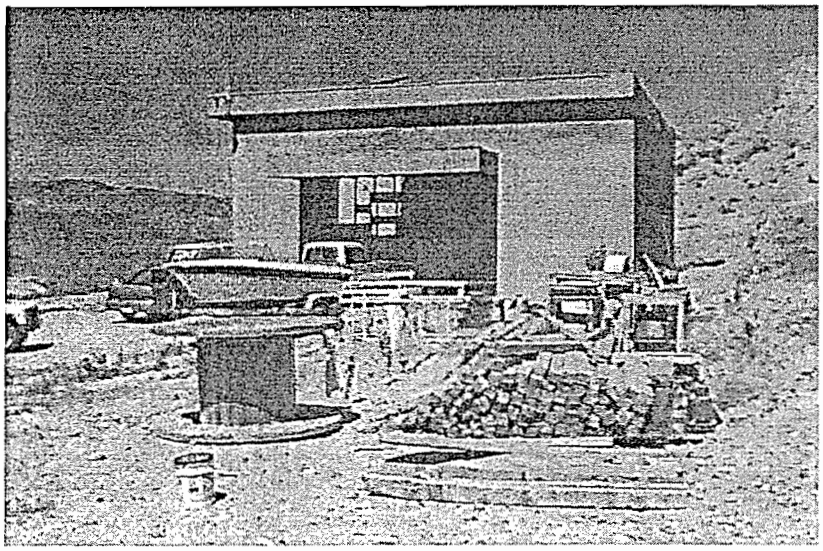
An inspection on May 27, 1998 by Glen Miller found laundry hanging outside of the building. Dogs, a number of vehicles, wood, copper wire and car parts were on site. No mining equipment or material stockpiles were on site.

View of the mill site from the south looking to the north. Note that there are vehicles present, construction materials and no visible mining processing equipment.

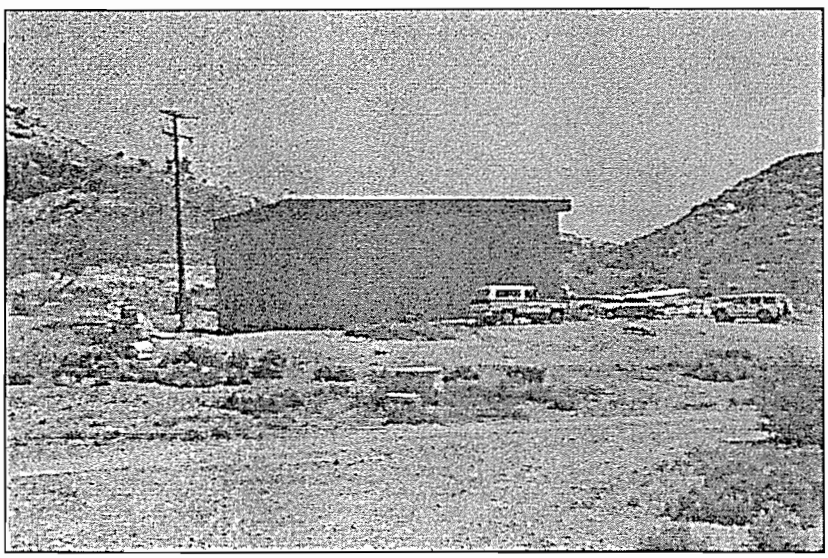
View of the mill site from the north looking to the east.
