# SAFETY OF DAMS

## CONDITION ASSESSMENT PROTOCOLS

### DAM DEFICIENCIES

By Dana Cork

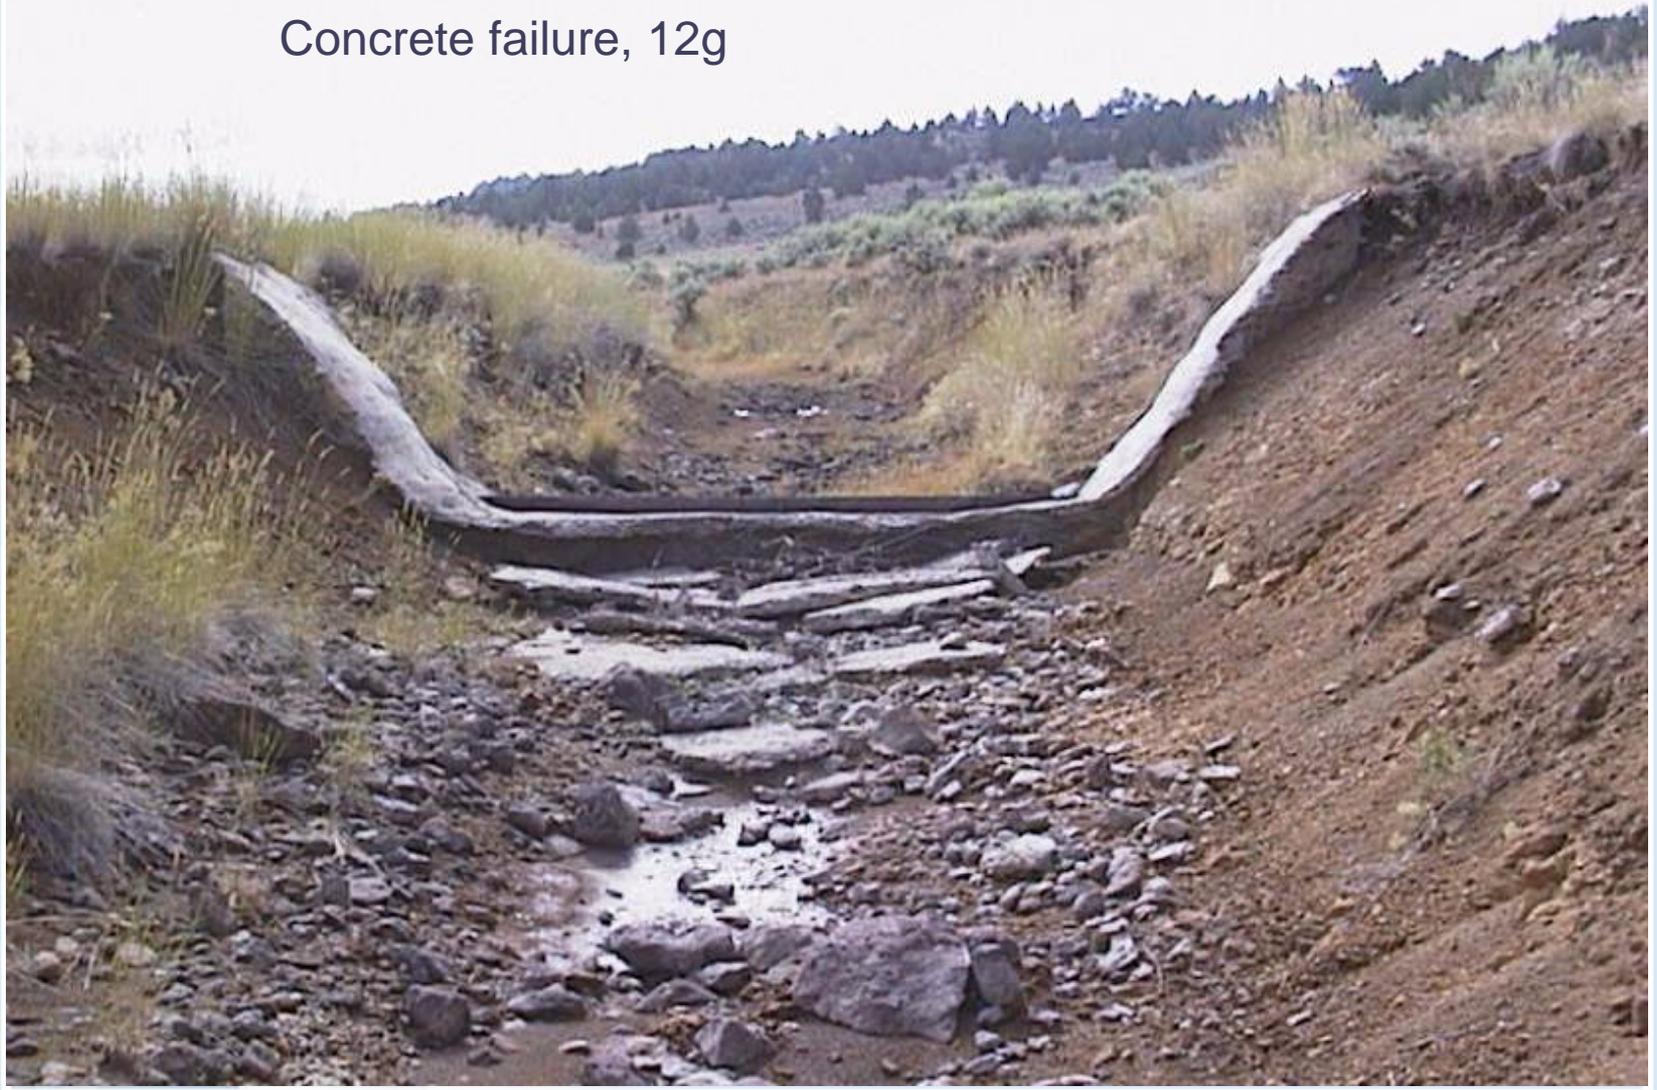
Undermining and erosion at the weir, 12 f (4)

Concrete failure, 12g

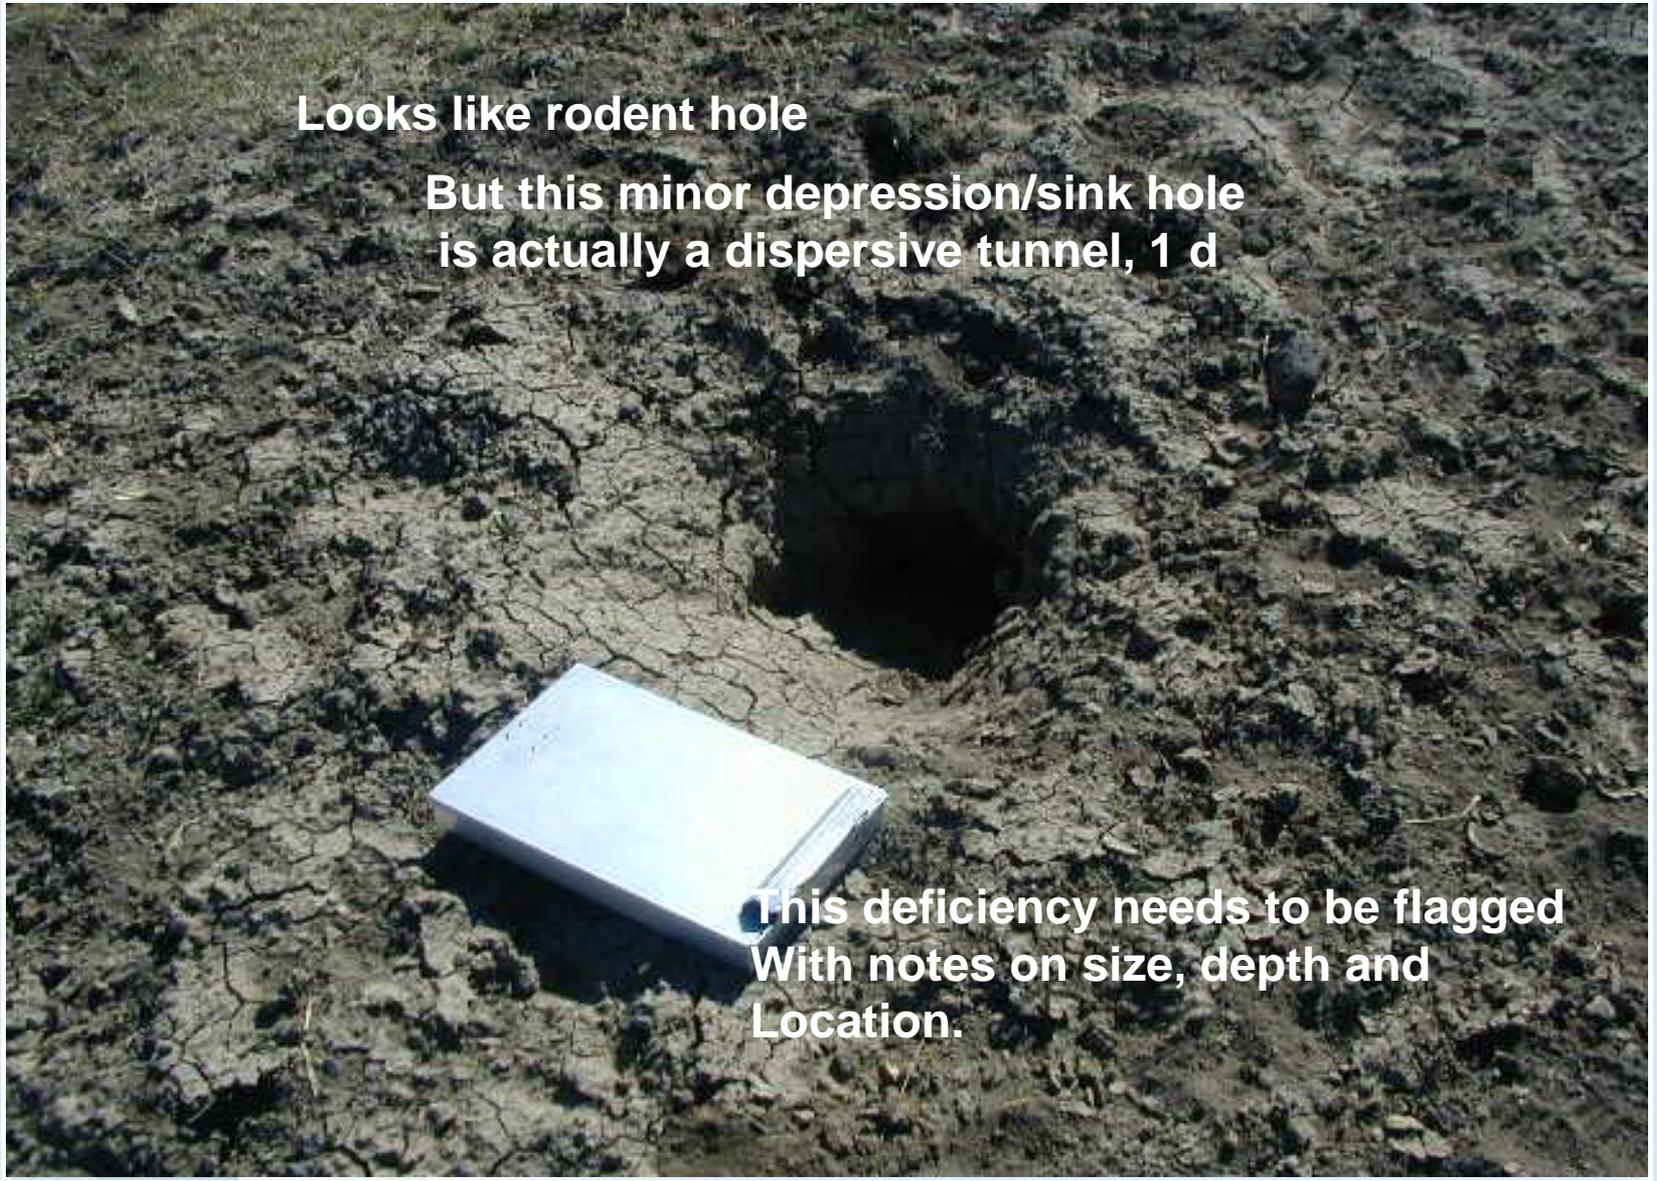
**Looks like rodent hole**

**But this minor depression/sink hole  
is actually a dispersive tunnel, 1 d**

**This deficiency needs to be flagged  
With notes on size, depth and  
Location.**

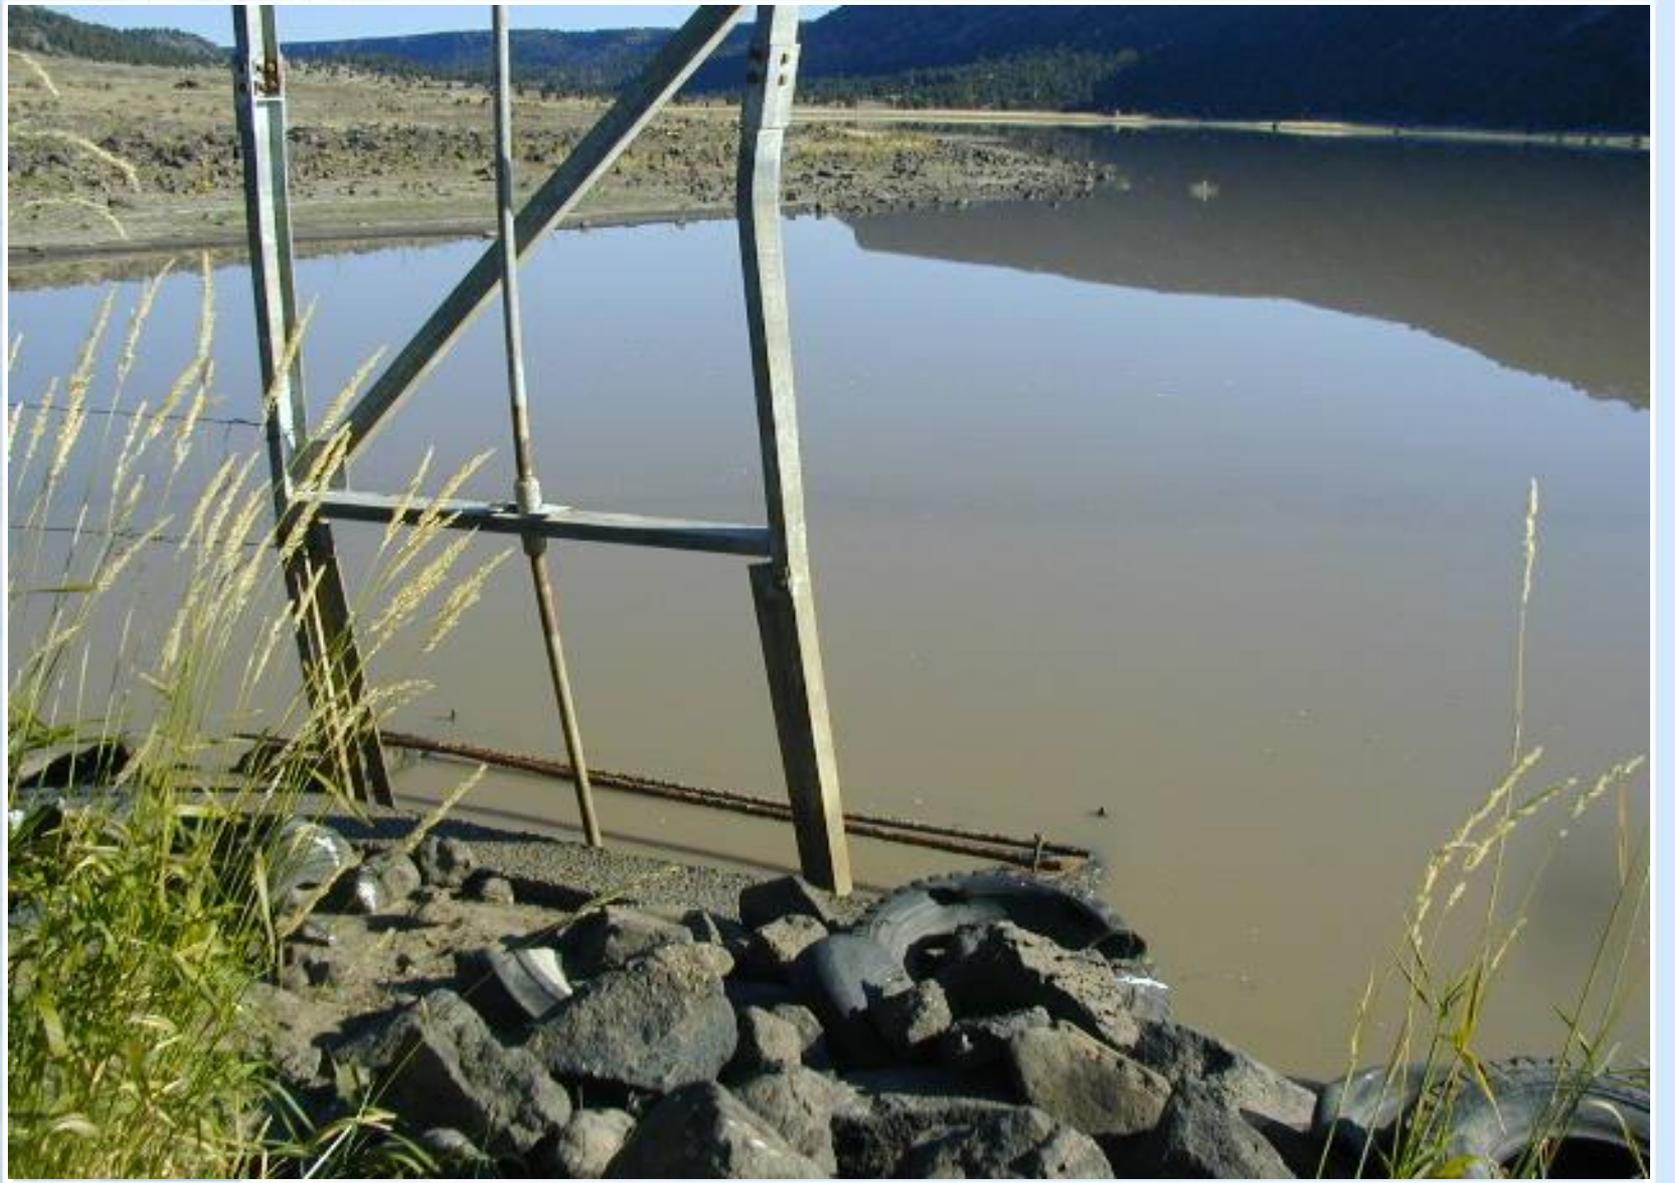
**What is the sediment at the invert?  
Rust or Willamette Valley clay?**

**Minor amount of water present, 9 d (2)  
Is the gate not closed all the way? Or  
Is there seepage at the gate? 10 a (2)**

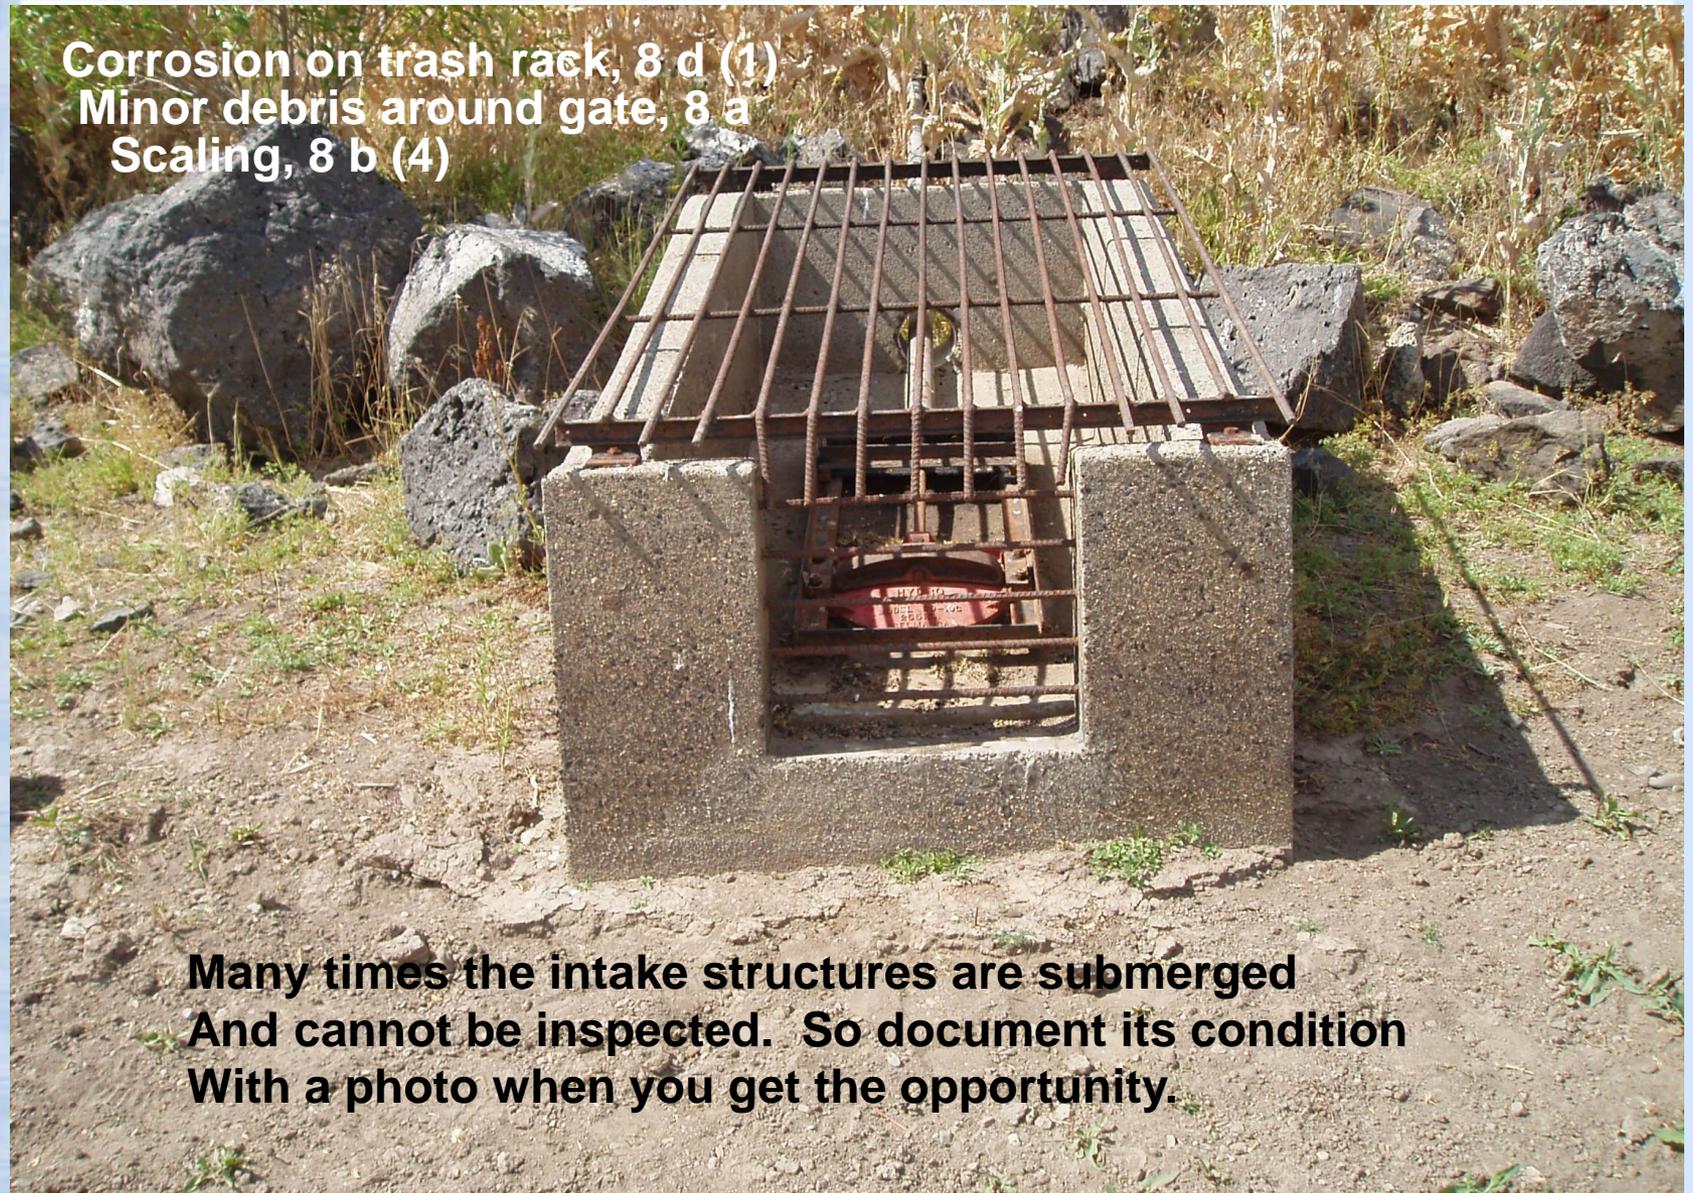
Corrosion on trash rack, 8 d (1)  
Minor debris around gate, 8 a  
Scaling, 8 b (4)

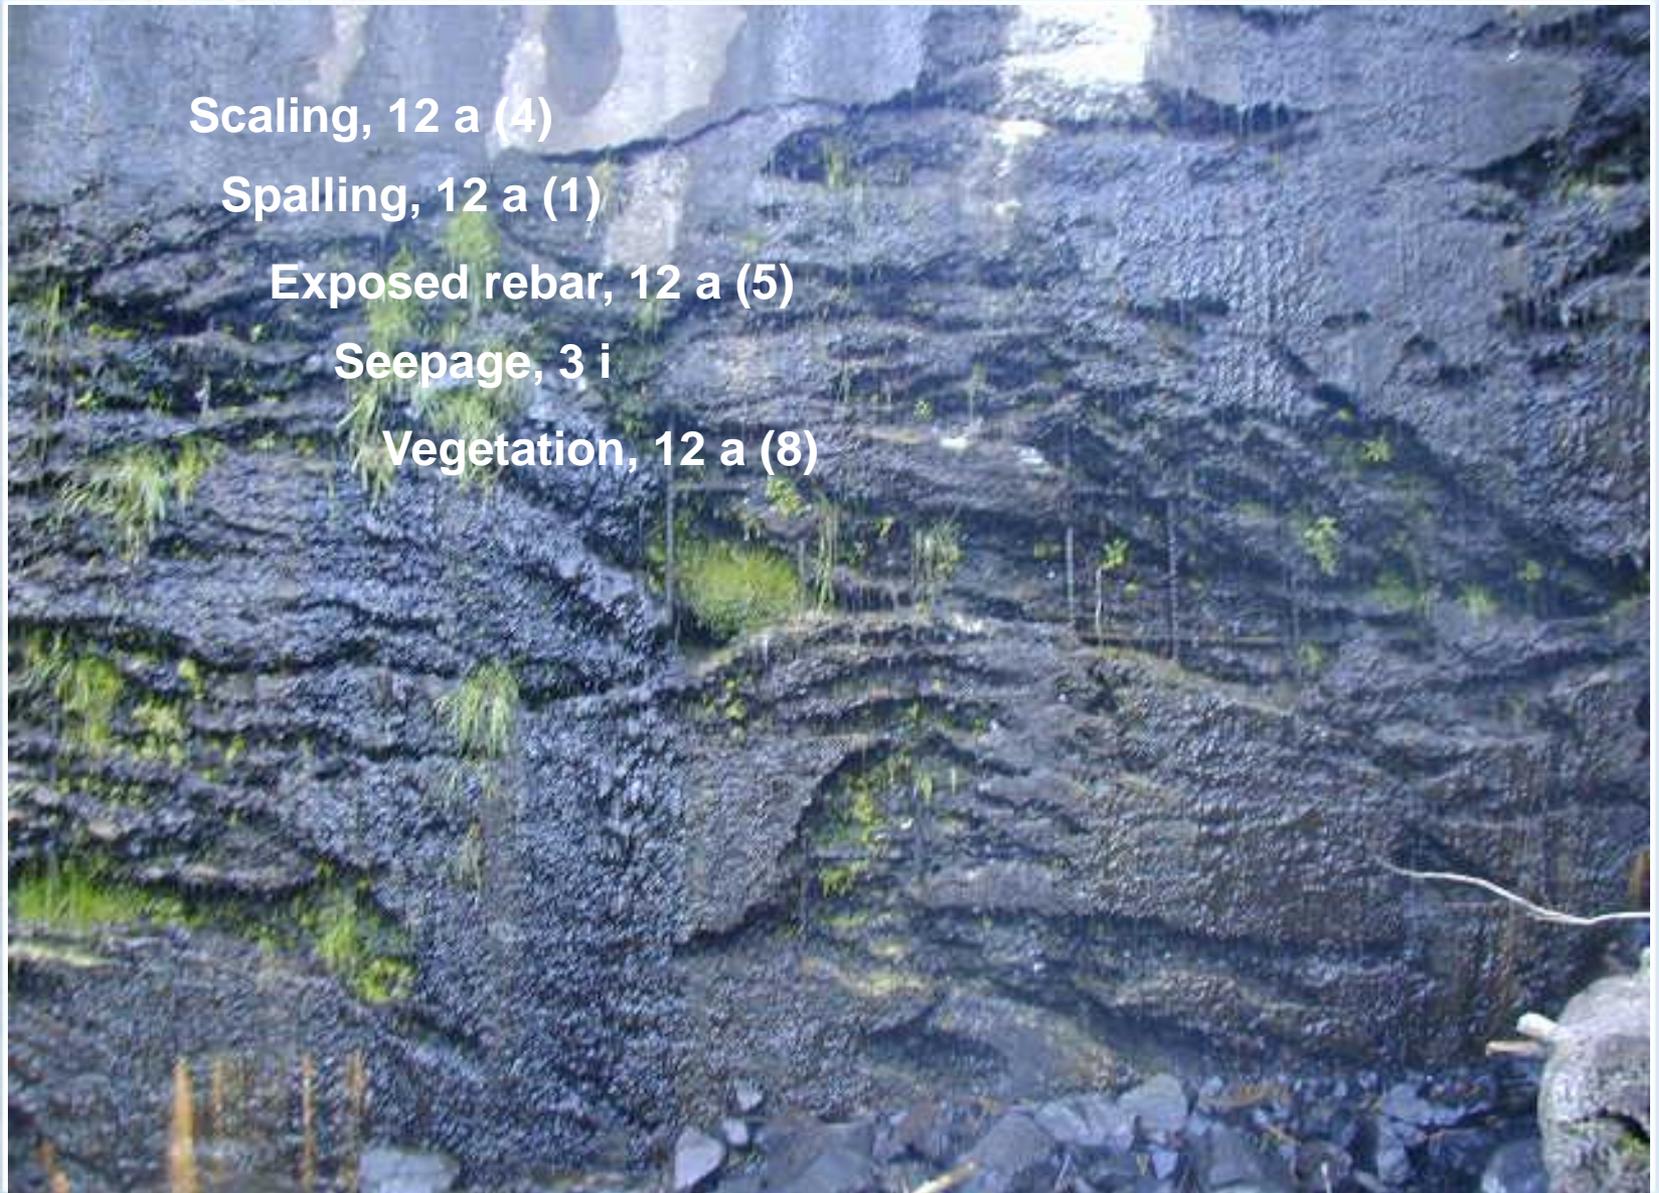
**Scaling, 12 a (4)**

**Spalling, 12 a (1)**

**Exposed rebar, 12 a (5)**

**Seepage, 3 i**

**Vegetation, 12 a (8)**
