UNITED STATES  
DEPARTMENT OF THE INTERIOR  
BUREAU OF LAND MANAGEMENT

**MINERAL REPORT**  
Surface Use Determination  
For The  
ERI Mill Site #1, ERI Mill Site #2, ERI Mill Site #3, ERI #39, ODM #21  
Mill Site and Lode Claims

Clark County, Nevada  
T. 28 S., R. 64 E., MDM  
Section 33, SW¼

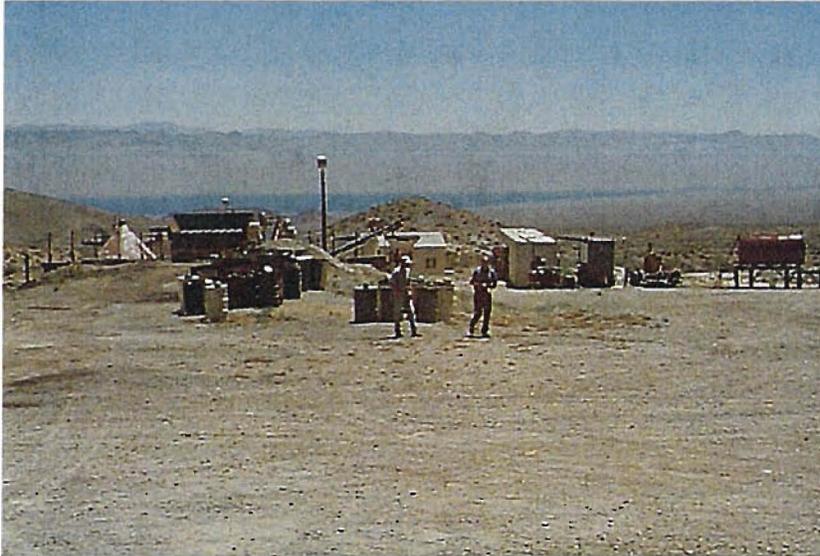
Photo #3 - Taken by J. Mur on 6/25/98. Shows barrels of mineral materials sitting at the start of the processing circuit. Generating plant and fuel storage tank at right. Located on the ERI Mill Site #1 mill site.

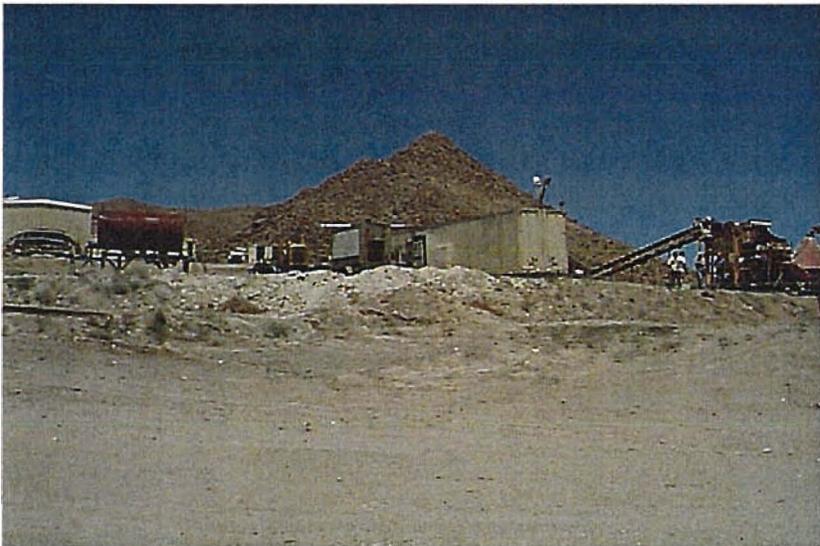
Photo #4 - Taken by J. Mur on 6/25/98. Looking at the generating plant and fuel storage tank from a different direction. Located on the ERI Mill Site #1 mill site.

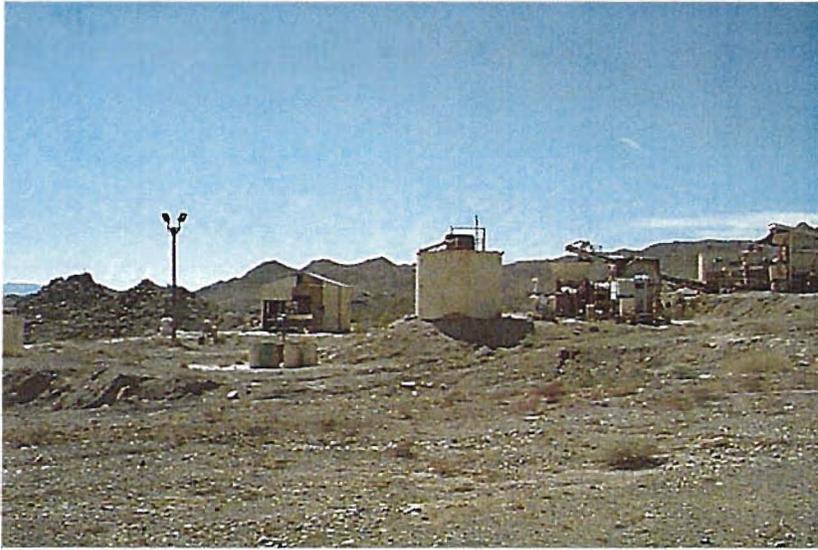
Photo #11 - Taken by J. Mur on 9/27/00. Shows bottom end of circuit, mixing tanks and storage building. Located on the ERI Mill Site #1 mill site.

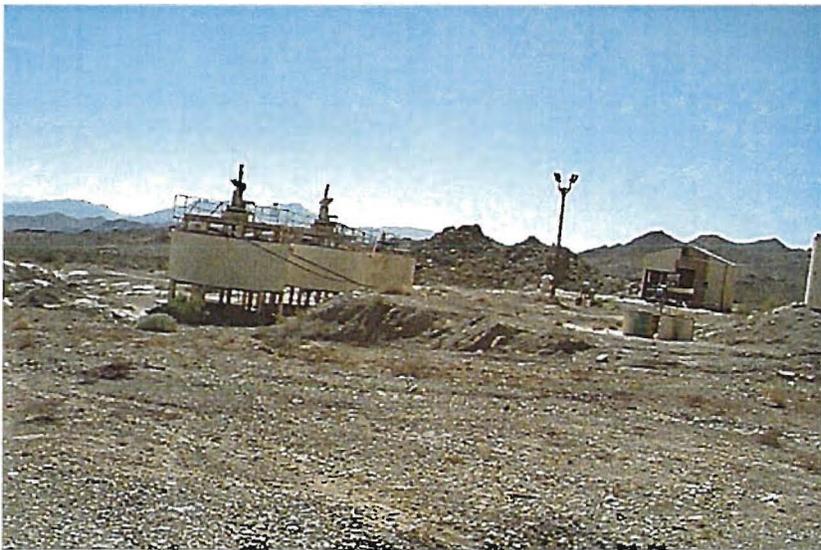
Photo #12 - Taken by J. Mur on 9/27/00. Shows lower set of mixing tanks. Located on the ERI Mill Site #1 mill site.

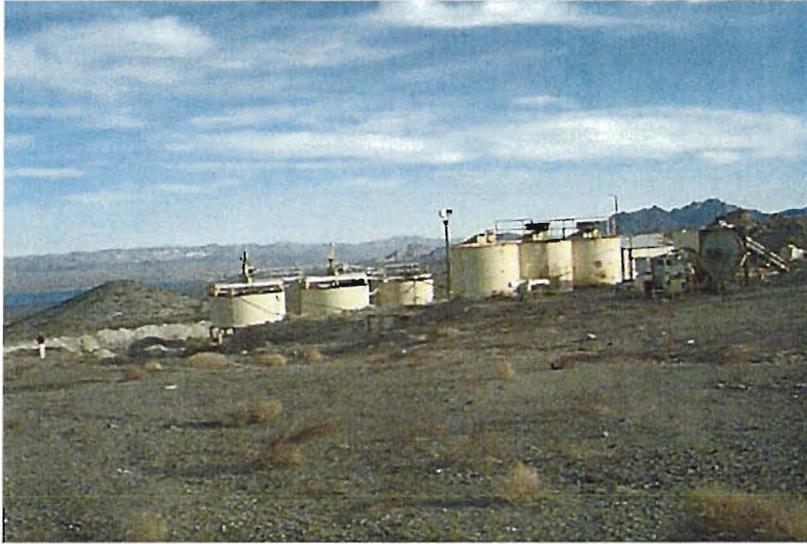
Photo #15 - Taken by J. Mur on 10/30/00. Another view of the mixing tanks. Located on the ERI Mill Site #1 mill site.

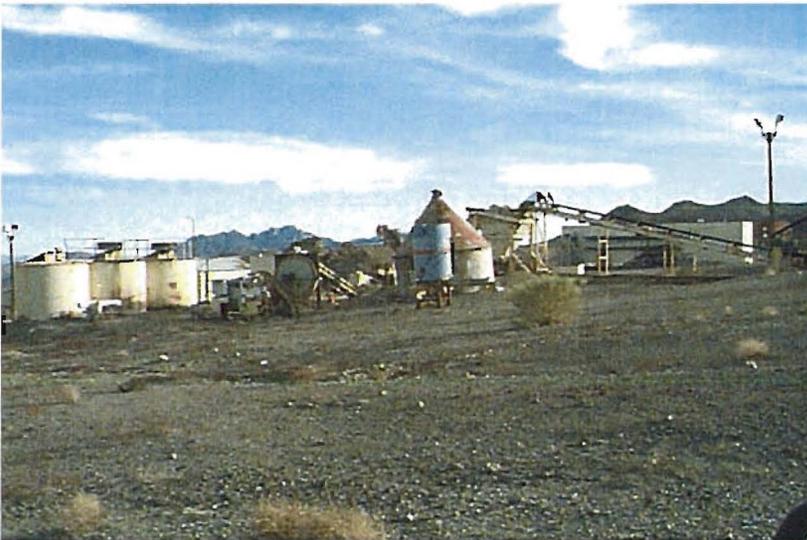
Photo #16 - Taken by J. Mur on 10/30/00. Shows part of processing equipment. Located on the ERI Mill Site #1 mill site.

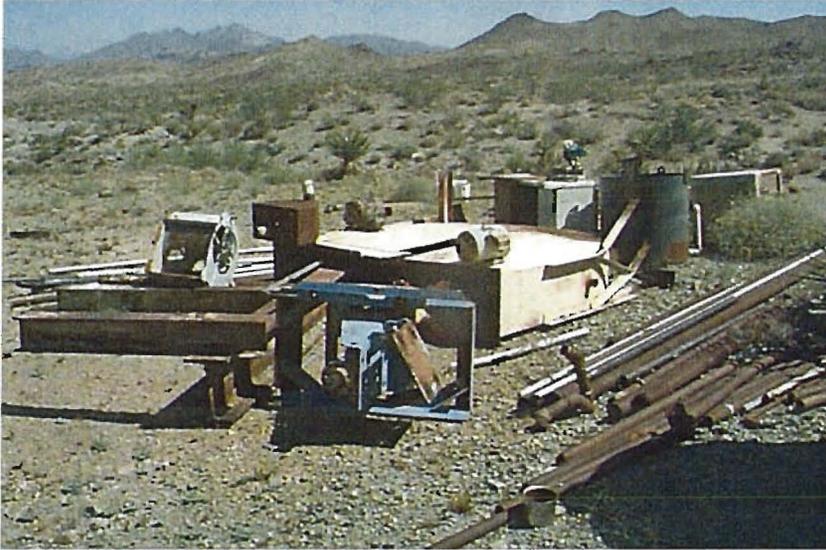
Photo #19 - Taken by J. Mur on 5/30/01. Shows parts stored on the ERI Mill Site #2 mill site.

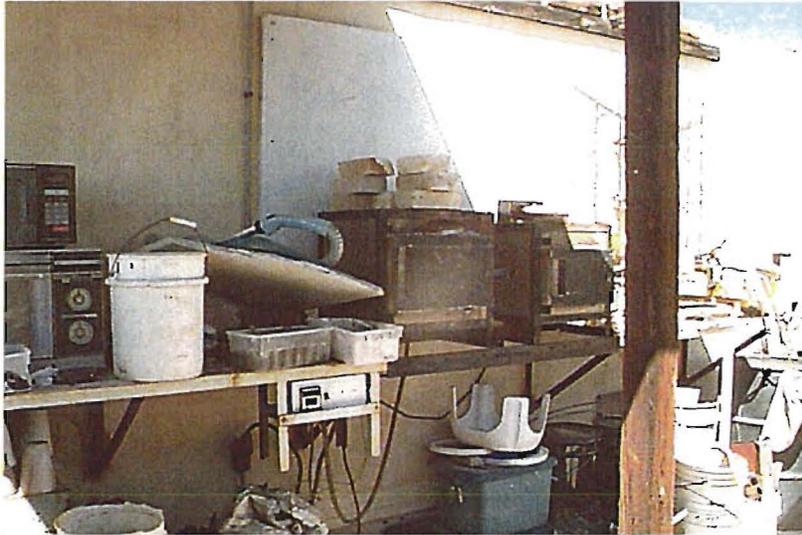
Photo #37 - Taken by E. Seum on 7/11/01. Shows furnaces outside the lab on the ERI Mill Site #2 mill site. See photos 13, 17 also.

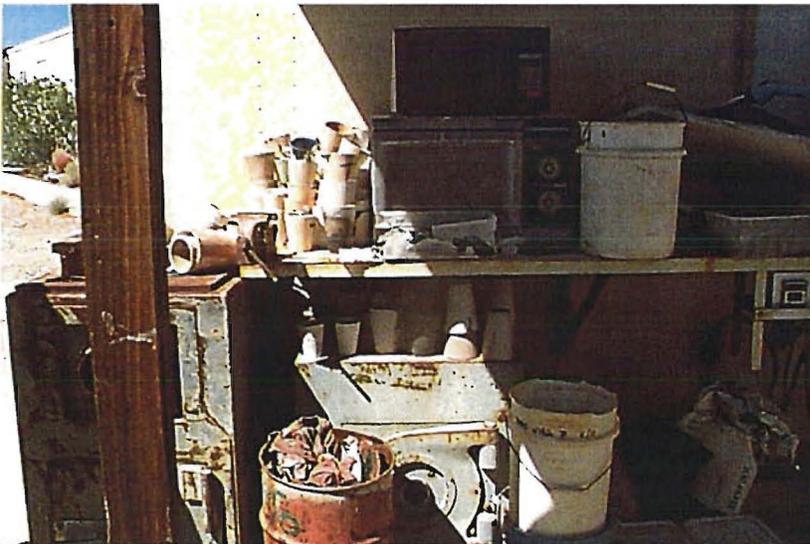
Photo #38 - Taken by E. Seum on 7/11/01. Shows more items, to the left of above picture, stored on the ERI Mill Site #2 mill site.

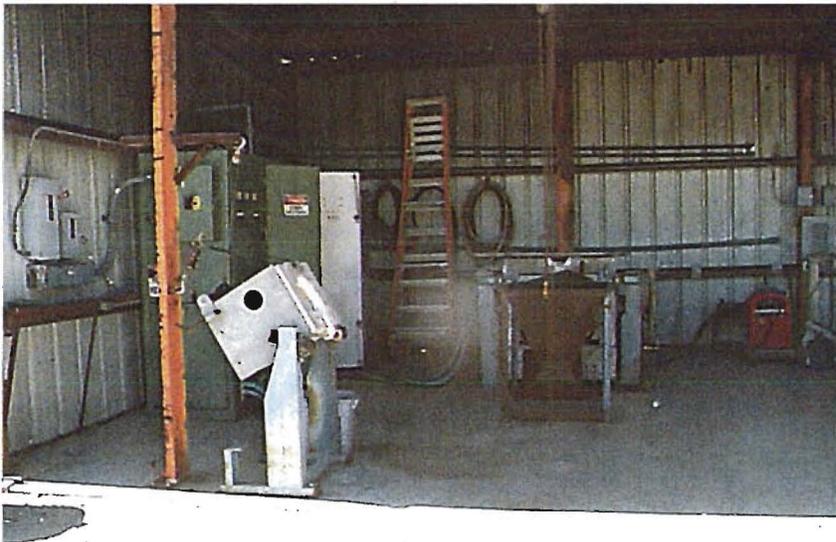
Photo #44 - Taken by E. Seum on 7/11/01. Shows furnaces and electric panels inside shop area on the ERI Mill Site #1 mill site.

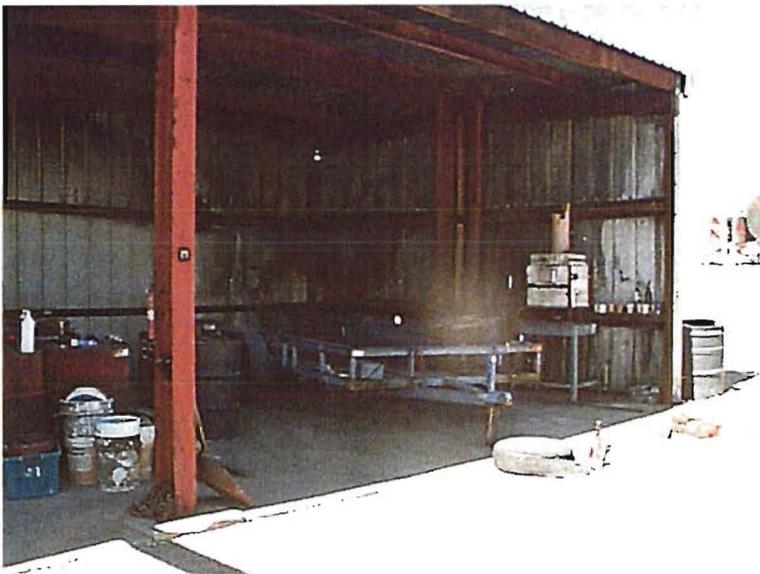
Photo #46 - Taken by E. Seum on 7/11/01. Shows furnace and trailer inside shop area on the ERI Mill Site #1 mill site.

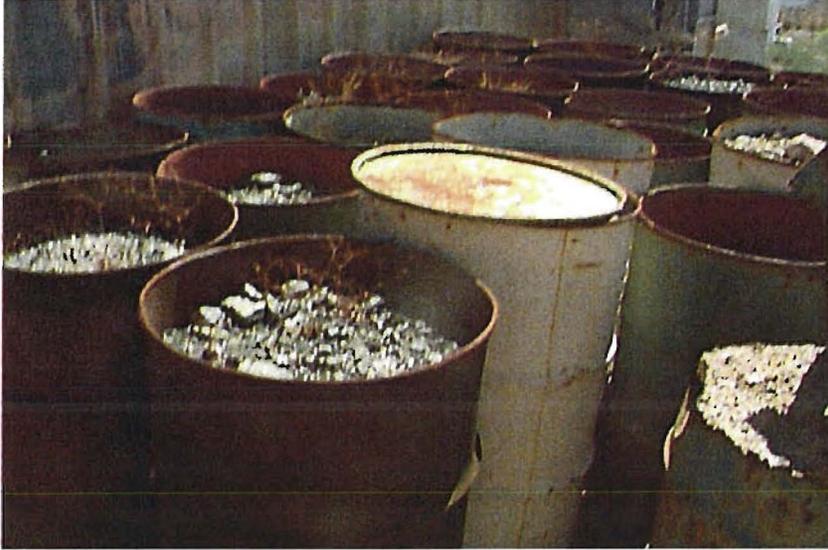
Photo #47 - Taken by E. Seum on 7/11/01. Shows barrels of mineral materials adjacent to the shop. On the ERI Mill Site #1 mill site.

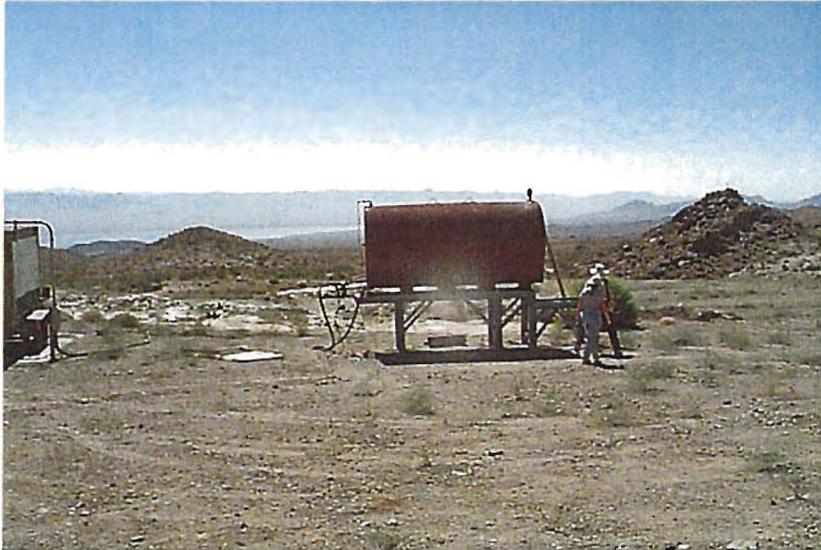
Photo #49 - Taken by E. Seum on 7/11/01. Shows fuel tank for generator in above photo. On the ERI Mill Site #1 mill site.

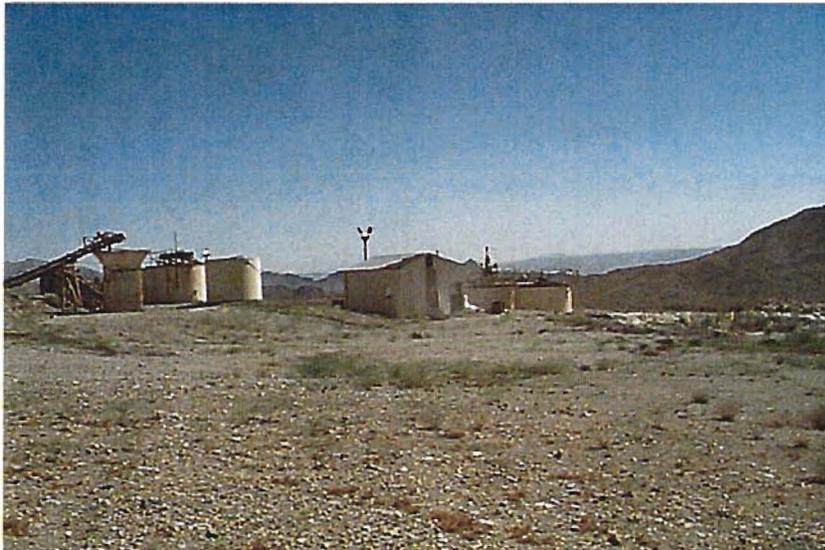
Photo #50 - Taken by E. Seum on 7/11/01. Shows mixing tanks and storage building on the ERI Mill Site #1 mill site.

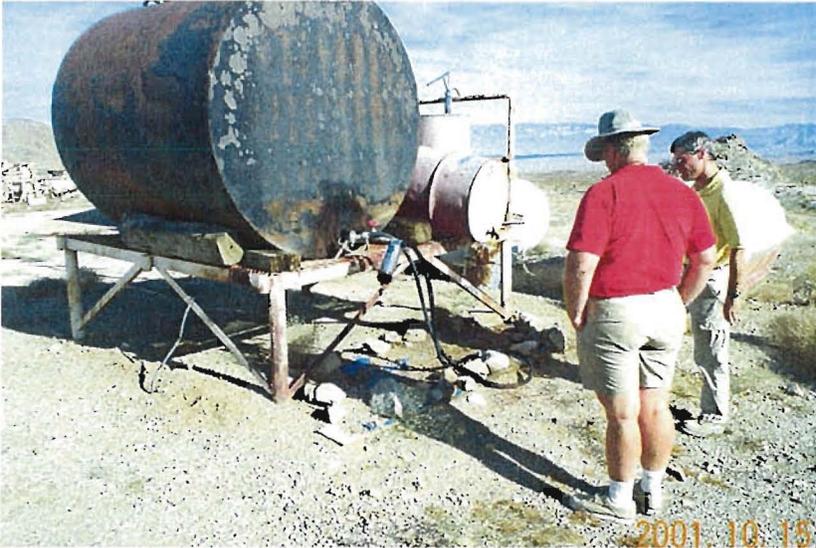
The October 15, 2001 inspection noted that there had been no processing or signs of use since the July 2001 inspection. Problems were noted with hydrocarbon spills and open containers of materials. The inspection of January 10, 2002 found the cable across the road locked. No one was on site during the inspection. The only signs of recent activity involved the attempt to clean-up the hydrocarbon contaminated areas. A few barrels of mineral materials were on site. An unsecured refrigerator sitting outside the lab building contained chemicals, including cyanide.

Photo #73 - Taken by J. Mur on 10/15/01. Shows fuel spillage onto the ground on the ERI Mill Site #1 mill site claim.

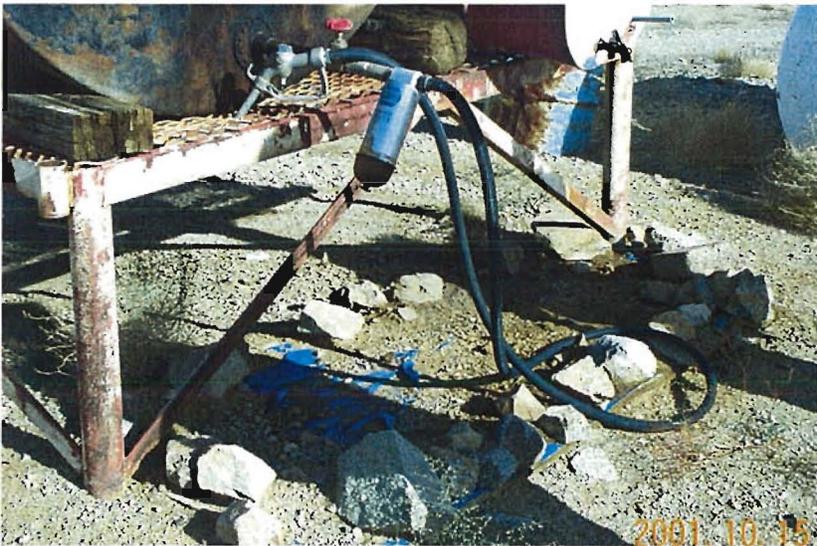
Photo #74 - Taken by J. Mur on 10/15/01. Close-up of above fuel spillage on the ERI Mill Site #1 mill site claim.

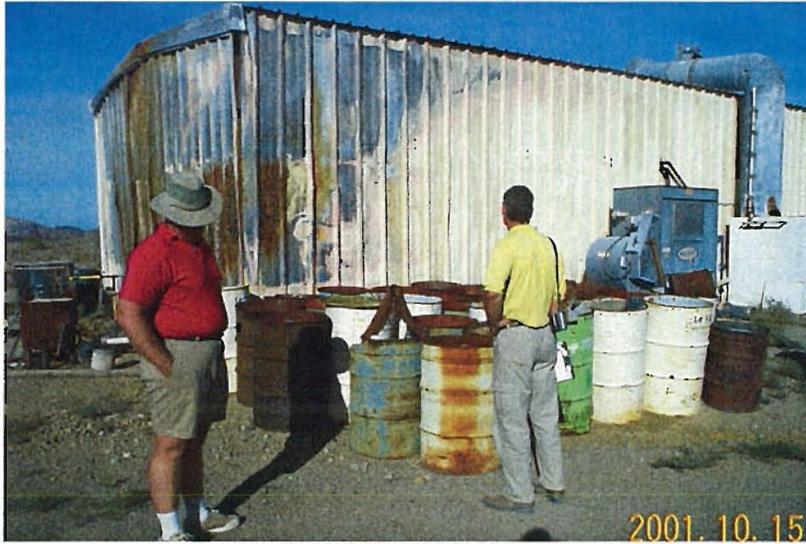
Photo #75 - Taken by J. Mur on 10/15/01. Shows barrels of mineral materials at rear of shop on the ERI Mill Site #1 mill site claim.

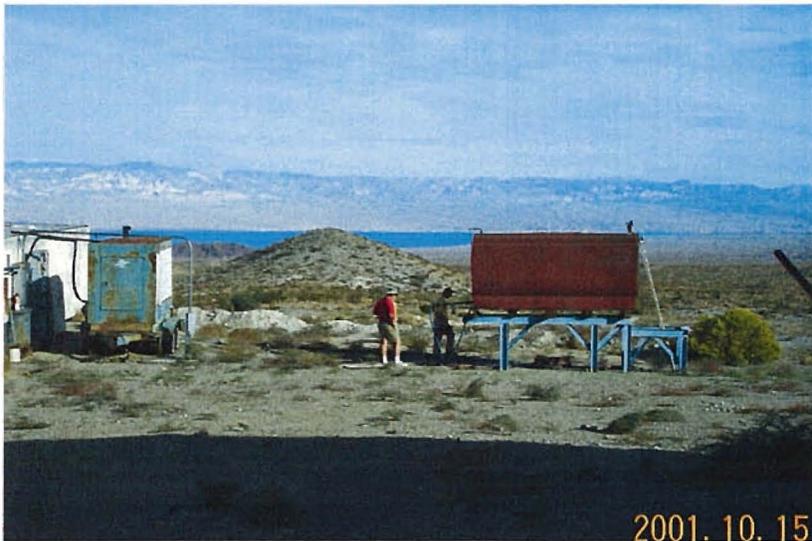
Photo #76 - Taken by J. Mur on 10/15/01. Shows generator and fuel storage tank on the ERI Mill Site #1 mill site claim.

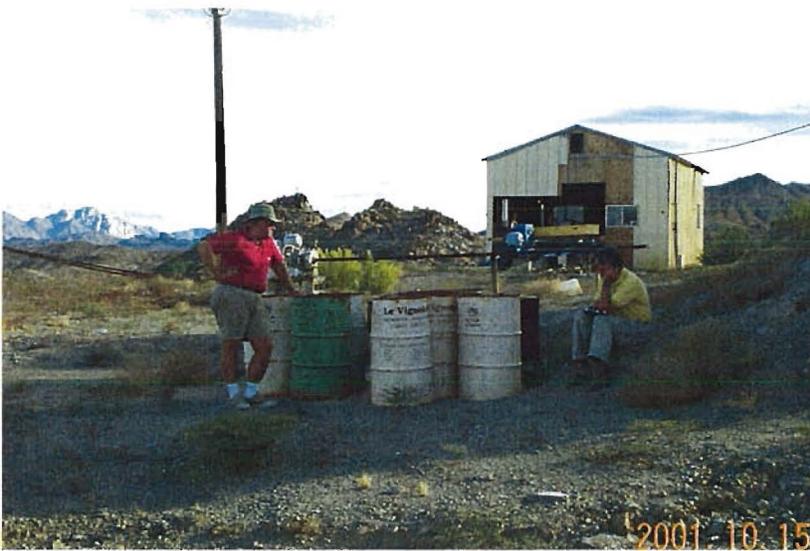
Photo #78 - Taken by J. Mur on 10/15/01. Shows barrels of mineral materials below circuit on the ERI Mill Site #1 mill site claim.

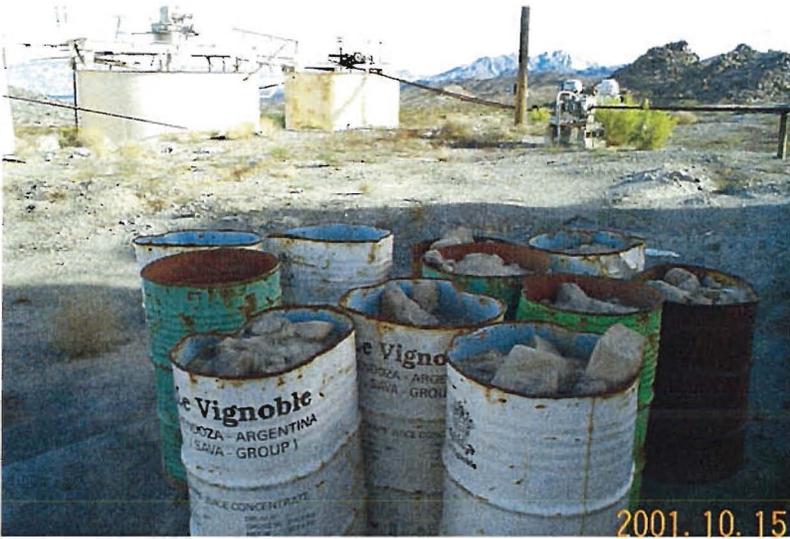
Photo #79 - Taken by J. Mur on 10/15/01. Close-up of barrels in above picture on the ERI Mill Site #1 mill site claim. These are the same barrels in the foreground of photo 14.

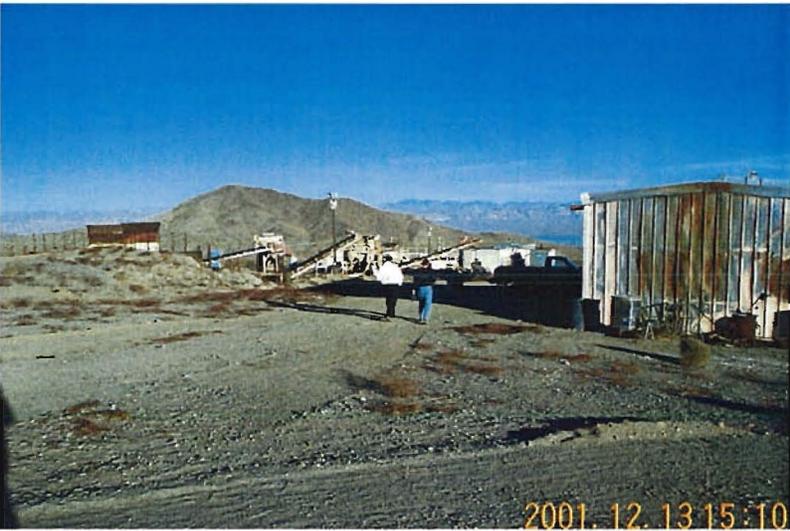
Photo #80 - Taken by J. Mur on 12/13/01. Looking at shop and processing area on the ERI Mill Site #1 mill site claim.

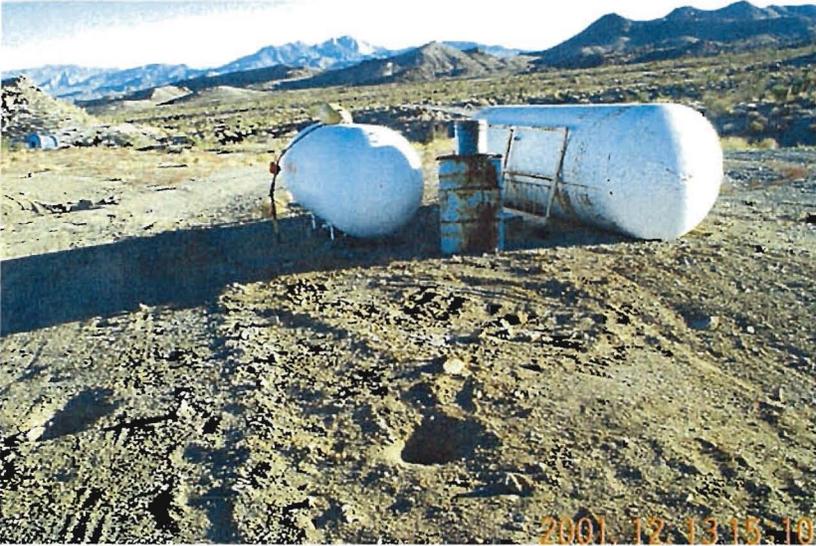
Photo #81 - Taken by J. Mur on 12/13/01. Fuel tanks on the ERI Mill Site #1 mill site claim. Ground in front of tanks has been sampled for hydrocarbon contamination.

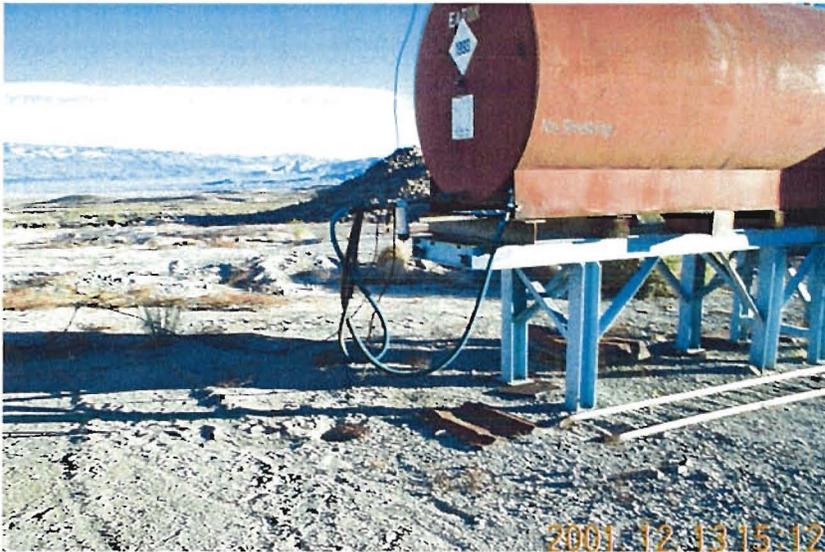
Photo #82- Taken by J. Mur on 12/13/01. Fuel tanks on the ERI Mill Site #1 mill site claim. Ground in front of tanks has been sampled for hydrocarbon contamination.

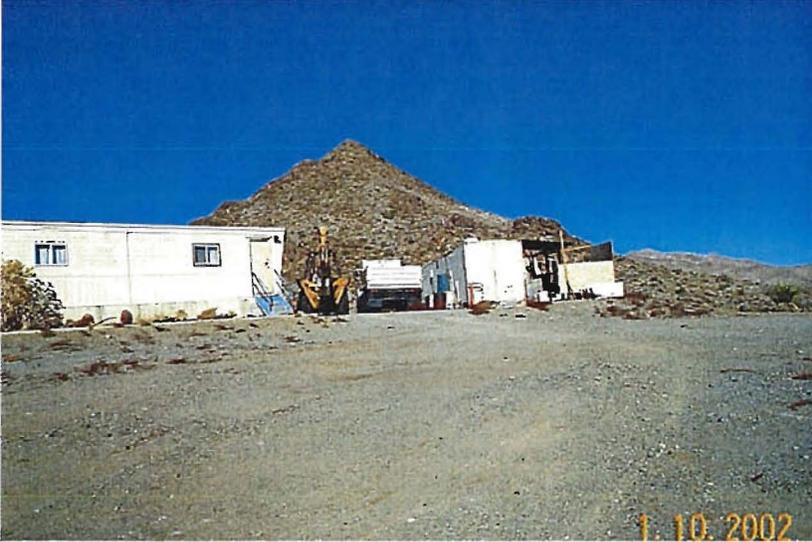
Photo #85 - Taken by E. Seum on 1/10/02. Shows office trailer and lab on the ERI Mill Site #2 mill site claim.

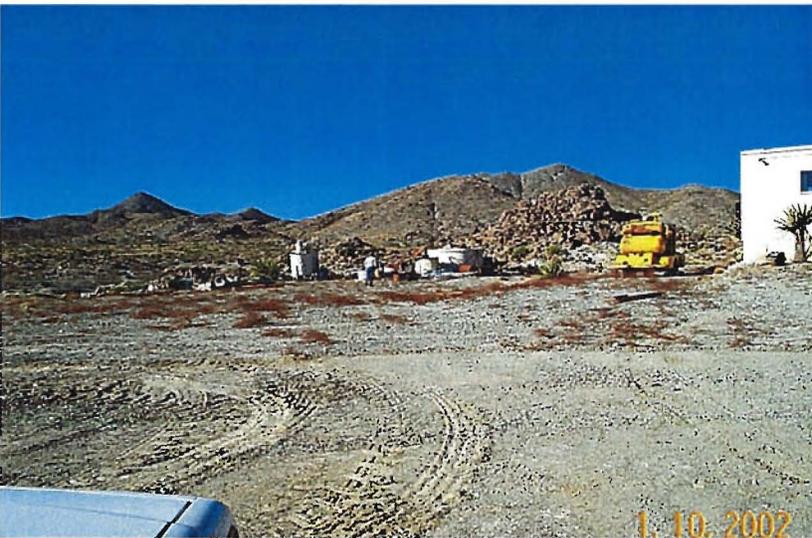
Photo #86 - Taken by E. Seum on 1/10/02. Shows air compressor for underground drilling and other items stored on the ERI Mill Site #2 mill site claim.

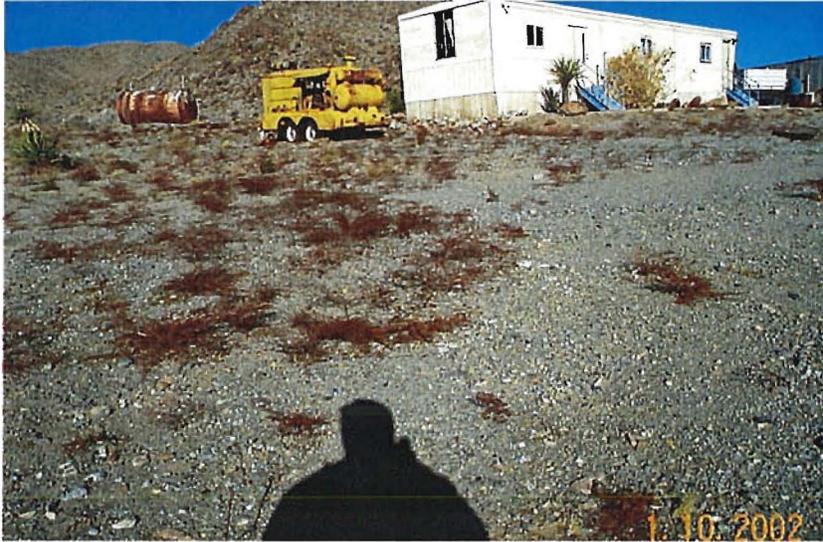
Photo #87 - Taken by E. Seum on 1/10/02. Shows office trailer, air compressor and storage tank on the ERI Mill Site #2 mill site claim.

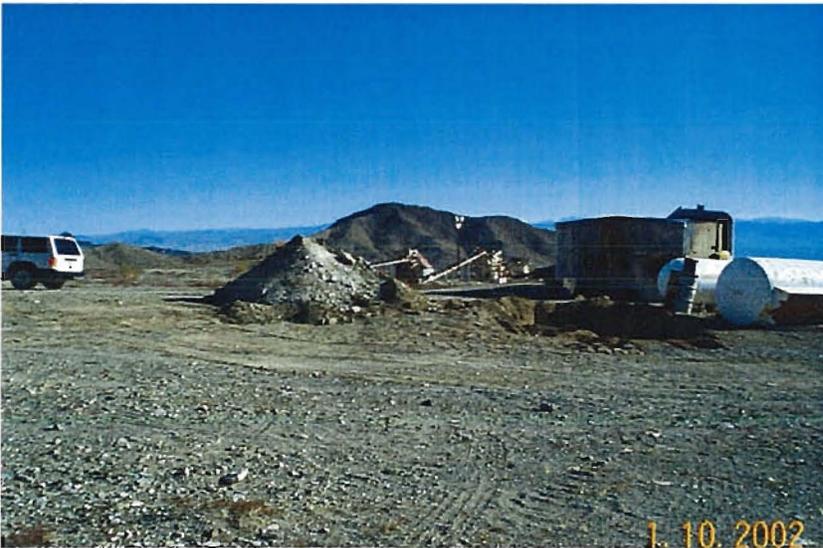
Photo #88 - Taken by E. Seum on 1/10/02. Shows materials excavated to remediate hydrocarbon contamination on the ERI Mill Site #1 mill site claim.

Operations on the site should not degrade surface or ground waters of the State. No hazardous materials or substances were found to be in contact with surface or ground waters during the exam. A well has been used for a water supply to the claims and appears to be properly maintained. Hydrocarbon contamination of the ground has occurred in several areas. However, the operator has, or is in the process of remediating these areas.

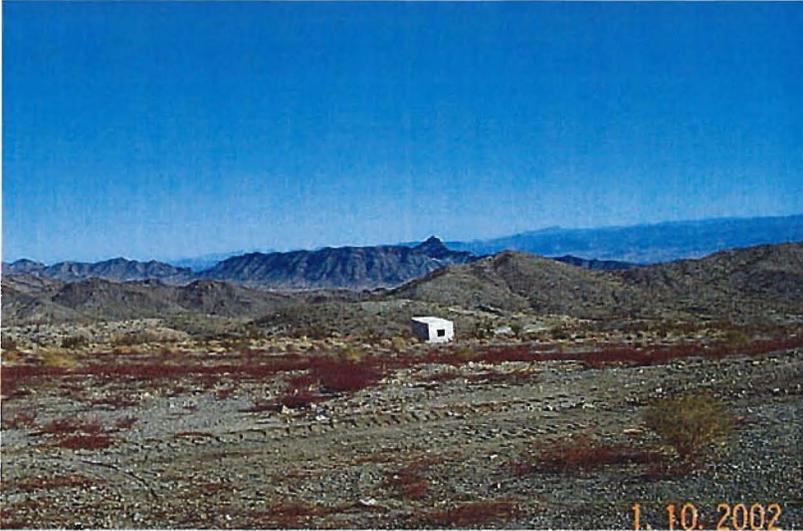
Photo #89 - Taken by E. Seum on 1/10/02. Shows watchman's trailer on the ERI Mill Site #3 mill site claim.

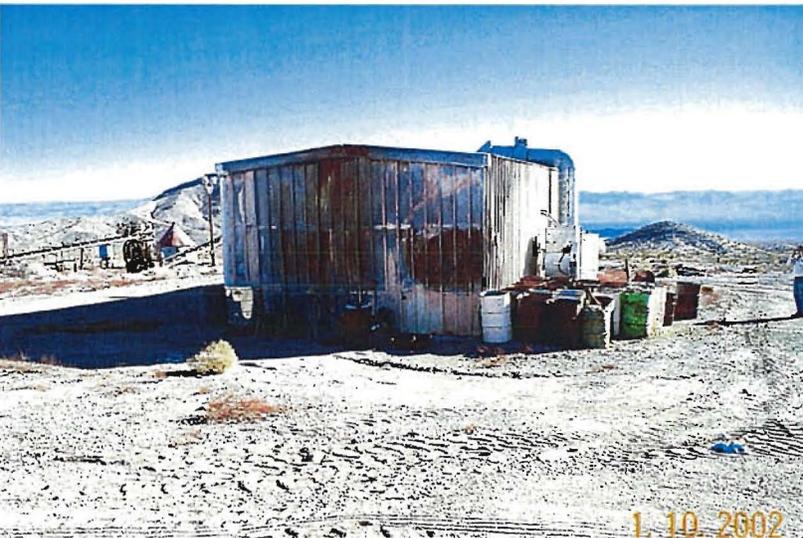
Photo #90 - Taken by E. Seum on 1/10/02. Shows barrels of mineral materials stored behind shop on the ERI Mill Site #1 mill site claim.

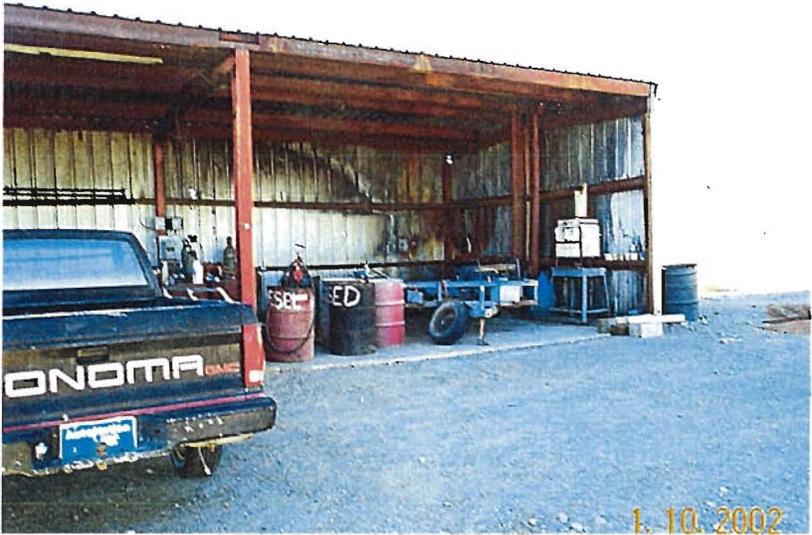
Photo #91 - Taken by E. Seum on 1/10/02. Looking inside the shop on the ERI Mill Site #1 mill site claim.

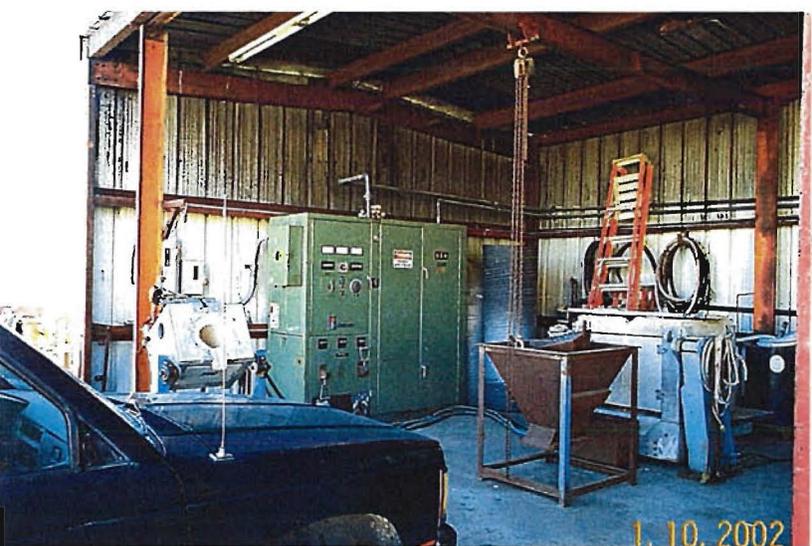
Photo #92 - Taken by E. Seum on 1/10/02. Looking inside the shop on the ERI Mill Site #1 mill site claim. Shows electric panel and furnaces.

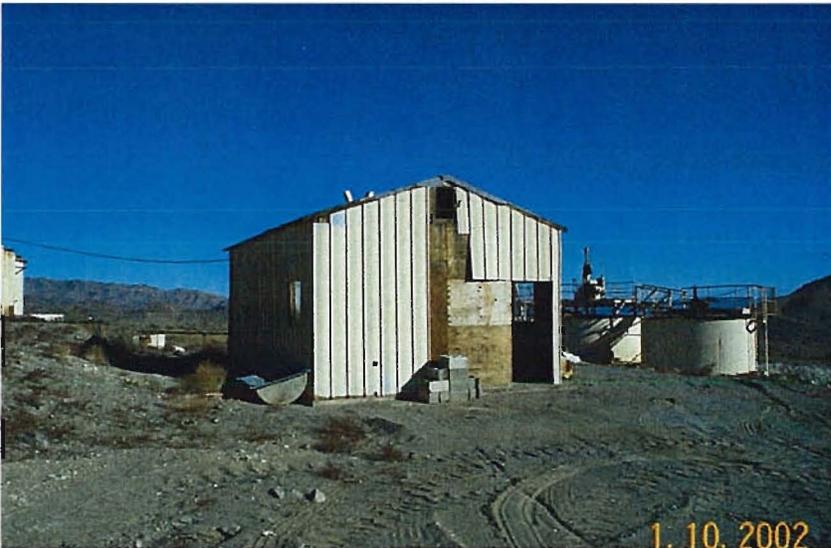
Photo #96 - Taken by E. Seum on 1/10/02. Looking at rear of storage building on the ERI Mill Site #1 mill site claim.
