**Visual Resources**

**Alternative B:** BLM would develop a parking area adjacent to Dance Hall Rock Historic Site on the east side of the Hole in the Rock Road. Development would occur in a previously disturbed area and include the following:

VISUAL CONTRAST RATING WORKSHEET

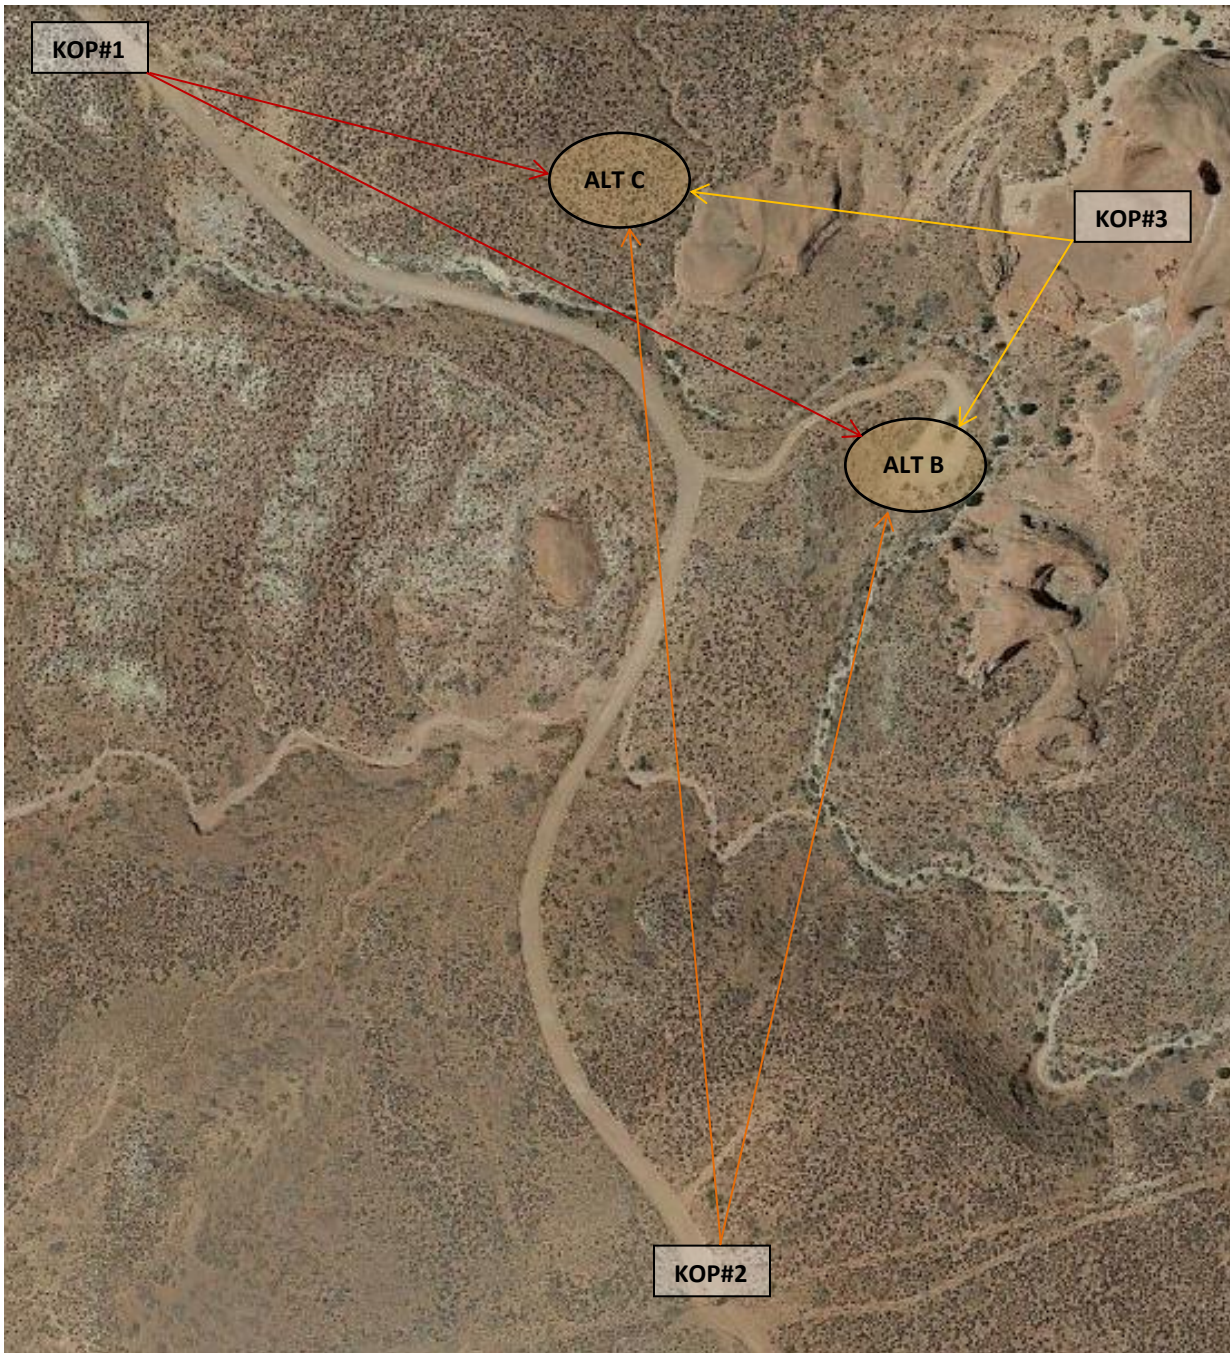
*Comparison of Visibility by Alternative from Key Observation Points*

<b>KOP#1</b>	<b>KOP#2</b>	<b>KOP#3</b>
<b>Alt A: No Action</b>	Not Visible	Minimally Visible	Fully Visible
<b>Alt B: Existing Disturbance Area</b>	Not Visible	Partially Visible	Fully Visible
<b>Alt C: New Disturbance Area</b>	Partially Visible	Fully Visible	Not Visible

KOP #1 was along Hole in the Rock Road looking south toward the sites; KOP#2 was also along Hole in the Rock Road but looking north toward the sites; and KOP#3 was on the floor of Dance Hall Rock looking outward across the landscape. The visibility of the alternatives from these KOPs is detailed in the table below.

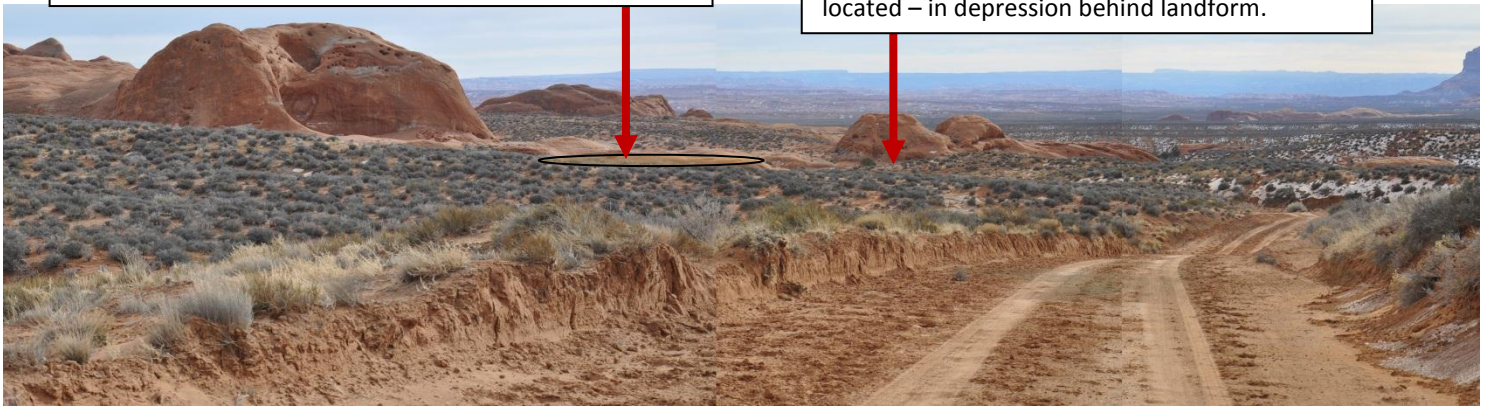
*KOP #1 – looking south toward Dance Hall Rock.*

**ALT C:** Area where site improvements would be located – on the backside of this gently rolling sand dune.

**ALT B:** Area where site improvements would be located – in depression behind landform.

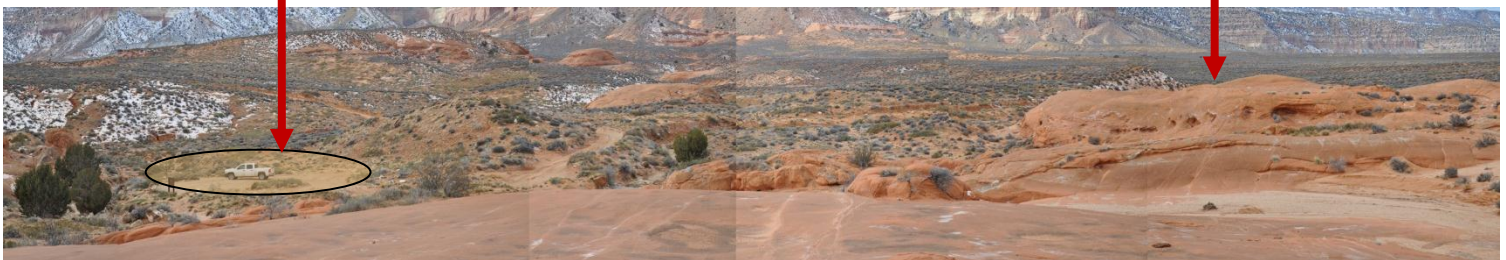
*KOP #3 – looking outward from floor of Dance Hall Rock.*

**ALT B:** Area where site improvements would be located.

**ALT C:** Area where site improvements would be located – behind this sandstone feature.

directions. The third KOP, on the Dance Hall Rock amphitheater floor looking outward, was selected per feedback from public scoping from those concerned about the preservation of the views from inside the historic site outward.

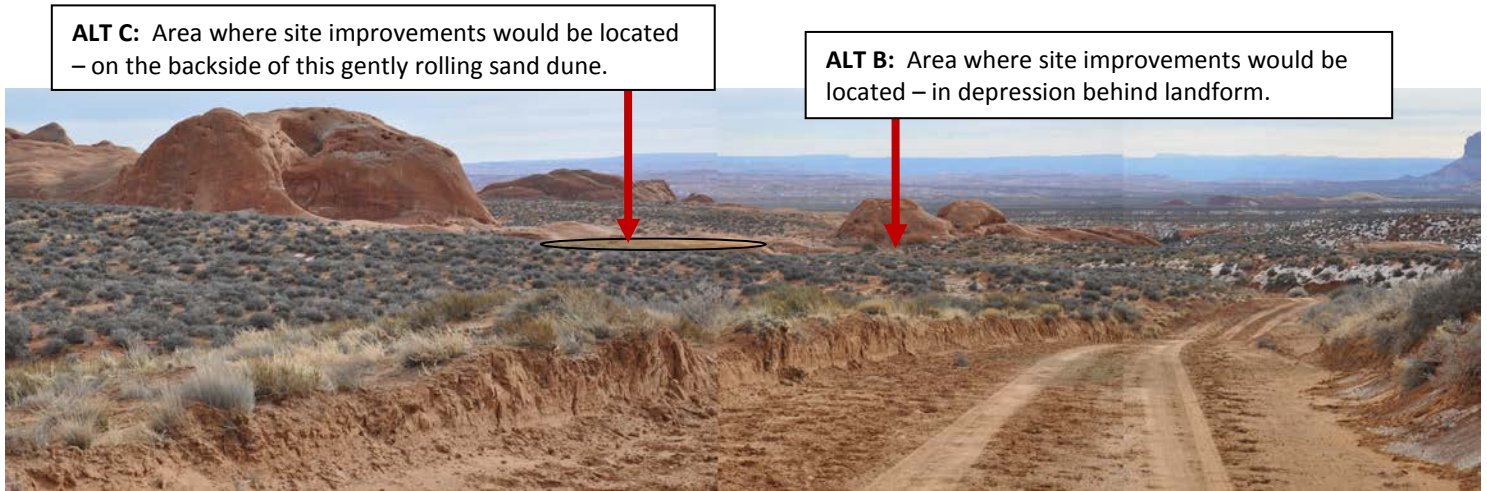
*KOP #1 – looking south toward Dance Hall Rock.*

For **Alternative B** as viewed from KOP 1 (traveling south on Hole in the Rock approaching the proposed area), the site improvement area would be completely screened from view. The casual observer would not see a vault toilet, vehicles or other site features because they would be located in a natural depression behind a berm-shaped landform.

For **Alternative C** as viewed from KOP 1 (traveling south on Hole in the Rock approaching the proposed area), the site improvement area would be located on the downhill side of the rolling landform thus partially screening it from view. The casual observer would see segments of the entrance road and signs and would likely see the upper portion of the vault toilet and some portions of the larger vehicles. The ground disturbance for the parking area would not be visible from this viewing platform.

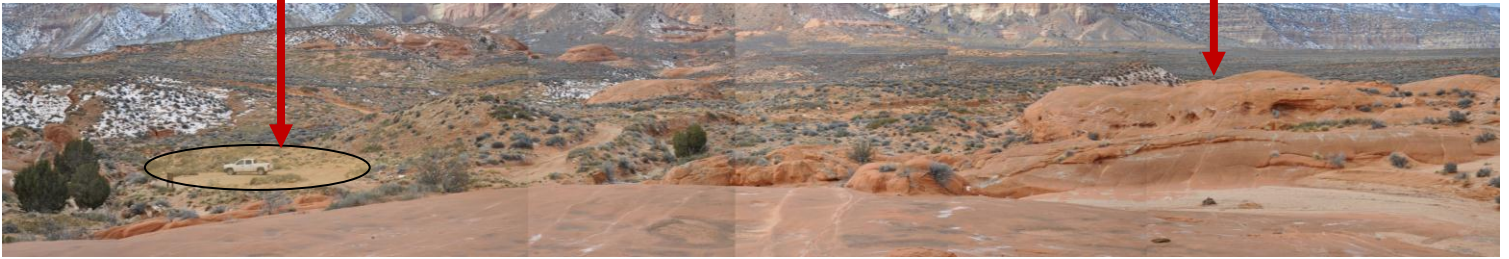
*KOP #3 – looking outward from floor of Dance Hall Rock.*

**ALT B:** Area where site improvements would be located.

**ALT C:** Area where site improvements would be located – behind this sandstone feature.
