Course 3800-16 Final Examination Scenario **[ADD reference material in BOLD on NTC version]**

The following matter involves an evaluation of the use and occupancy of four contiguous mill sites that were located in southern Nevada. The Assistant Field Manager (AFM) for Minerals and Lands, also known as the Authorized Official or AO has asked the solid minerals staff to inspect the location of a suspected abandoned mineral processing operation based on information received from the public. The AFM requests a report with findings and recommendations about the situation. You have been asked to assist. The area to be inspected is within Township 25 South, Range 57 East, Section 26, east-half, Mount Diablo Meridian, Clark Co, NV (see file/Doc1_MTP_T25S_R57E_Clark_co_NV.pdf). **Hint:** review this MTP with an individual of your Lands-Realty staff for their insight into how to determine whether or not Section 26 is withdrawn from mineral entry.

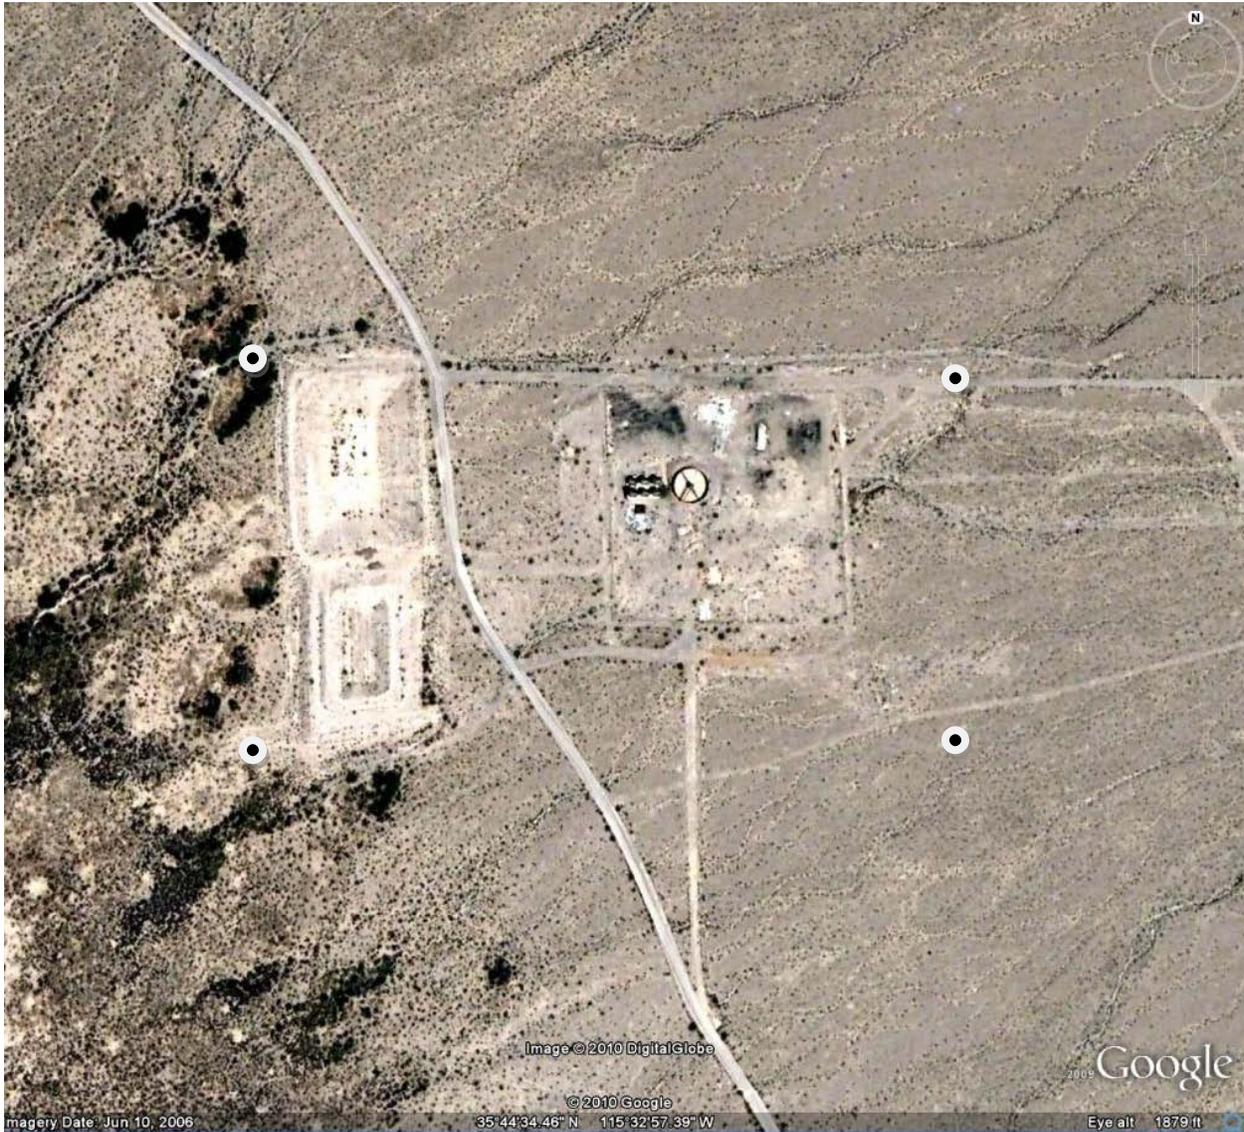
Figure 4 – Screen capture of aerial of view of the subject land from GoogleEarth.com (6-10-2006 aerial coverage, one inch equals about 340 feet). The approximate locations of the outer corners of the contiguous mill site block are shown.

Figure 4 is an aerial photograph which shows that some structures and excavations may be present.

Doc4_Figure_3.jpg and Figure 4 above show a road crosses through the western side of the mill site locations, so the area should be accessible by vehicle.

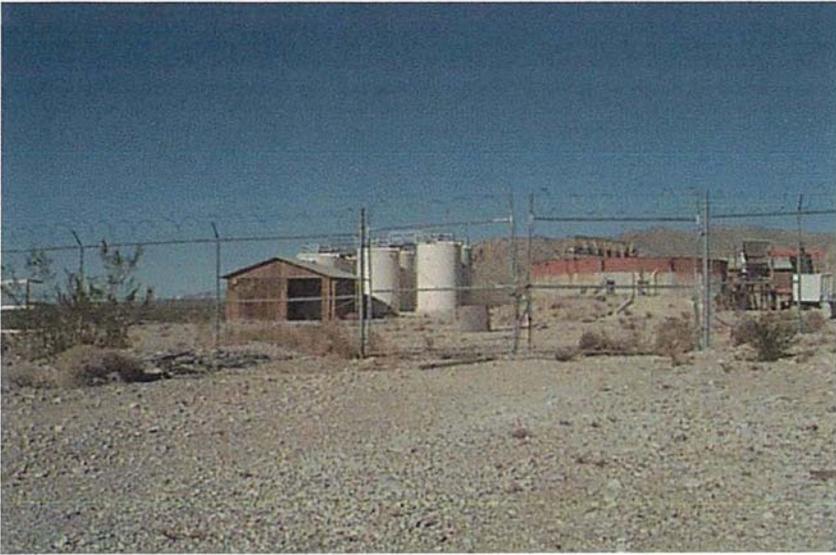
Figure 5 – view to east-northeast of inactive facilities behind chain link fence.

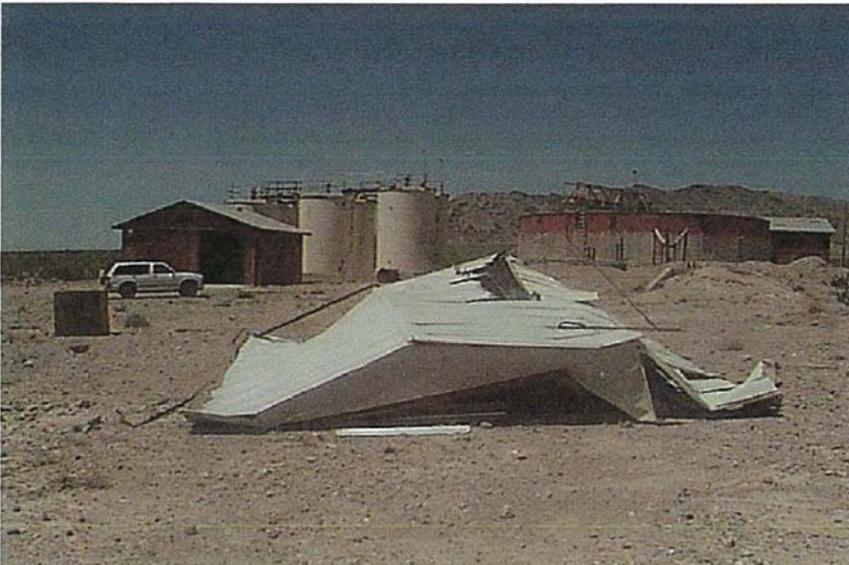
Figure 6 view to northeast from within the fenced area (note vehicle for a sense of scale). A collapsed metal shed is in the foreground.

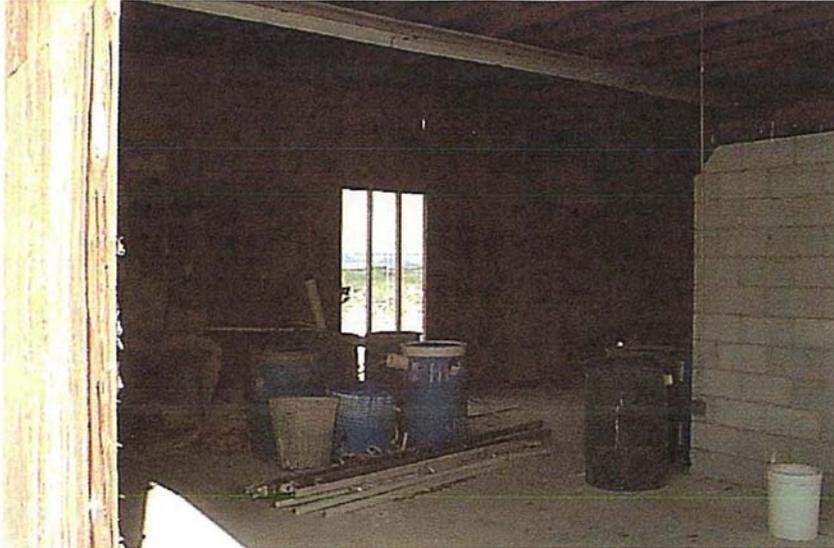
Figure 7 – view to northeast inside the small wooden building in the left of Figure 6. The door to the building is missing as is part of the exterior wall (center of this image) apparently due to vandalism. The interior is in disarray. Empty and partially filled containers and other materials are strewn about. This building sits atop a concrete foundation.

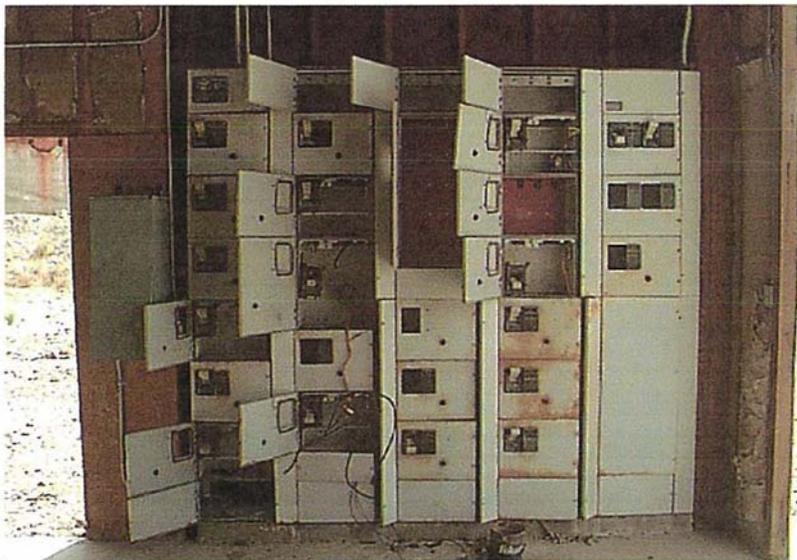
Figure 8. View of an electrical panel on the south wall of the building in Figure 6 that appears to have been vandalized.

There were no commercial utilities; e.g., electricity, water, etc. on or near the former mill sites locations. There were a few power poles within the fenced area (one is shown in Figure 13) and a vandalized electrical panel in one of the buildings (see Figure 8) but there are no electric lines. None of the equipment appears to be operable. There is nothing to indicate any locatable minerals were processed on location; a processing circuit that may have been used is not evident. The condition of the buildings and tanks indicate they have been abandoned for some years. The residents in the area indicate they never saw processing taking place at the location which has been abandoned since about 1995 and that the buildings and equipment appear to have been vandalized since their abandonment.

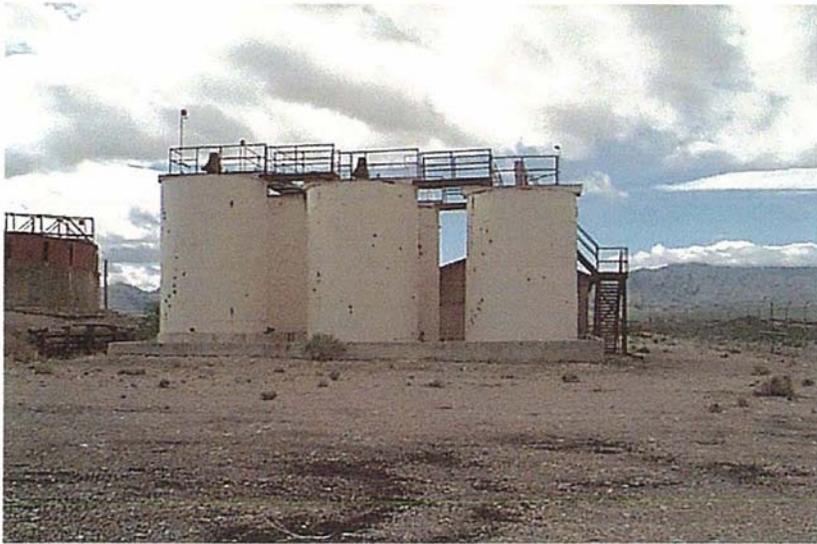
Figure 9. Six metal tanks that are located behind (north) of the wooden building pictured in Figure 6. The exterior of these have been shot numerous times. Metal steps and walkways provide access to the tops of these tanks.

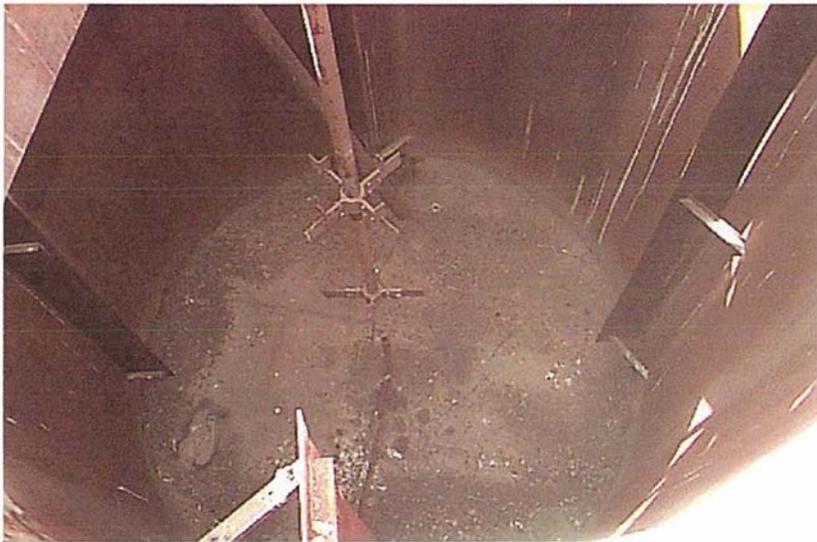
Figure 10 – View from the top into one of the tanks shown in figure 9. These appear to be mixing tanks and which could contain up to 50,000 gallons of fluid. The rod that hangs vertically in the middle of each tank has paddles attached to aid in mixing. The rod connects to an electric motor that sits atop each tank. There appears to be flakes of paint and rust in the bottom of the tanks.

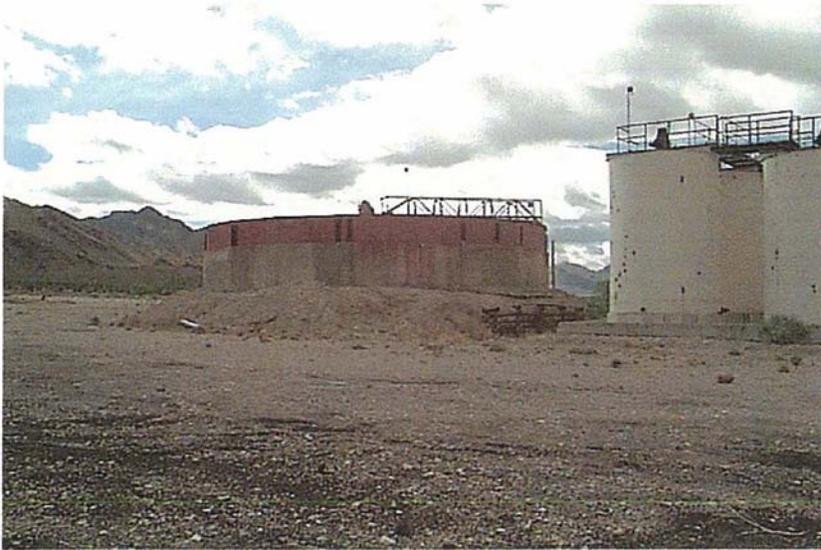
Figure 11 – View to southeast of a larger tank to the east of the white colored mixing tanks.

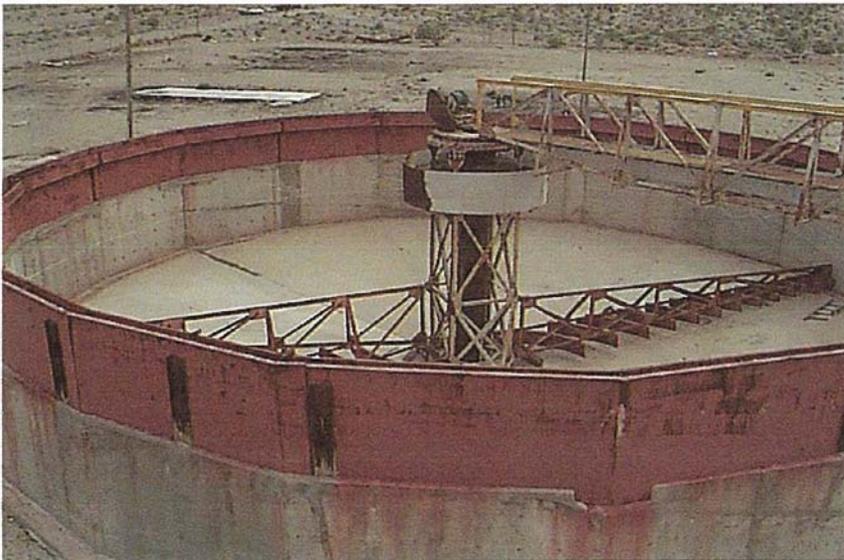
Figure 12 – View to the northeast into the top of the larger tank shown in figure 11. A placard atop the center spindle indicates this is a 50' diameter thickening tank. There is no residue on the tank bottom and there are no pipes or fitting which connect it to the buildings or other tanks. A concrete pad is in the background.

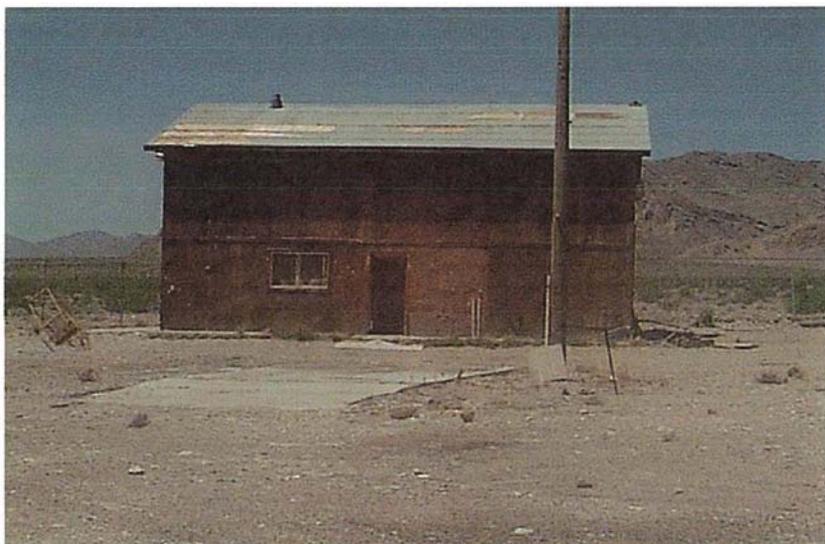
Figure 13. View to north of another wooden building in the northeastern part of the fenced area. The east end of this building appears on the right side of Figure 6. The entry door has been removed.

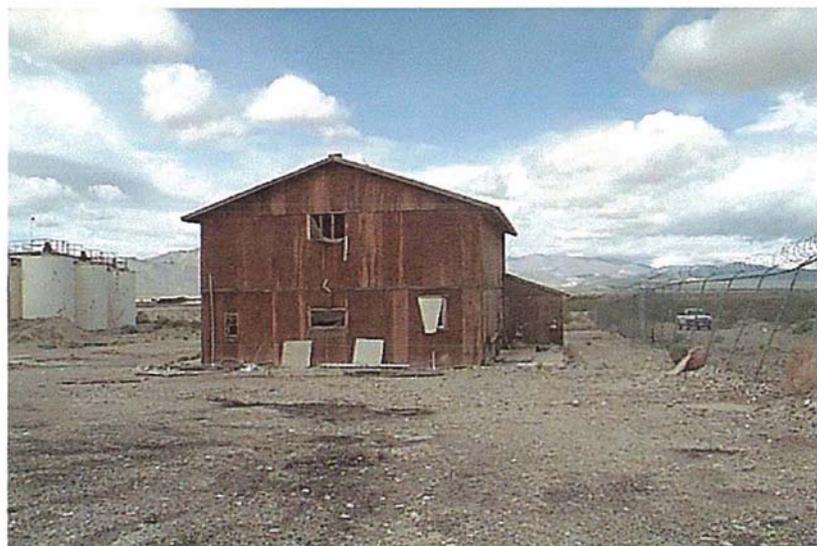
Figure 14 – View to west showing the east side of the building in Figure 13. Windows have been broken-out. The north line of the fence that encloses the buildings and tank is at right.

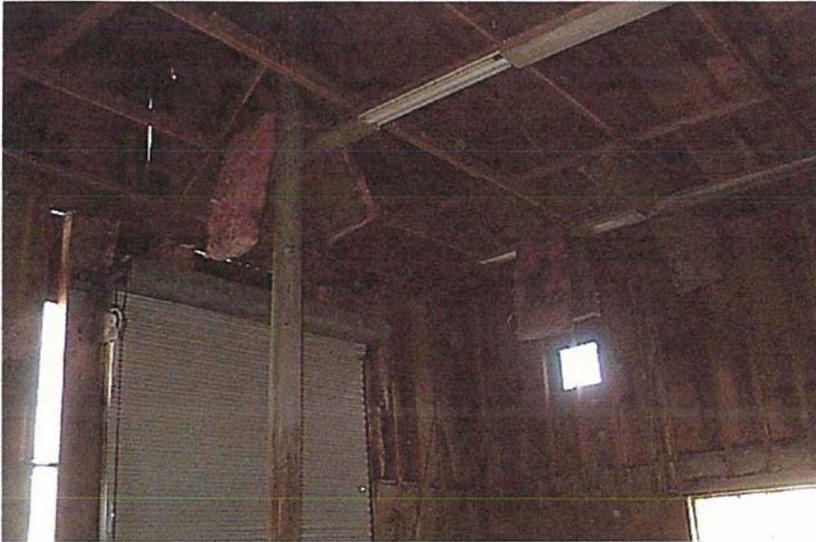
Figure 15. View to northwest of west wall and portion of north wall interior of the building in figures 13 and 14. There is no ceiling and insulation hangs from the rafters. The tube at left is an exhaust for a heating unit showing in Figure 16.

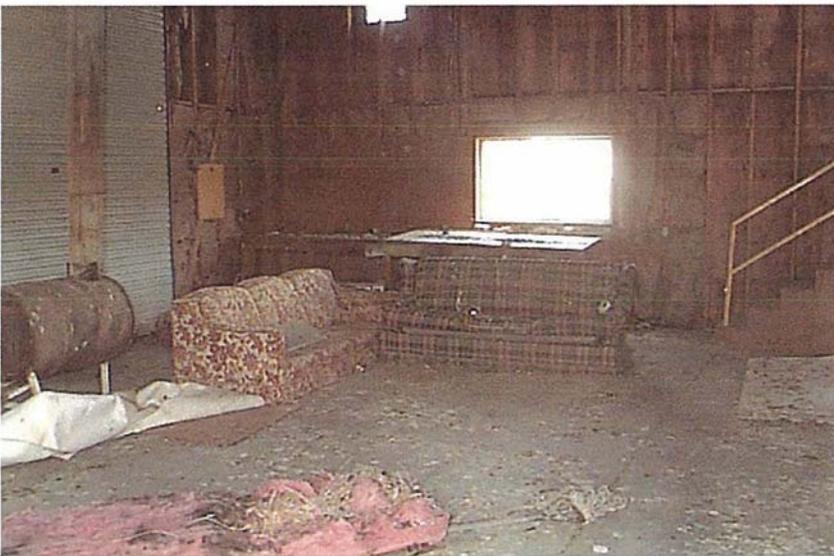
Figure 16. View of the concrete floor to the building (pan downward from the view in Figure 15). This building is also in disrepair. What appears to be a heating unit is at left.

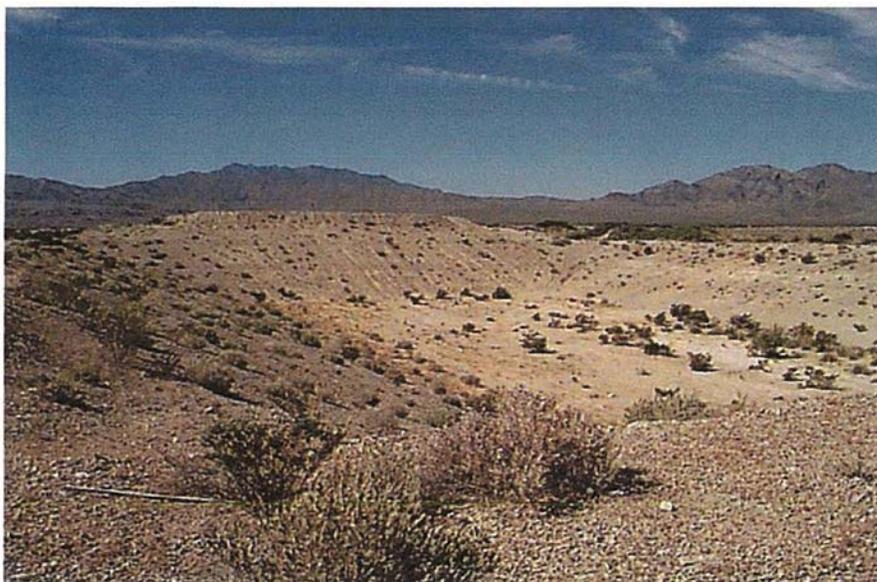
Figure 17. View to northeast of the northern of the two pits shown in Figure 4. This may have been a water holding pond or some type of settling-tailings retention pond. This pit area was excavated into natural alluvial sand and gravel.
