Suggested Practices for Avian Protection On Power Lines: The State of the Art in 2006

PIER FINAL PROJECT REPORT CEC-500-2006-022

Avian
Power
Line
Interaction
Committee

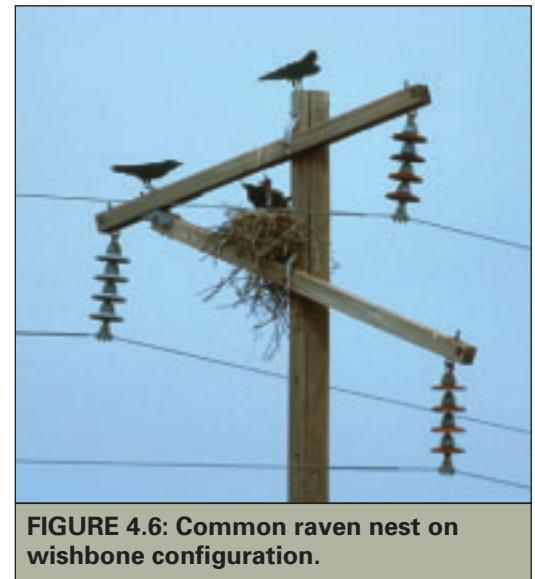
FIGURE 4.6: Common raven nest on wishbone configuration.
